### Instrument Cluster TFT Displays Inactive

Vehicle Type: **Panamera (971)**

Model Year: **2017 - 2018**

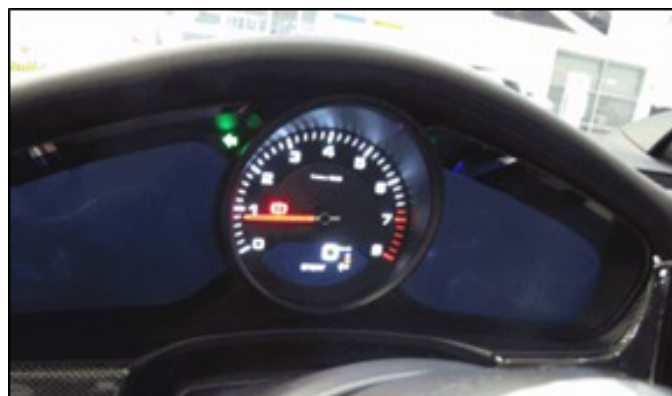
Figure 1

Customer Concern: The customer reports that the left and right instrument cluster TFT displays do not function. (See figure 1.)

Technical Concern: This failure is often accompanied by a long list of instrument cluster faults, including "C11011 - Control unit faulty, watchdog". All reported cases have been at PDI or with very low mileage.

Service Information: The recommended repair is to replace the instrument cluster. Only part numbers with suffix "G" or later should be used.
