**Title:** Radar Sensor Interference w/Rock Screen/Shield

**Applies To:** LT with collision avoidance feature codes 08TPL, 08TPU, 08TUE

This document will guide the user through identification and correction of rock screen/shield gap.

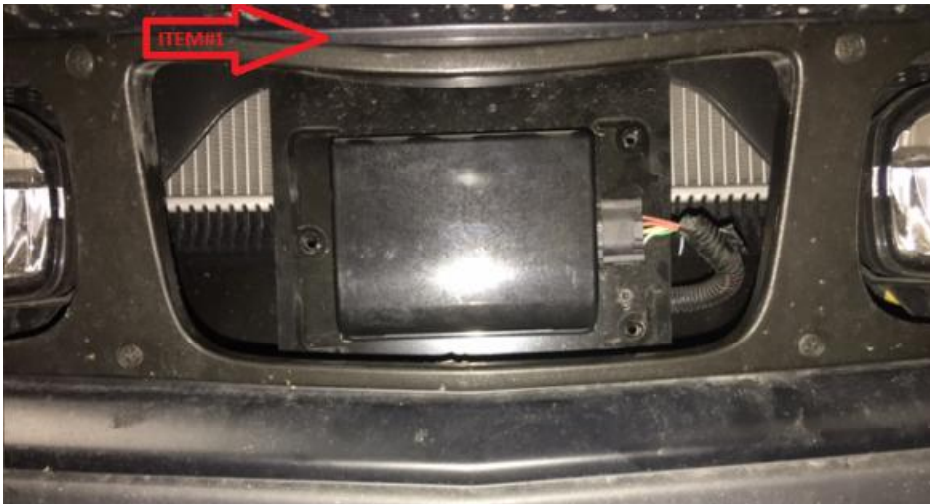
Figure 1 - Front Bumper

| Step | Action | Decision |
|---|---|---|
| 1 | <b>DIAGNOSTIC:</b><br>Does the unit have a visible gap between rock screen/shield and bumper? See Figure 1 Item 1. | Yes - Continue to Step 2. |

Item 1: Identify screen/shield gap interfering with radar sensor.

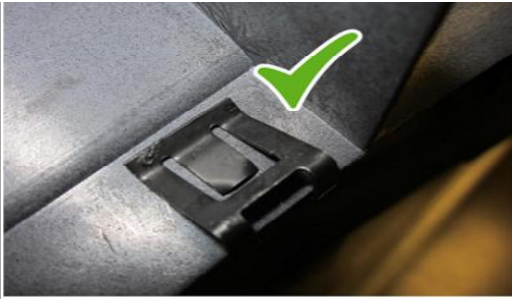
**Figure 3: Clip installation**

**Note:** Clip color and shape may vary by supplier.

| Step | Action | Decision |
|---|---|---|
| 2 | <b>DIAGNOSTIC:</b><br>Follow Figure 2 and Figure 3 repair steps below for proper clip installation. | Clear faults, retest for concern and continue to Step 3. |
