**Title:** LT/ Prostar Exhaust Stack Heat Shield Crack

**Applies To:** A26, ISX15, LT and Prostar Chassis with 07BER

This document will guide the user through identifying exhaust heat shield cracking and the repair method.

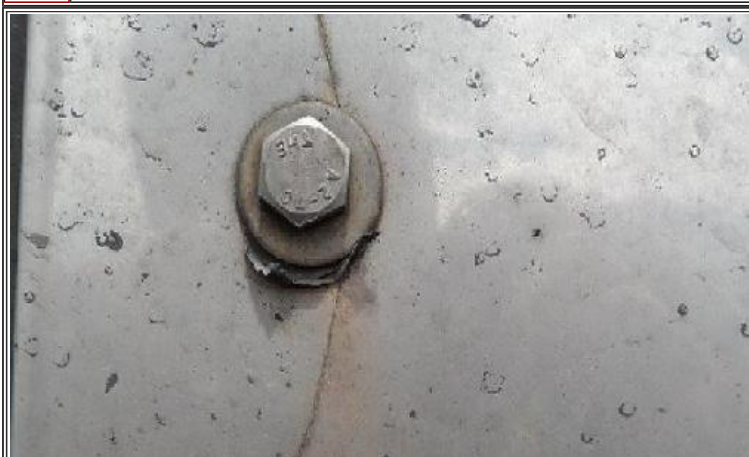
**Figure 1: Heat Shield crack**

Exhaust stack heat shield cracked at bolt hole(s).

| Step | Action | Decision |
|---|---|---|
| 1 | <b>DIAGNOSTIC:</b><br>Is the exhaust heat shield cracked (Figure 1)? | Yes. Continue to Step 2. |

| Step | Action | Decision |
|---|---|---|
| 2 | Replace the heat shield with lineset heat shield, install bolt and washer contained in kit (3804756C1) | Continue to Step 3 |

Torque the six exhaust shield mounting bolts to the following specs, 17Ft LBS or 204 inch LBS.
