**Title:** Oil Pump Bushing Replacement Procedure

**Applies To:** MaxxForce 11/13, N13, A26

This a step by step procedure for replacement of the oil pump bushing within a MaxxForce 11/13, N13 and A26 engine.

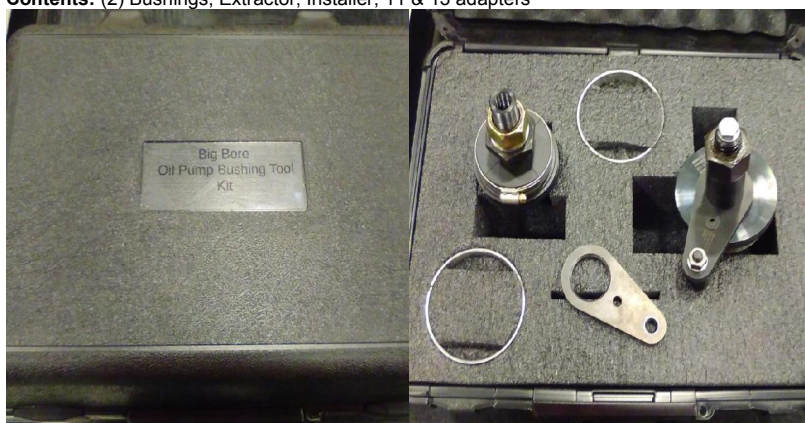
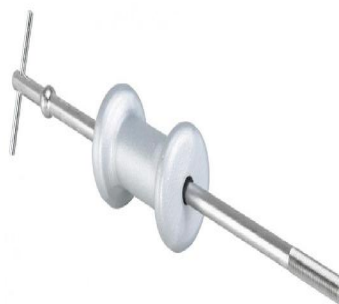
**Navistar Supplied:** Oil Pump Bushing Tool Kit

**Contents:** (2) Bushings, Extractor, Installer, 11 & 13 adapters

**Slide Hammer:** Dealer supplied: ZTSE1879A or

OTC Part# SKU1155 with a 5/8"-18 threaded end.

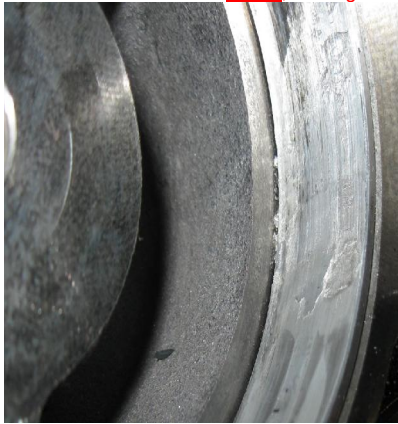
**Note:** The oil pump bushing has spun in the bore blocking the supply port.

Do not continue with the iKNow, the engine block has to replaced.

**If the oil pump bushing is spun the engine block has to be replaced. Do not replace the bushing!**

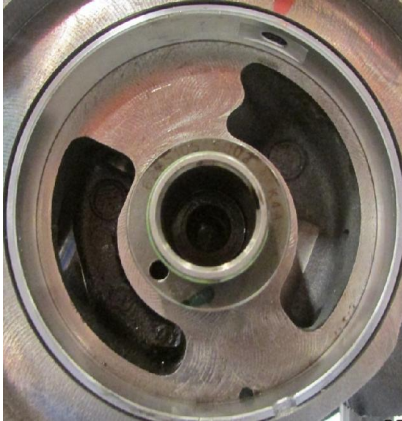
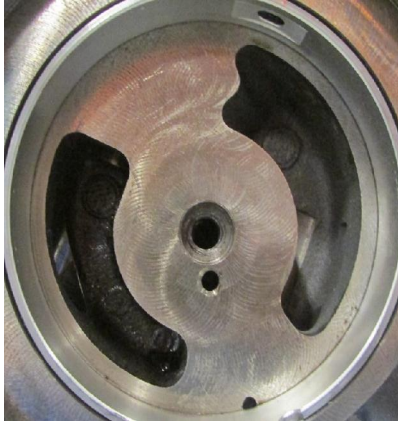
**Step 2:** Remove the oil pump pinion.

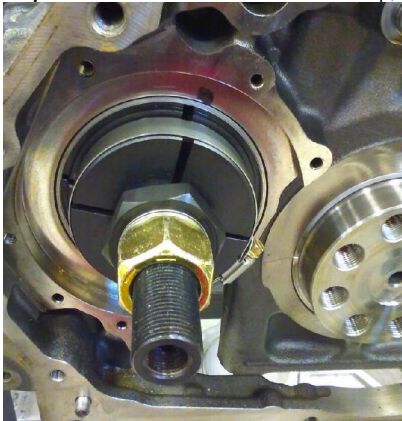
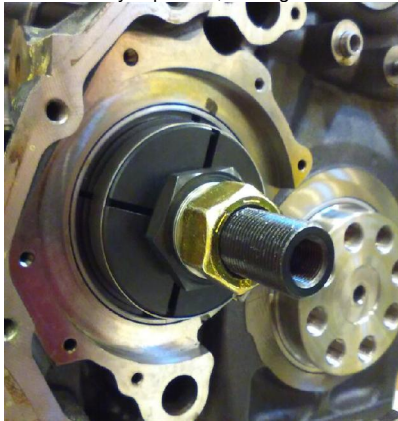
**Step 3:** Install the extractor and loosen clamp, tighten nut until it's fully expanded, making contact with the bushing.

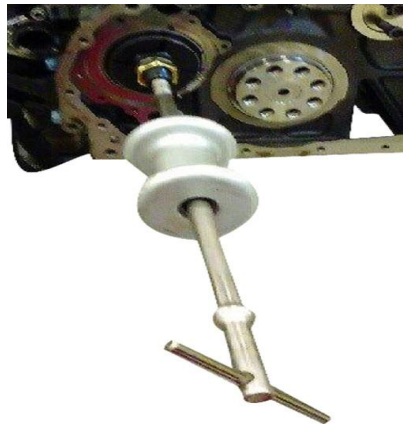
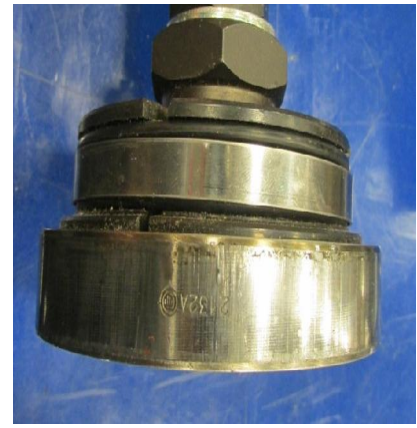
**Step 4:** Thread the slide hammer in 3/4 - 1", this will prevent damage to the extractor. Slide hammer the bushing from the engine.

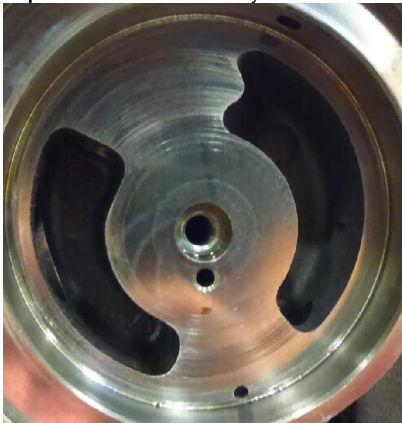
**Step 5:** Clean and remove any excess debris and oil from the pump bore.

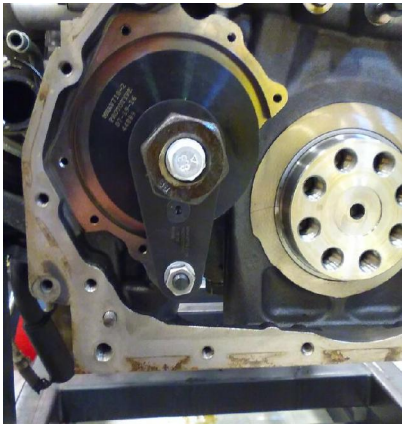
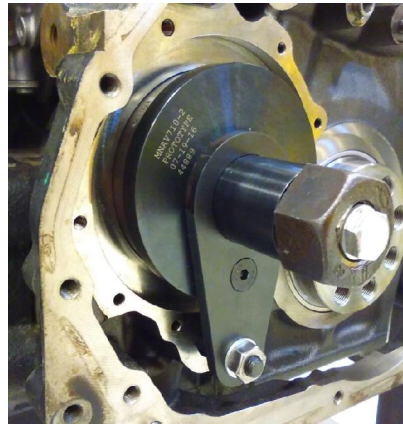
**Step 7:** Use the correct adapter. The 13L adapter will be installed with the tool. If needed, the 11L adapter will be in the storage cavity. Thread the installation bolt into the block and check alignment. To install the bushing, tighten the outer nut, this will press the bushing into block. The tool will be flush with the block after installation.

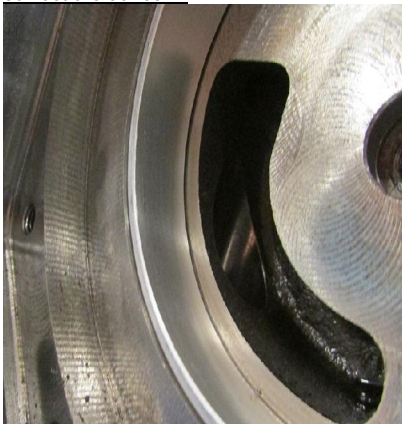
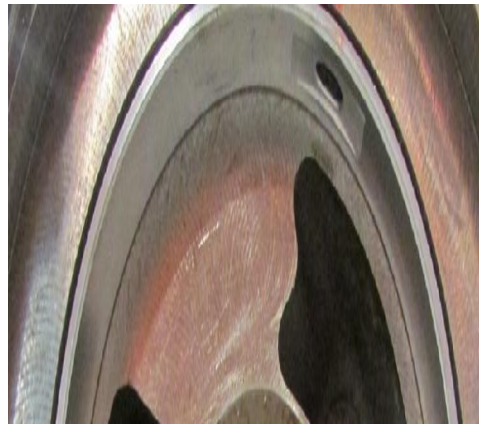
**Step 8:** Remove the installation tool and check for proper installation of the bushing with the supply port. If the oil feed is blocked, replace the bushing to correct the concern.
