**60 17 02** May 31, 2017 **2045403** Supersedes Technical Bulletin 60-17-01 (V601701) dated February 6, 2017 to update procedure labor operation time units, reduce kit quantity and remove note about repair kit claiming.

Water leak from the Sunroof (Panoramic Roof) on Golf and GTI models

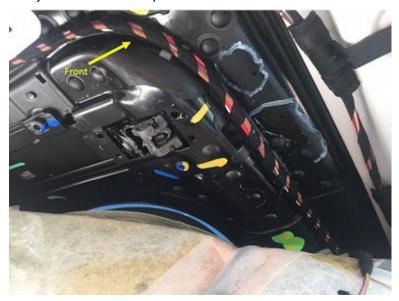
Verify the customer complaint. Water leaks occur near the A-Pillars in the corners of the sunroof water channel.

Figure 1 (Water leaking through corner of water channel, headliner lowered for clarity.)

Some of the plastic rivets/buttons may be missing from the steel reinforcement plate as illustrated by the white outline in Figure 1. This will not affect the structure of the water channel. <u>DO NOT</u> attempt to repair or seal the openings caused by the missing rivets.

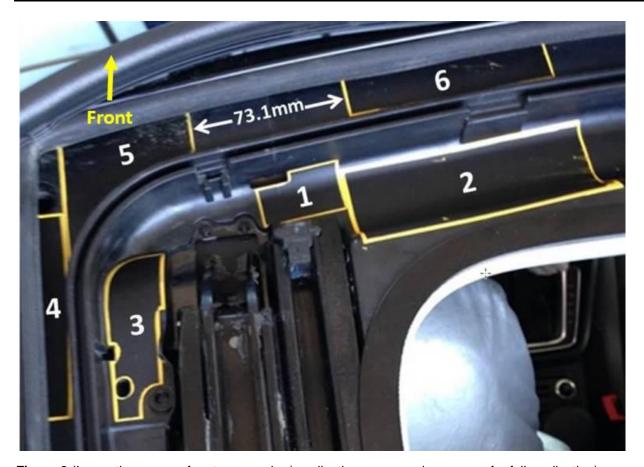
Inspect the sunroof water channel for stress cracks (see figure 2). There are a total of 12 areas to inspect for cracks which are outlined in Figure 3 below. (More than 1 crack may be found).

Figure 3 (Inspections zones for stress cracks / application zones and sequence for foil application)

Left side shown in figure 3 above. Please note foil patches are applied to the right side in the same application zones and sequence.

A difference in the expansion rate between the plastic water channel and steel reinforcement plates may cause stress cracks to occur at the edges of the reinforcement plates.

In most cases there will be stress cracks in multiple locations of the water channel. Care must be taken to ensure all cracks are identified, sealed and that all 12 foil patches are installed correctly. Failure to seal all cracks and install all 12 foil patches will result in a repeat failure.

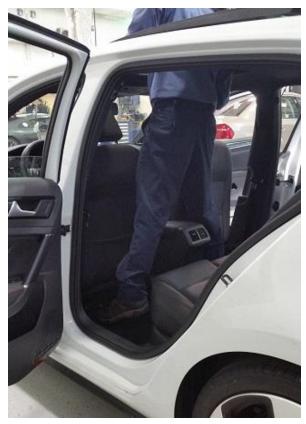
Figure 4

1. Move the front seats forward and tilt the seat backs forward to allow room to work on the roof by standing through the sunroof opening from the rear of the vehicle (See Figure 4).

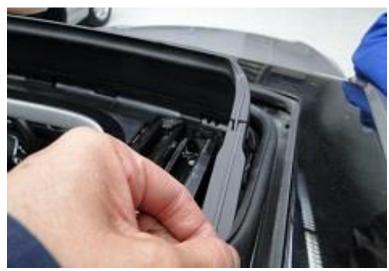
2. Remove the inner sunroof seal from around the front of the sunroof opening and lay it back over the sunroof glass (See figures 5 and 6).

Figure 5 (Inner Sunroof Seal)

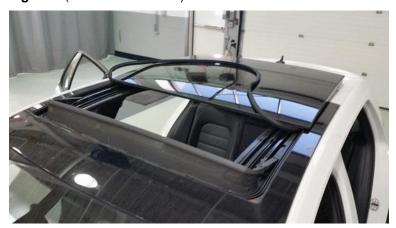
Masking tape can be used to hold the seal in place on top of the sunroof glass for the duration of the repair.

Figure 6 (Inner sunroof seal draped over sunroof glass)

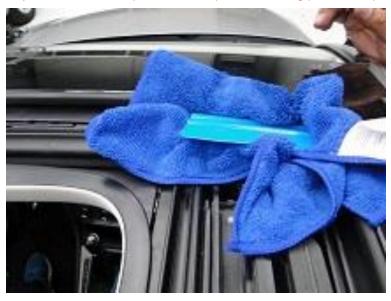
#### Figure 7

4. Thoroughly clean the water channel with isopropyl alcohol, a microfiber cloth and compressed air. Use a bone tool or the squeegee supplied with the repair kit to clean the area underneath the sunroof trim panel by pushing the cloth underneath the trim (See Figure 7).

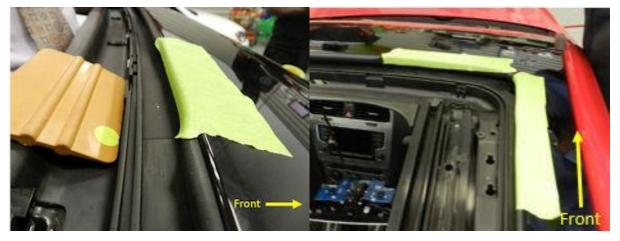
Figures 8 and 9

- 5. Wait at least 10 minutes after cleaning the water channel before proceeding to allow alcohol to evaporate.
- 6. Use masking tape to lift and compress the outer sunroof seal to provide additional access to the water channel underneath the sunroof trim panel (See Figures 8 and 9).

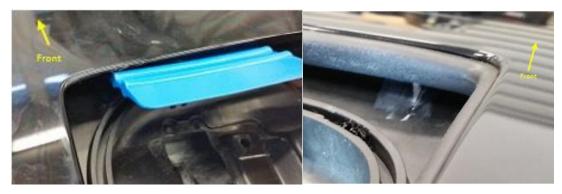
9. Remove all excess sealant from the water channel. There must not be any excess sealant that may prevent the foils from being applied completely flat to the water channel. The crack should be filled with sealant with no excess sealant around the crack (See figures 12 and 13).

**Figures 12 and 13** (Spread sealant working from sunroof opening to underneath the trim panel. Sealant should fill crack and there should be no excess sealant on the water channel.)

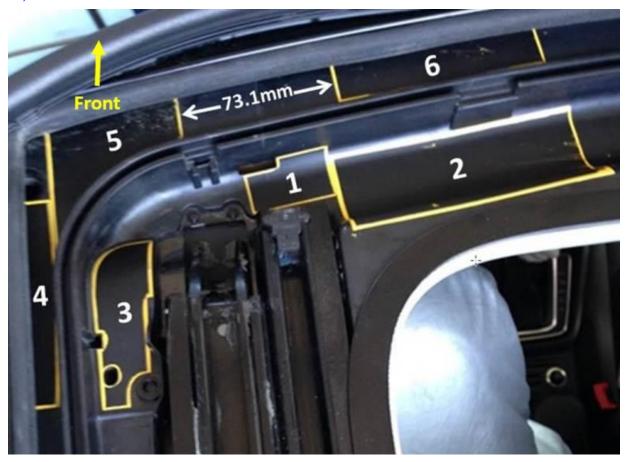
12. Apply the foil tapes one at a time according to the sequence shown in Figure 14.

Foil tapes must be applied in all 12 positions regardless if there is a crack or not.

Figure 14 Foil application sequence (Both sides of water channel).

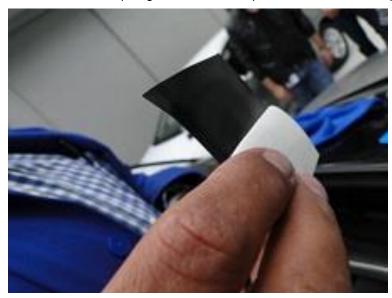
13. Peel half of the backing tape off the foil and fold it over to use to hold the foil during application. Align the foil with the edge of the water channel and apply the foil, working it forward using the included squeegee to ensure there are no air bubbles, wrinkles and that there are no gaps under the foil. Peel backing tape off as you work forward. Use the squeegee to work the tape down as smooth as possible.

Figure 16 Peel half of backing tape off foil and fold in half to use to hold the foil as it is applied.

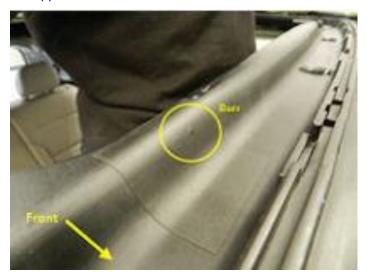
There may be a burr on the water channel in this location that appears to be an air bubble. This is normal and an acceptable condition after applying the foil (Figure 17).

Figure 17 Burr under foil position 1.

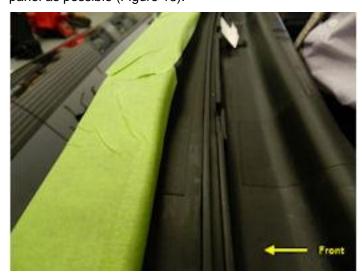
14. **In position 6**, peel half of the backing tape off the section of foil to be placed underneath the trim panel and fold it over to use to hold the foil during application. Ensure the tape is as far underneath the trim panel as possible before beginning to adhere it to the water channel. Apply the foil working it toward the rear using the included squeegee to ensure there are no air bubbles or wrinkles and that there are no gaps under the foil. Peel backing tape off as you work. Use the squeegee to work the tape down smooth and as far underneath the trim panel as possible (Figure 18).

Figure 18 Foil positions 2 and 6 fully applied.

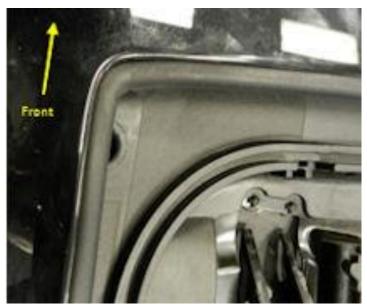
15. **In position 5,** peel half of the backing tape off starting at the pointed edge in the radius and fold it over to use to hold the foil during application. Carefully align the radius of the foil to the radius of the seal channel and ensure the drain hole and witness mark around the drain will not be covered. Apply the foil working it forward using the included squeegee to ensure there are no air bubbles or wrinkles and that there are no gaps under the foil. Peel backing tape off as you work. Use the squeegee to work the tape down smooth and as far underneath the trim panel as possible (Figure 19).

Figure 19 Foil position 5 fully applied.

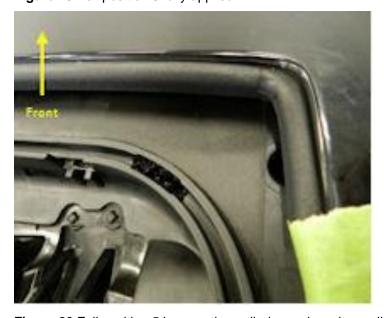
Figure 20 Foil position 5 incorrectly applied covering witness line around drain.

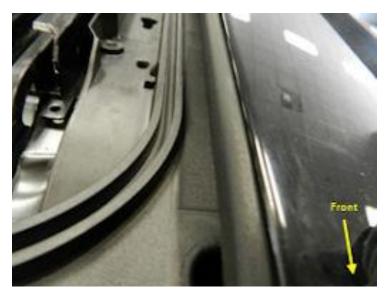
16. In position 4, peel half of the backing tape off the section of foil to be placed underneath the trim panel and fold it over to use to hold the foil during application. Use a pivoting motion to swing the foil underneath the trim. Ensure the tape is as far underneath the trim panel as possible before beginning to adhere it to the water channel. Apply the foil working it from underneath the trim toward the sunroof opening. Use the included squeegee to ensure there are no air bubbles or wrinkles and that there are no gaps under the foil. Peel backing tape off as you work. Use the squeegee to work the tape down smooth and as far underneath the trim panel as possible (Figures 21 and 22).

Figure 22 Foil position 4 fully applied.

It is more important that the foil in position 4 be applied as far underneath the trim panel as possible versus attempting to align it to the edge of the seal channel.

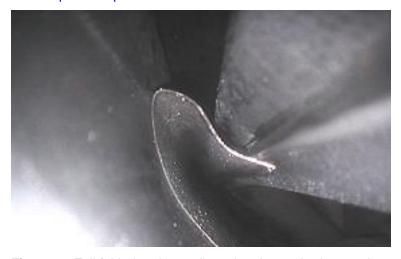
The foil must be fully applied underneath the trim panel. If the foil is folded over, it should be removed and a new piece applied (see figure 27). Use the squeegee to work the foil down on to the water channel as far underneath the trim panel as possible.

Figure 27 Foil folded and not adhered underneath trim panel
