Emissions Recall

Code: 23Q3

Subject	2.0L TDI Engine (GEN 3) Emissions Control Software – <u>USA ONLY</u>											
Release Date	May 26, 2017											
Revision Summary	Updated to reflect repair availability for all affected vehicles.											
Affected Vehicles	U.S.A.: 2015 MY Volkswagen 2.0L TDI (Gen 3)

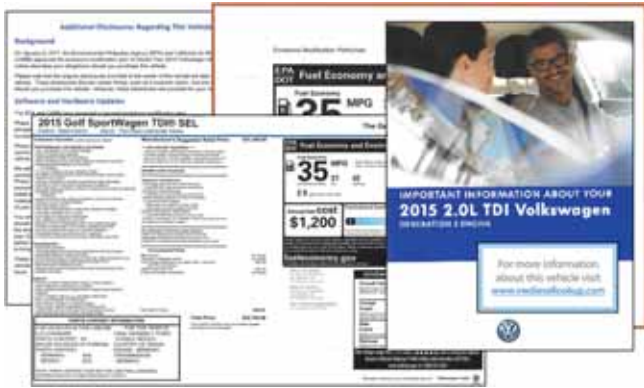
- Enter the VIN in Elsa and proceed to the “Campaign/Action” screen.

- Confirm the Campaign/Action is open <arrow 1>. If the status is closed, no further work is required.
- Note the Applicable Criteria ID <arrow 2> for use in determining the correct work to be done and corresponding parts associated.
- Check for other Open campaign actions <arrow>.
- Other Open campaign actions must be completed prior to releasing the vehicle to the customer.

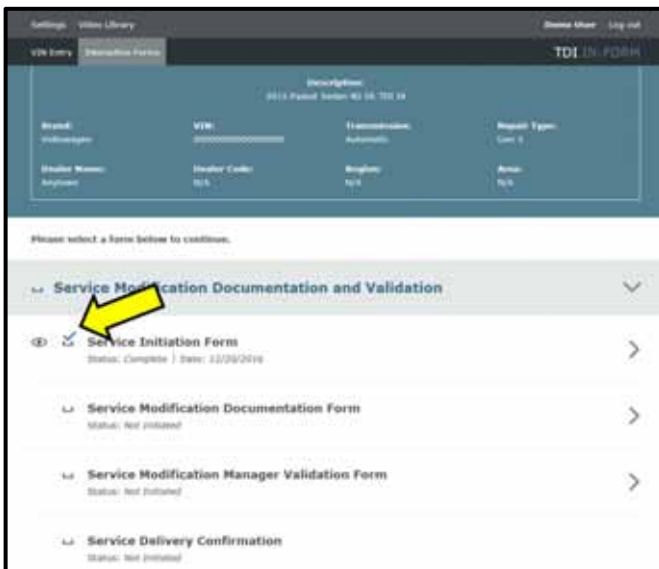
Ensure that the “check mark” <arrow> is present prior to beginning any work.

- Ensure the Service Initiation Form has a “check mark” <arrow>.
 - If the Service Initiation Form does not have a “check mark” <arrow>, immediately contact your Service Consultant to complete the initiation.
 - If “check mark” <arrow> is present, initiate Service Modification Documentation Form and continue work.

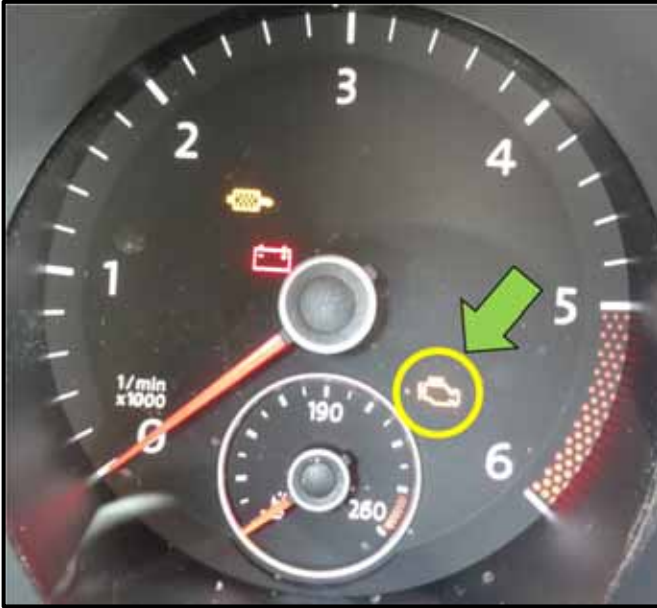
- Check for illumination of the MIL <arrow>.
 - If MIL is illuminated, STOP, obtain GFF diagnostic log, create a VTA ticket and contact the Volkswagen Technicians Helpline.
 - If MIL is not illuminated, continue work procedure.

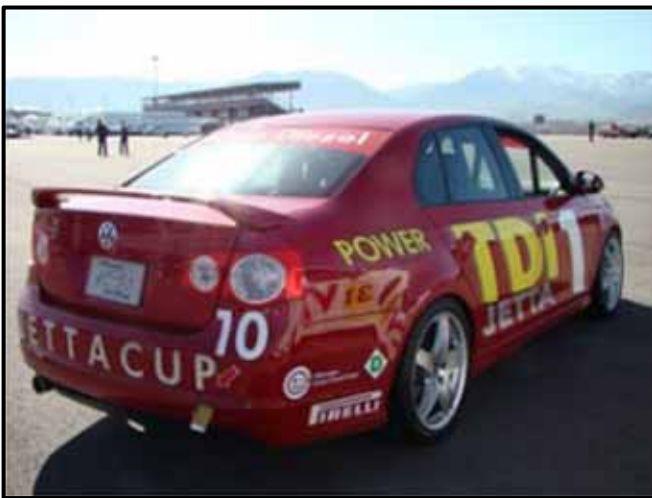
- Check for vehicle modifications from original equipment.
 - If vehicle modifications from original equipment related to emissions components are found, STOP, create a VTA ticket and contact the Volkswagen Technicians Helpline.
 - If vehicle modifications from original equipment related to emissions components are not found, continue work procedure.

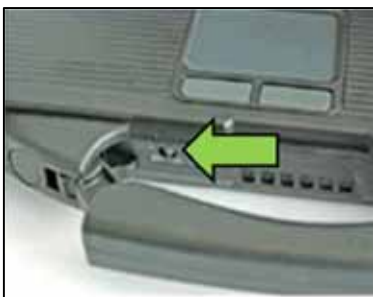
VAS 6150 & VAS 6150A
(Front panel behind handle)

- Performing a software update using a Bluetooth connection increases the risk of losing connection during the update, which could result in damage to the control module. It also greatly increases the time required to perform the update. Requests for additional time or parts will be denied if the GFF log shows the update was performed using Bluetooth.
- ✓ **The Bluetooth function of the scan tool is physically switched off <see pictures below>.**

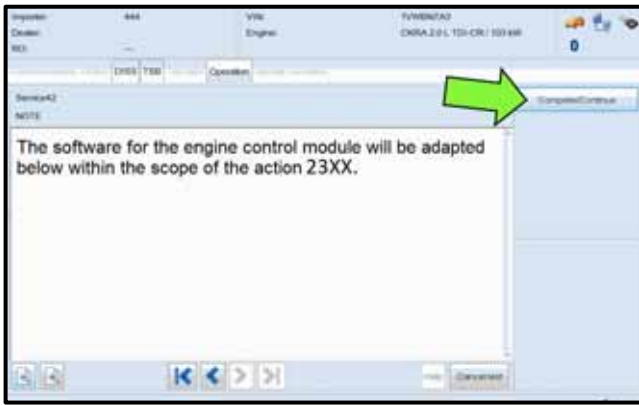
- Once the GFF scan is complete, select “Special functions”.
- Select the test plan “**Adapt software, diesel, exhaust EA189 action 23XX**” <as shown>.
- Select “Perform test” <arrow>.

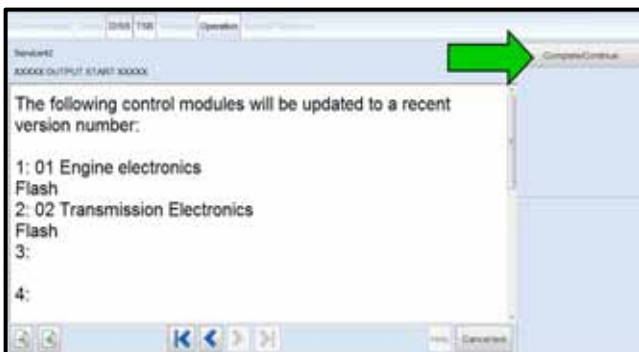
- Select “Complete/Continue” <arrow> to begin the software update process.
 - If the response indicates that the control modules are current **Flash Process is Complete, proceed to Section C.**
 - If the response indicates new software versions are available <as shown>, Select “Complete/Continue” and follow the on-screen prompts to **complete the test plan.**

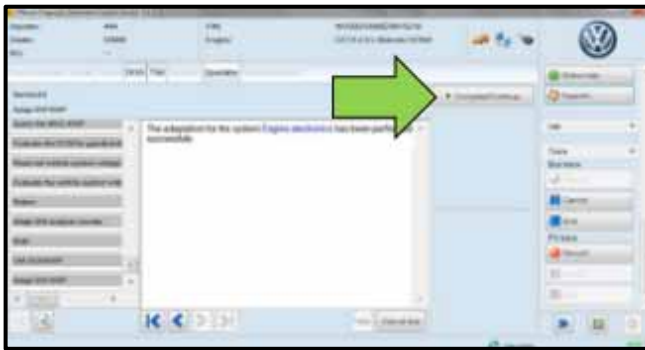
- When the SVM update is complete a confirmation message is displayed <as shown>.
- Select “Complete/Continue” <arrow>.

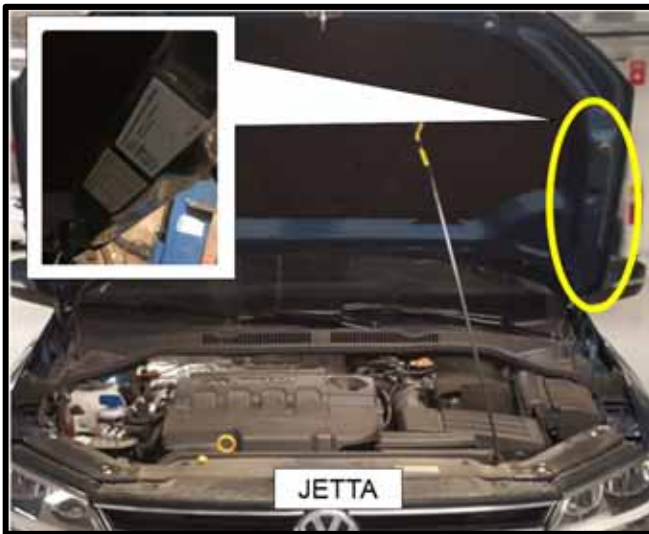
- Open the hood.
- Clean the surface where the label is to be installed <circle>.
- Install the Supplemental Vehicle Emissions Control Information Label, **03L 010 005 J**, in the location shown <circle>.

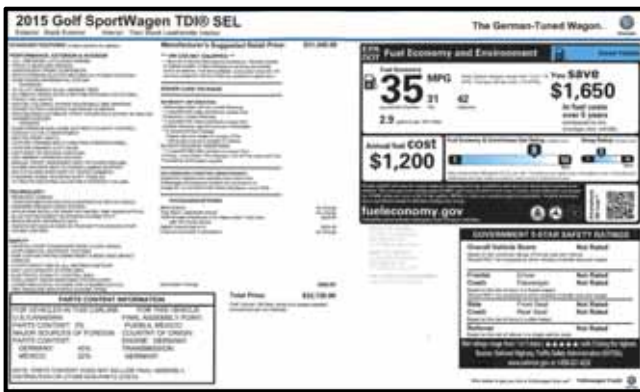
- Remove original Monroney Label and discard.
- Install new Monroney Label <example pictured left> on the rear passenger side window <example pictured below>.

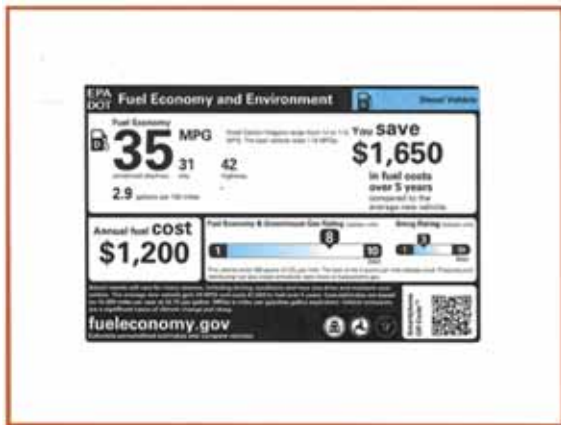
- Install new Fuel Economy Label <example pictured left> to the right of the new Monroney Label. If necessary, use the passenger front window <examples pictured below>.

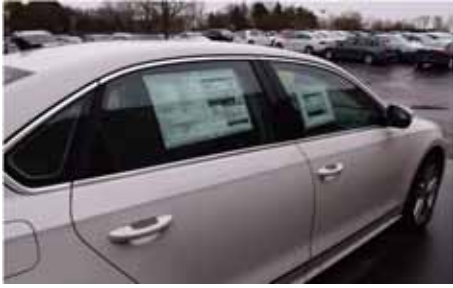
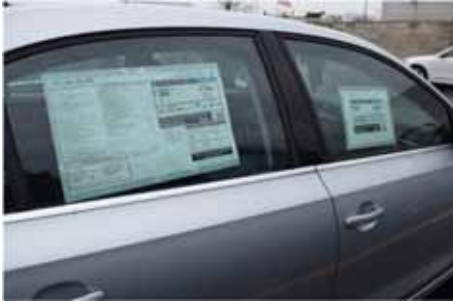
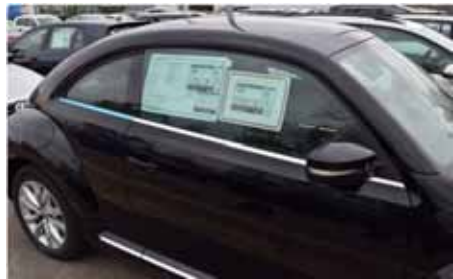
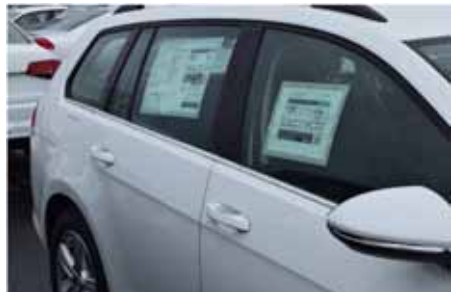
- Examples of properly Installed Monroney and Fuel Economy Labels <pictured left> on various vehicle models.

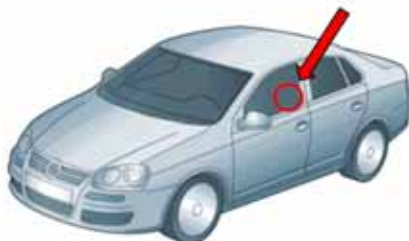
- Place the “more information” permanent window sticker <pictured left> on the front driver-side window in the lower right corner of the window <arrow>. Install the sticker from the inside of the window.
 - Affix the “more information” sticker to the front driver-side window as necessary either above, beside, or under any other required State and/or Local Labels (example, California Prop 65).
