UPDATE Technical Bulletin

60C7 UPDATE – Panoramic Sunroof Frame (NVLW)

This update has been proactively released to prevent water leaks to the interior of the vehicle that could be caused by cracks in the sunroof frame

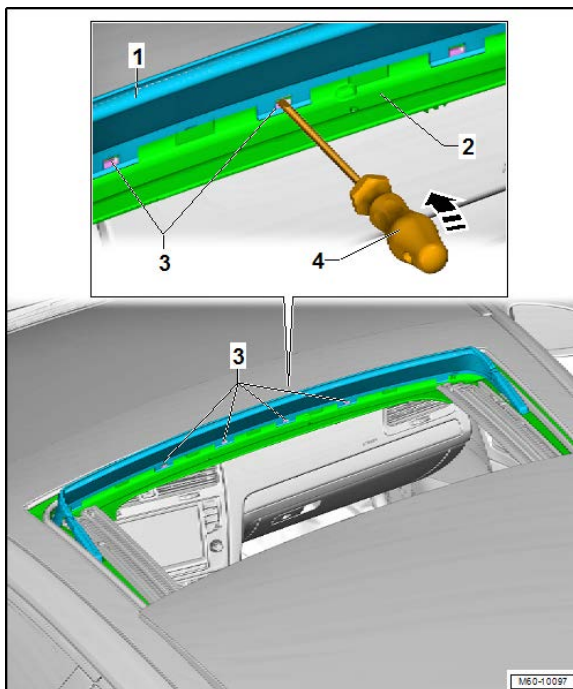
- Open the sunroof glass panel all the way.
- In the lower section of the wind deflector screen frame <1>, release the mounting tabs <3> using a flat-head screwdriver <arrow>.
- Loosen the wind deflector screen frame <1> from the sunroof frame <2>.

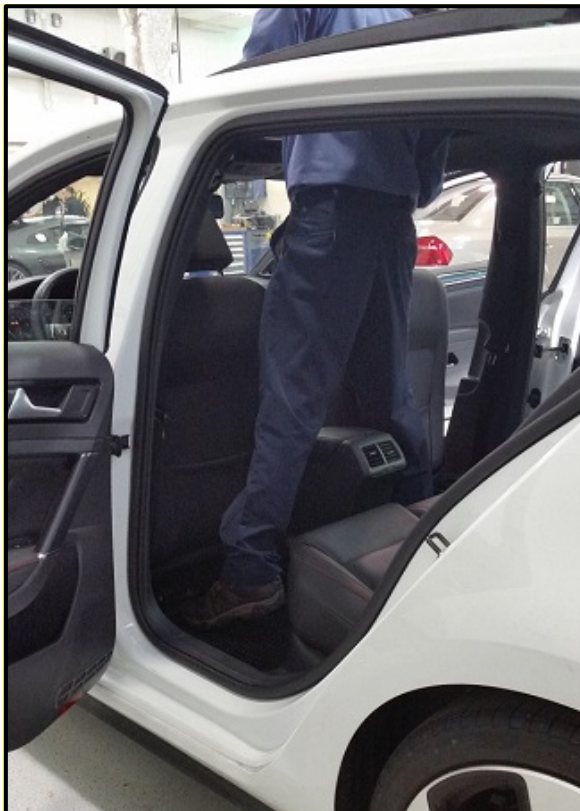
- Loosen the mounting tabs <A> for the wind deflector <1> on both sides using a flat-head screwdriver.
- Release the wind deflector <1> towards the vehicle rear -B-.
- Remove the wind deflector upward from the sunroof frame <2>.

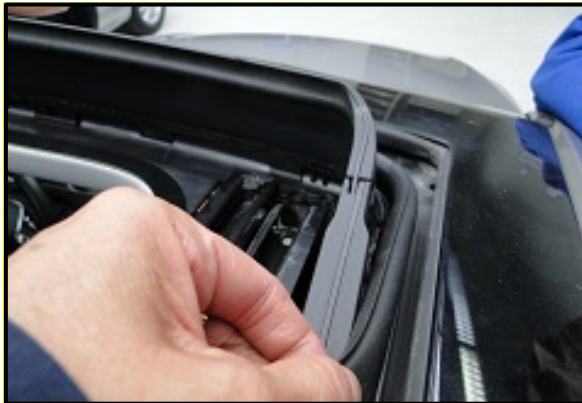
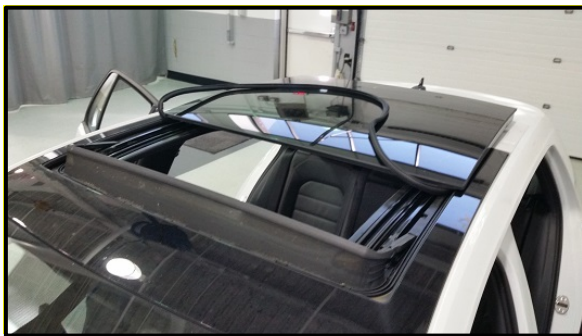
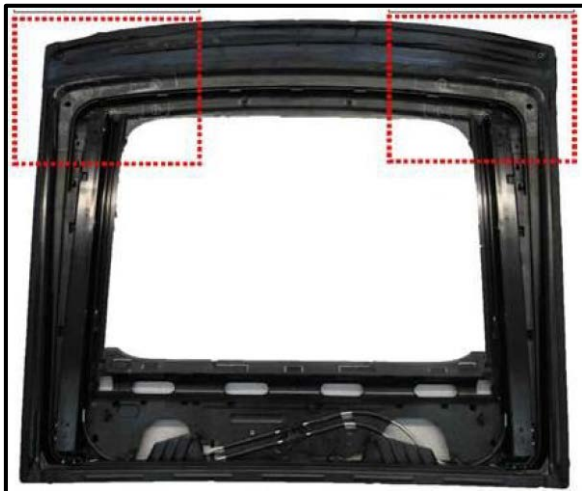
- Remove the inner sunroof seal from around the front of the sunroof opening and lay it back over the sunroof glass.

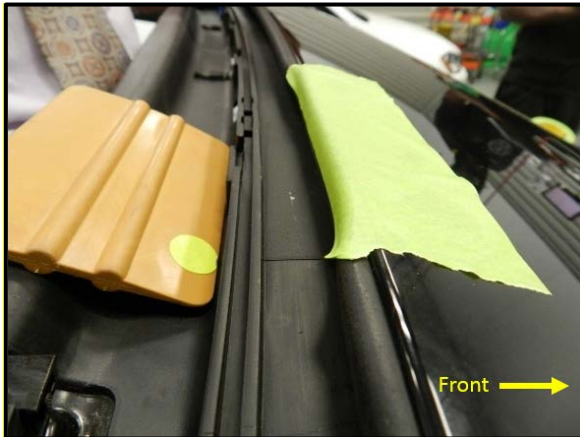
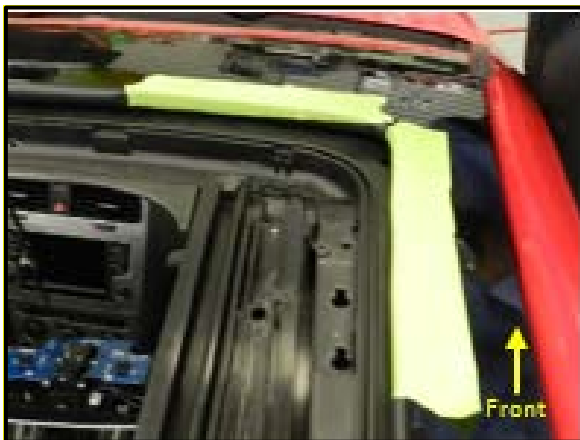
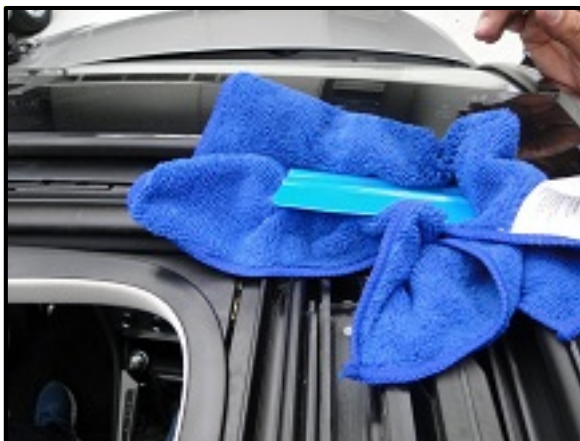
- The patch foils in the kit will be applied in the front corners of the sunroof frame.

Frame shown removed for clarity. Do not remove the sunroof frame.

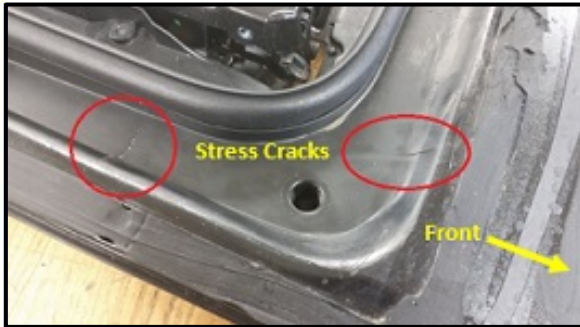
- Use extreme care when working around the sunroof frame so that the exterior part of the frame is not scratched, cracked or otherwise damaged.
 - Damage to the sunroof frame during this repair will not be covered by this action.
-
- Thoroughly clean the water channel with isopropyl alcohol, a microfiber cloth and compressed air. Use a bone tool or the squeegee supplied with the repair kit to clean the area underneath the sunroof trim panel by pushing the cloth underneath the trim.
 - Wait at least 2 minutes after cleaning the water channel before proceeding to allow alcohol to evaporate.

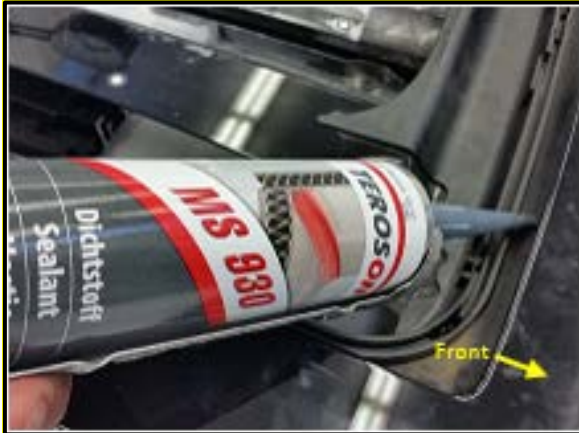
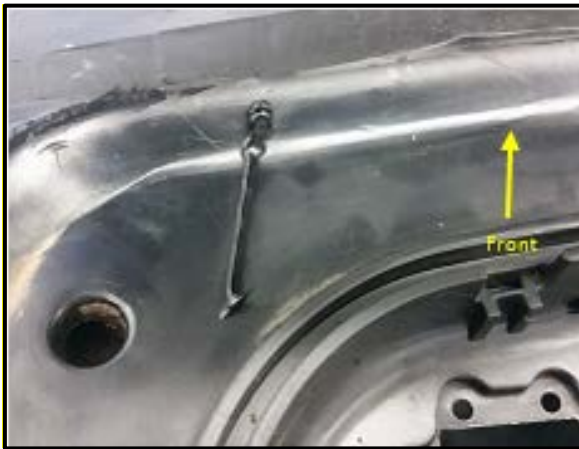
- There are a total of 12 areas to inspect for cracks.

- Left side is shown. Inspect the same six areas on the passenger side.
- More than one crack may be found. All cracks will need to be repaired.
- In most cases there will be stress cracks in multiple locations of the water channel. Care must be taken to ensure all cracks are identified, sealed and that all 12 foil patches are installed correctly. Failure to seal all cracks and install all 12 foil patches will result in a repeat failure.

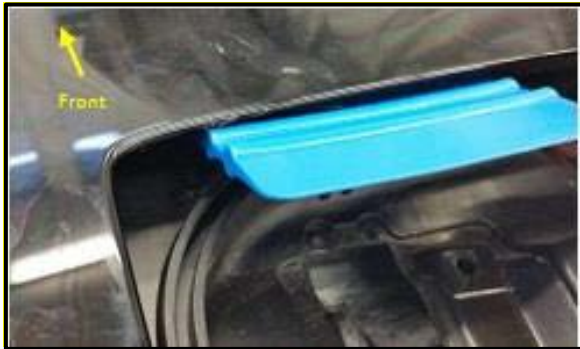
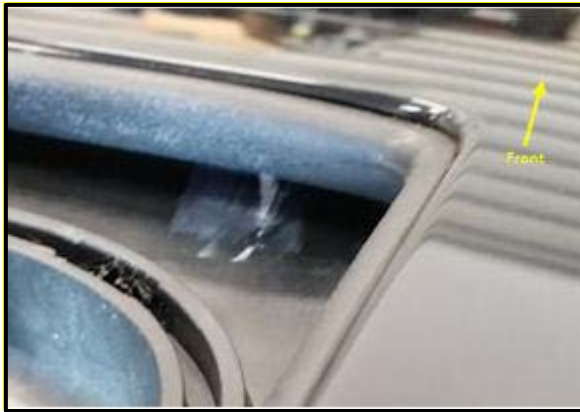
- For all cracks, put a 1 mm bead of sealant (Teroson MS-930, part number D 172090A2) over any existing cracks, 1 at a time. Start the sealant bead as far under the sunroof trim as possible and pull the bead to the end of the crack.

- Using the squeegee supplied with the repair kit, spread the sealant pushing it underneath the trim panel from the inside edge of the roof opening to completely cover the crack.
- Remove all excess sealant from the water channel. There must not be any excess sealant that may prevent the foils from being applied completely flat to the water channel. The crack should be filled with sealant with no excess sealant around the crack.

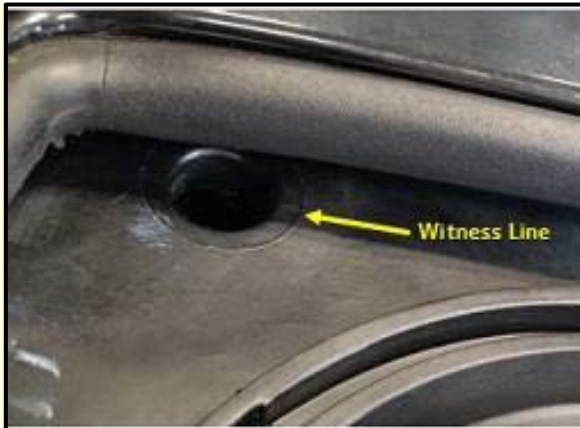
- For foil positions 4 and 6, it is more important to apply the foil as far underneath the trim panel as possible then attempting to align the foil with the seal channel.
- Foil positions 4 and 5 should not overlap each other.

- DO NOT cover the water drain hole or the witness line around the water drain with the foil in positions 4 or 5.

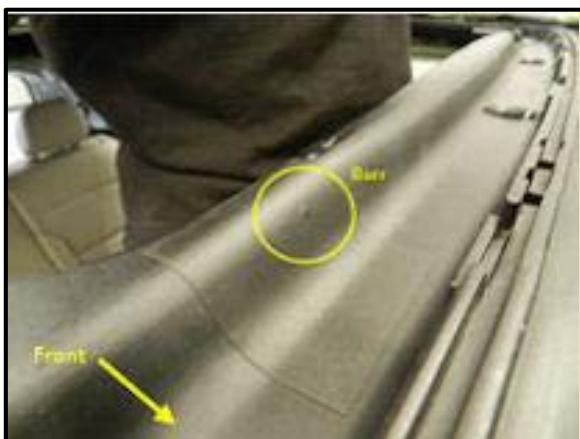
- Peel half of the backing tape off the foil and fold it over to use to hold the foil during application.
- Align the foil with the edge of the water channel and apply the foil, working it forward using the included squeegee to ensure there are no air bubbles, wrinkles and that there are no gaps under the foil.
- Peel backing tape off as you work forward.
- Use the squeegee to work the tape down as smooth as possible.

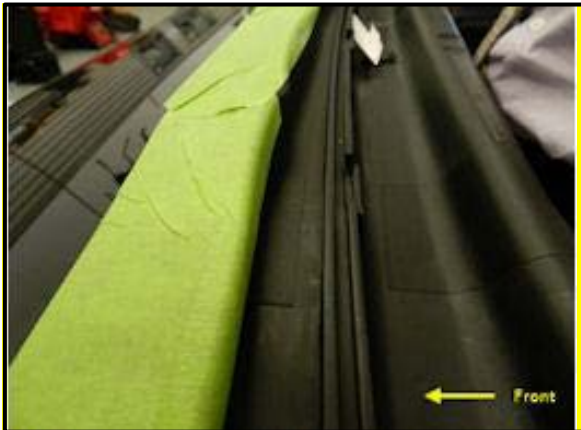
- In position 6, peel half of the backing tape off the section of foil to be placed underneath the trim panel and fold it over to use to hold the foil during application. Ensure the tape is as far underneath the trim panel as possible before beginning to adhere it to the water channel. Apply the foil working it toward the rear using the included squeegee to ensure there are no air bubbles or wrinkles and that there are no gaps under the foil. Peel backing tape off as you work. Use the squeegee to work the tape down smooth and as far underneath the trim panel as possible

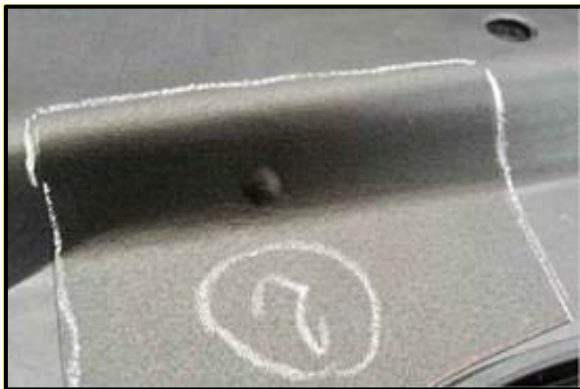
- Foil position 4 fully applied.

It is more important that the foil in position 4 be applied as far underneath the trim panel as possible versus attempting to align it to the edge of the seal channel.

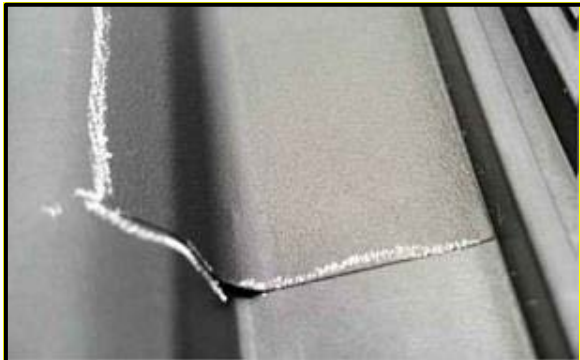
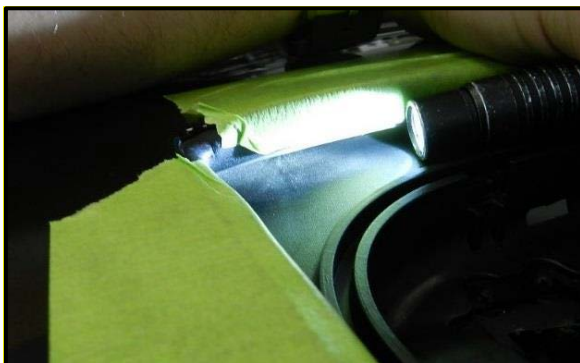
- After all six foils have been applied to one side of the water channel, repeat steps on the opposite corner of the water channel.
- Once all 12 foils have been applied to the water channel, inspect the foils to ensure they are completely flat to the water channel and that there are no air bubbles or gaps underneath the foil. Use the squeegee to help push out any defects

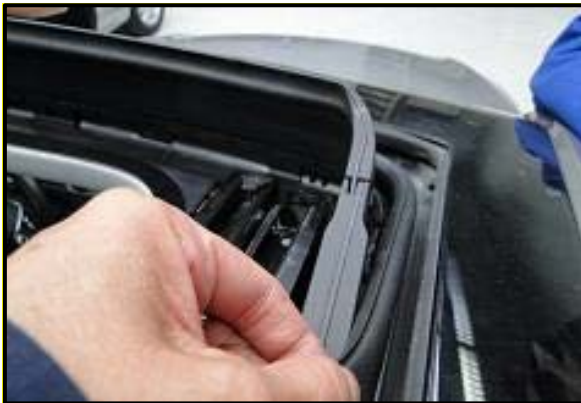
- The foil must be fully applied underneath the trim panel. If the foil is folded over, it should be removed and a new piece applied. Use the squeegee to work the foil down on to the water channel as far underneath the trim panel as possible.

Photo shows foil folded and not adhered underneath trim panel.
