# Service Bulletin

Bulletin No.: 17-NA-220

**Subject:** Accessory Cargo Net T Bolts Loose

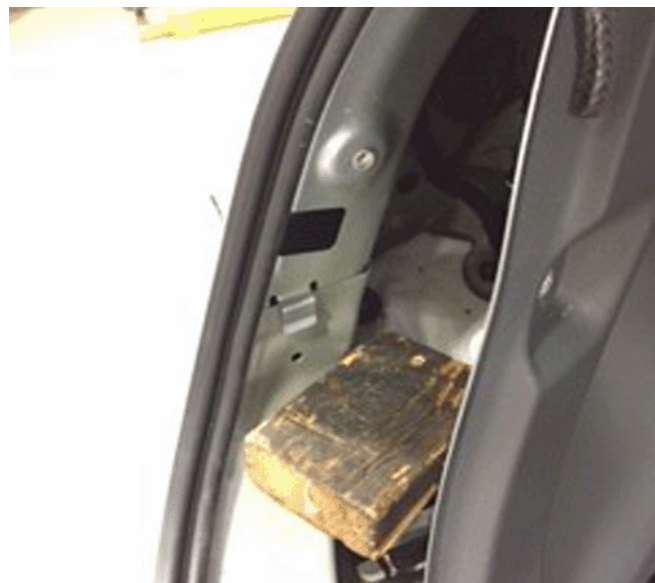
4828889

1. Unclip the rear of the quarter lower rear trim panel to gain access to the T bolt hole.

**Note:** Use a standard 2 x 4 block as a wedge support as illustrated above.

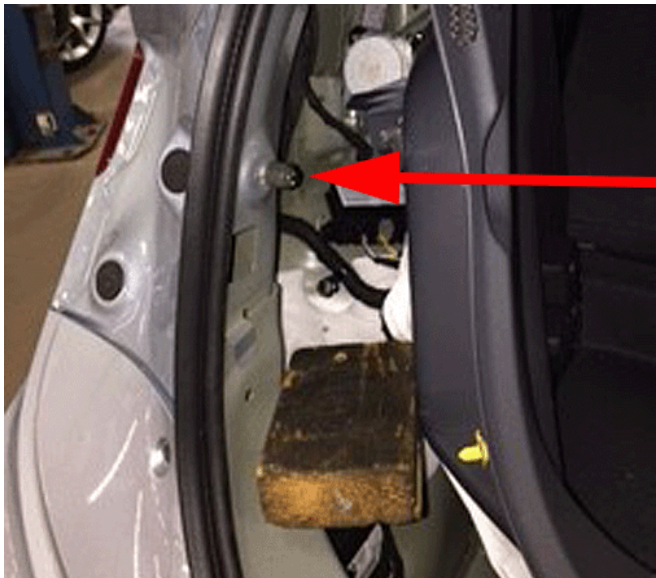
4828891

2. Using a 23/64 drill bit, drill out existing hole for the installation of Riv-Nut.

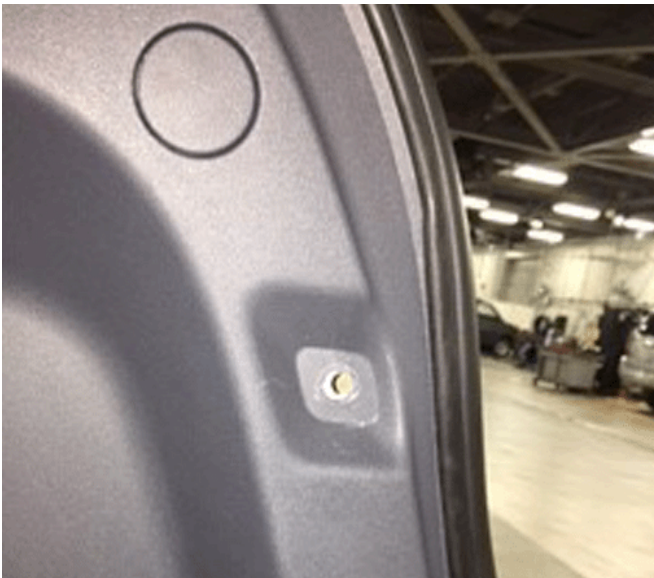
4828897

3. Using the Kent Moore Riv-Nut installer (B0-42151-8MM-KIT) or equivalent, insert and expand the Riv-Nut into the newly drilled hole.

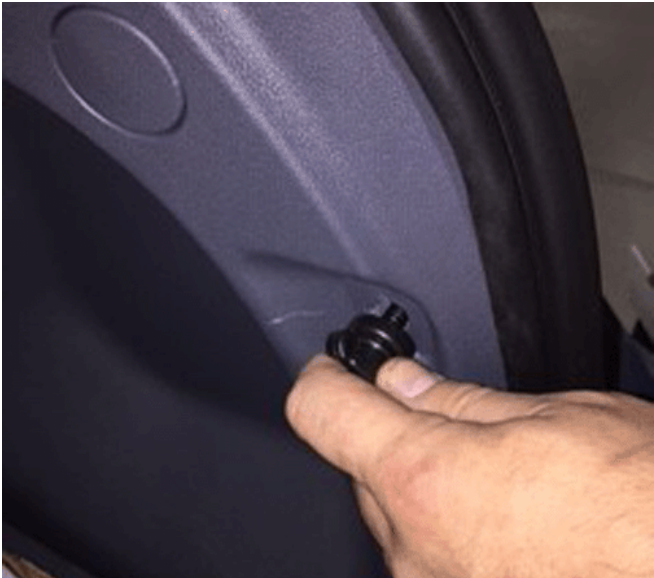
4828899

5. Install fine threaded T bolt into new Riv-Nut and tighten.
