SERVICE BULLETIN

Classification: BT16-021a	Reference: NTB16-103a	Date: November 17, 2017
------------------------------	--------------------------	----------------------------

2014 – 2018 FRONTIER; MANUAL SEAT TRACK ADJUSTMENT DOES NOT LOCK INTO POSITION

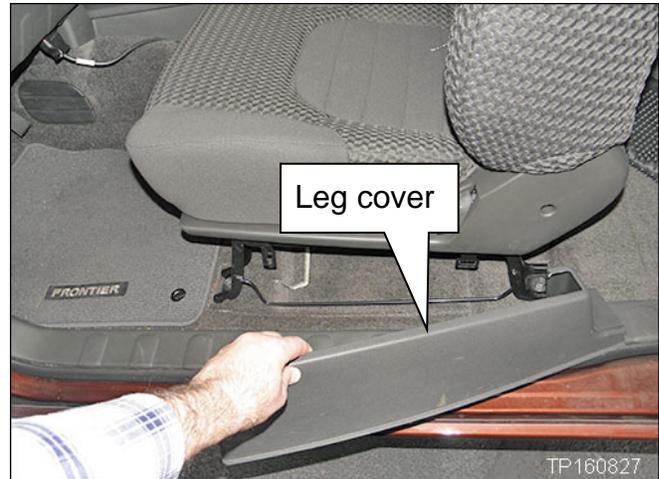
Figure 1

1. Remove the leg cover from the outboard seat track.

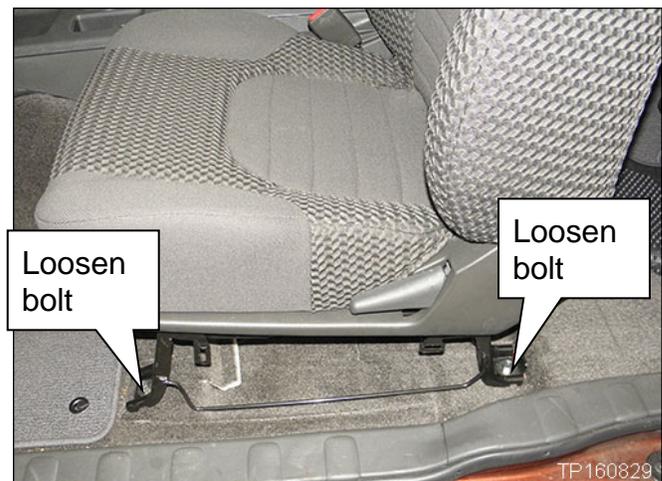
Figure 2

2. Loosen, don't remove, the outboard seat track mounting bolts.

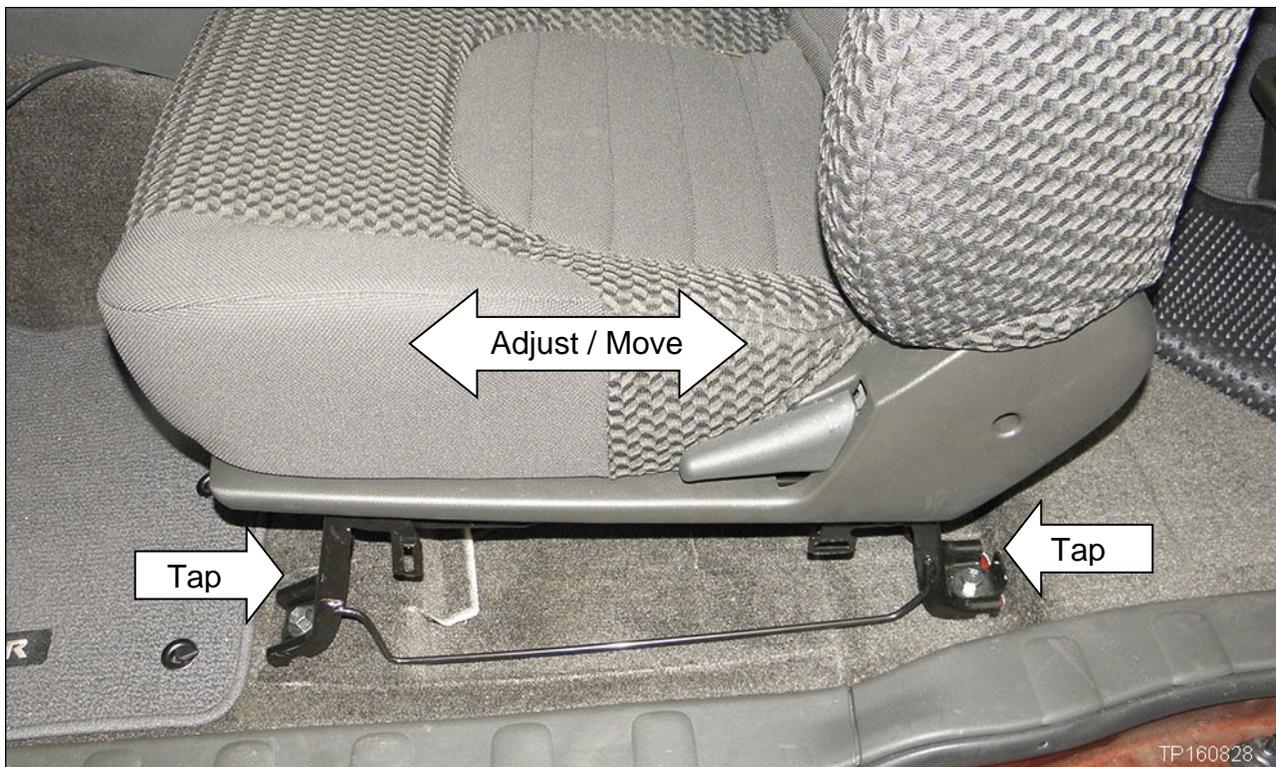
Figure 3

3. Adjust the seat and outboard track as needed to ensure track adjustment pawls are synchronized (they lock at the same time on both sides):
 - Tap the outboard seat track forward or backward as needed.
 - By hand, move the seat cushion as needed.

4. Once the seat tracks are synchronized, tighten the seat track mounting bolts.
 - Torque bolts to: 45 N•m (4.6 kg-m, **33 ft-lb**)
5. Re-install the leg cover.
