MODEL: Karma Revero**DATE:** November 2017**TITLE:** Catalytic Converter and Center Muffler Joint Inspection**First Release****PRIORITY:** On Complaint**APPLICABILITY:** MY17 and MY18 Revero**MARKET REGION:** North America**PURPOSE:** Correction for MIL on condition P1200

Technical Service Bulletin

TB-17-12-37

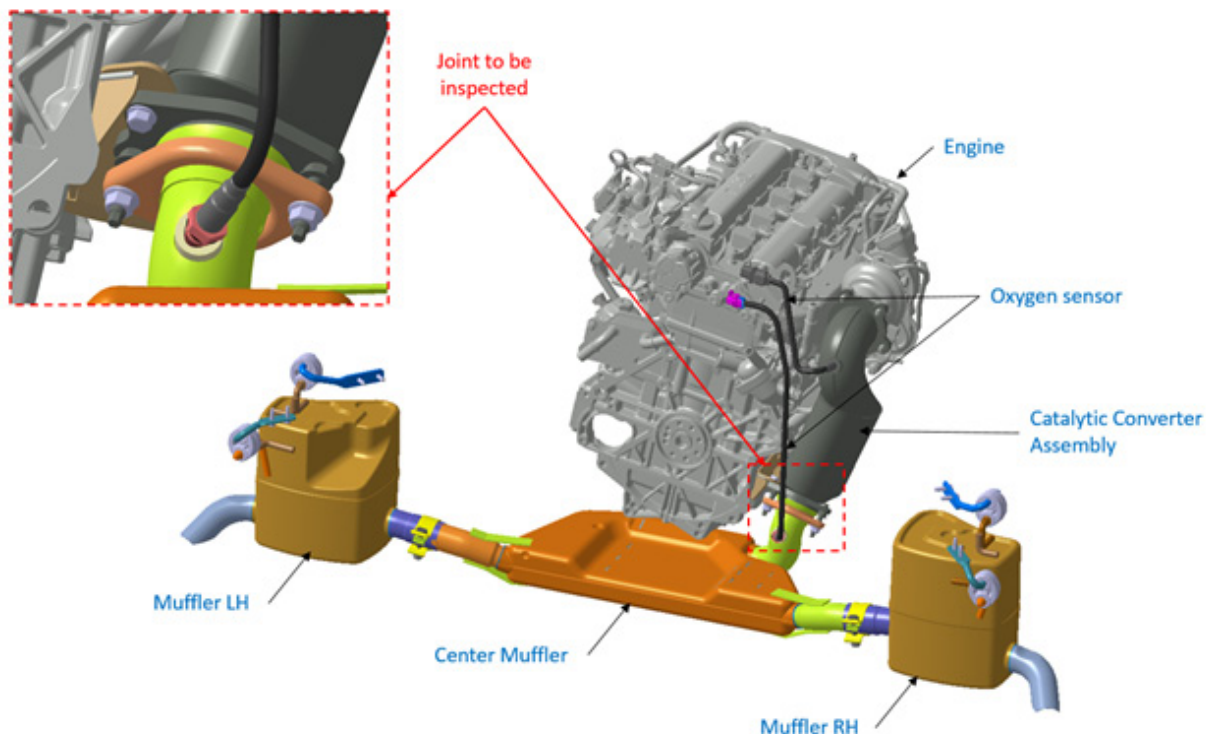
fig 1
System Overview

Inspect the joint between catalytic converter and center muffler to ensure catalytic converter studs and center muffler flange are not bent (fig 1).

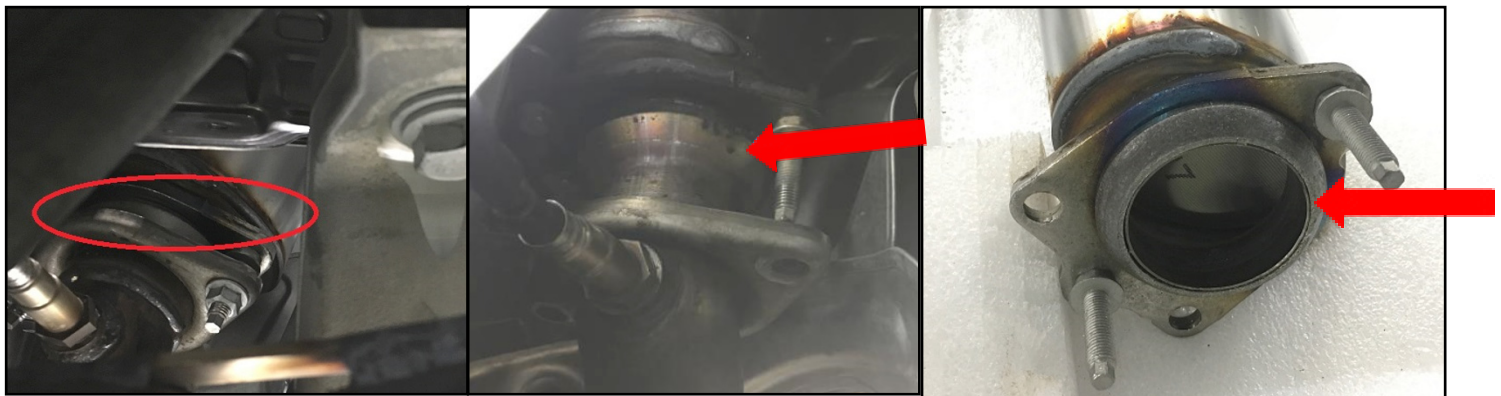
fig 2a

1. Catalytic Converter Gasket is in place
2. Studs are straight (fig 2b)
3. Flange is not bent (fig 2c)

Missing gasket

Gasket in Place

If the studs are bent replace the following:

- Studs
- Catalytic converter Gasket
- Nuts

If the flange on the center muffler is bent:

- Studs
- Catalytic converter Gasket
- Center Muffler
- Nuts

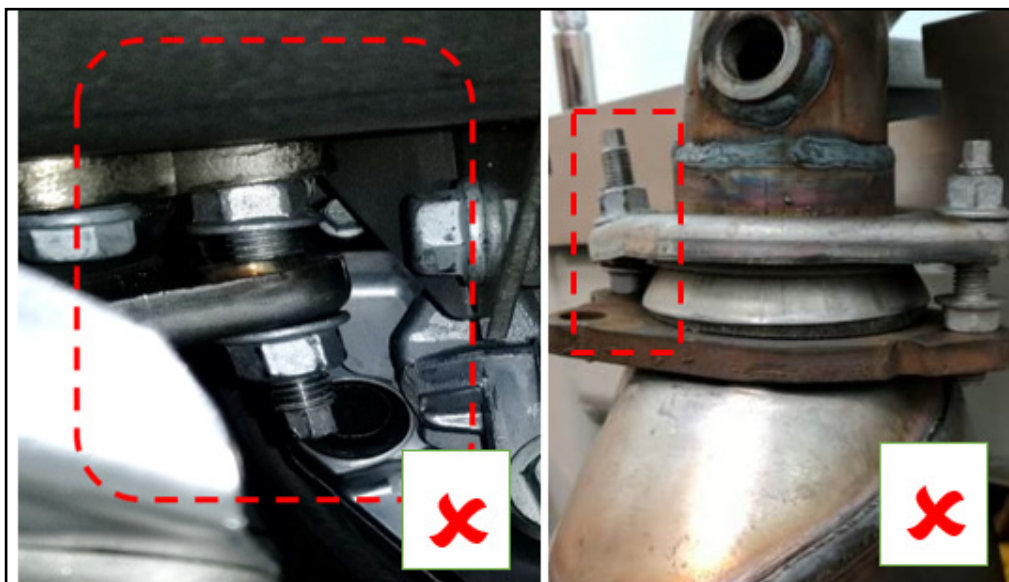
fig 2b

Bent exhaust studs

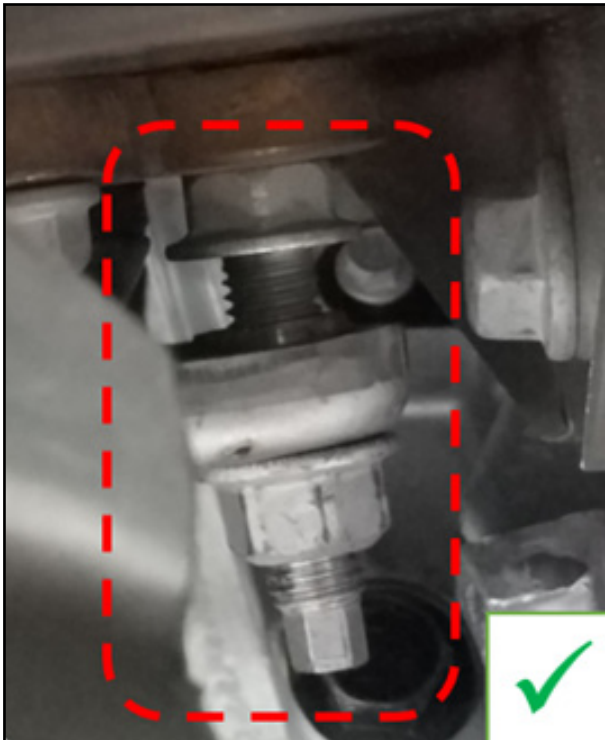
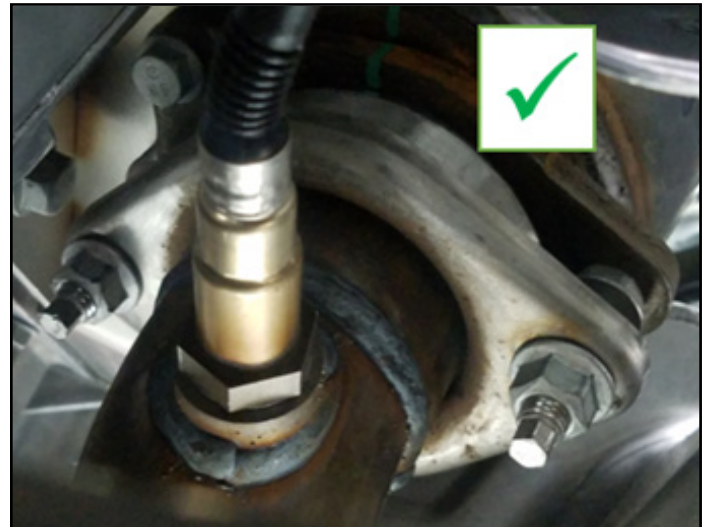
The exhaust stud and flange show below (fig 3a,3b) are correct.

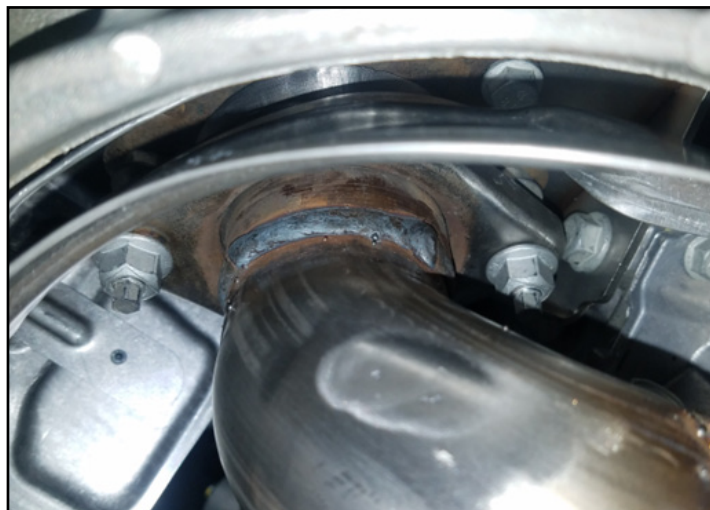
fig 3a

Install Nuts right before the thread starts are visible. (fig 3a)

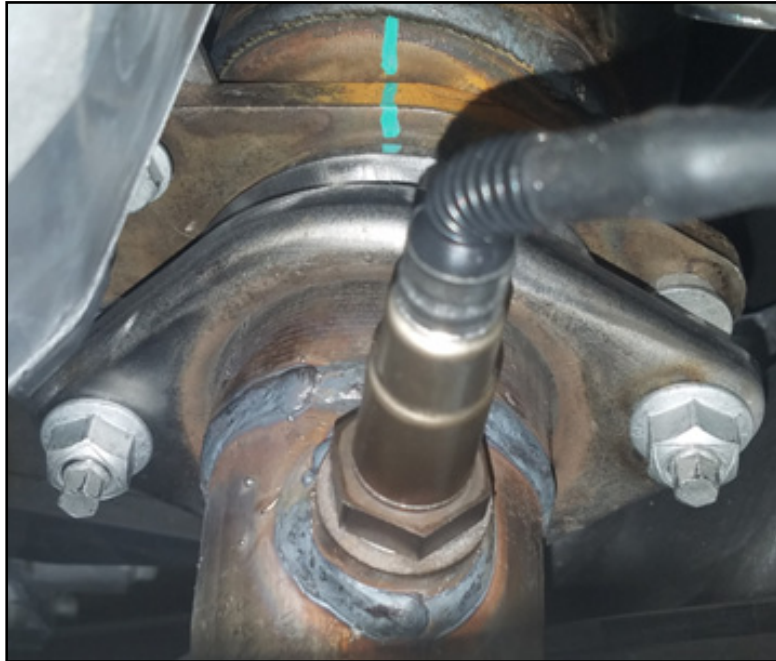
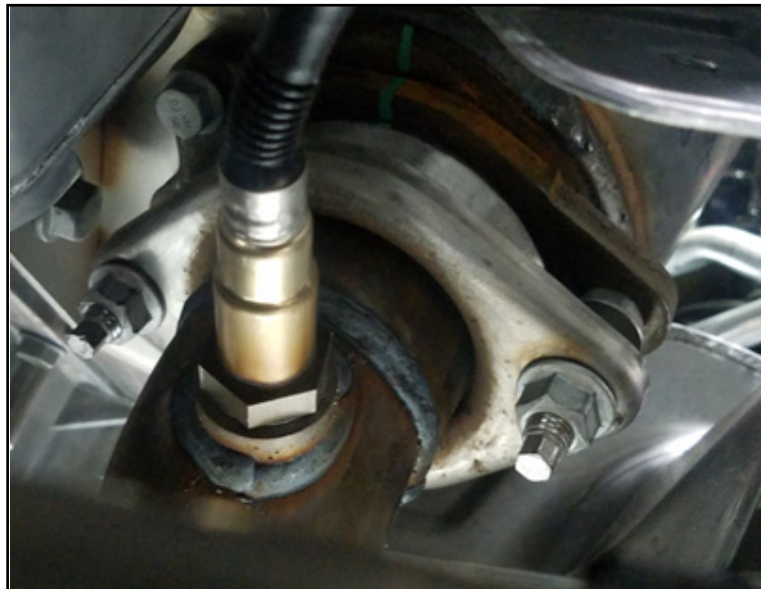
From this position “walk” the parts together. (fig 3b, 3c)

Alternate sides increasing torque 1Nm by side until specified torque is reached, target is 17 Nm \pm 2 Nm.

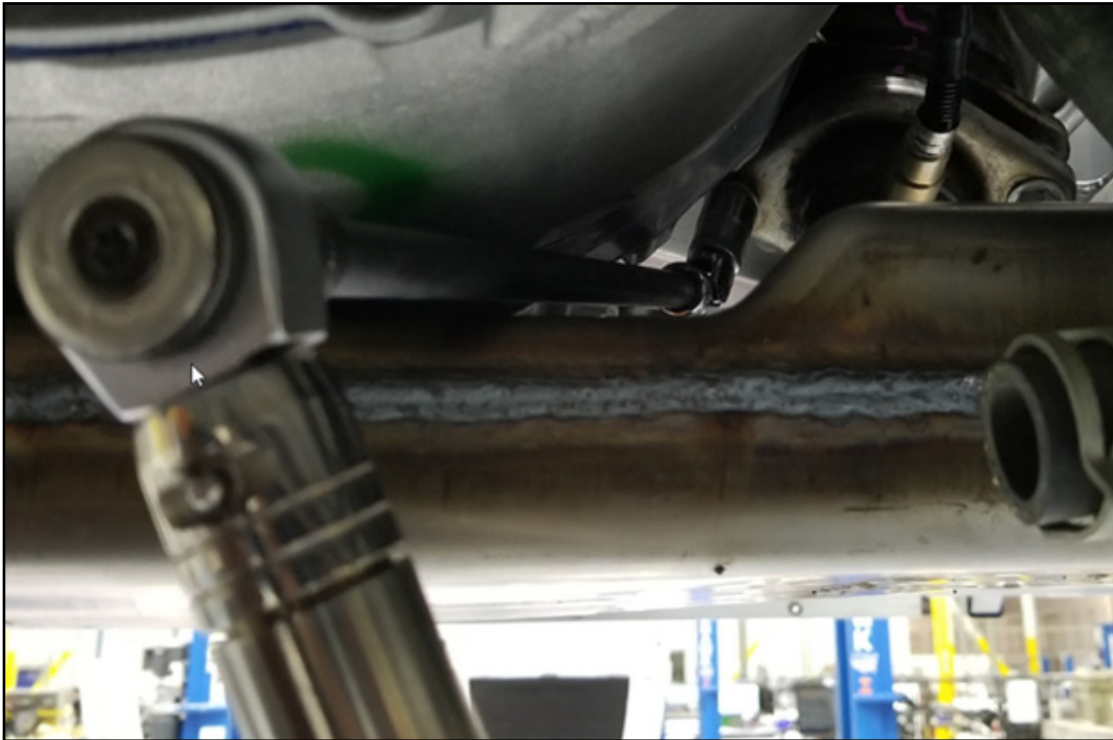
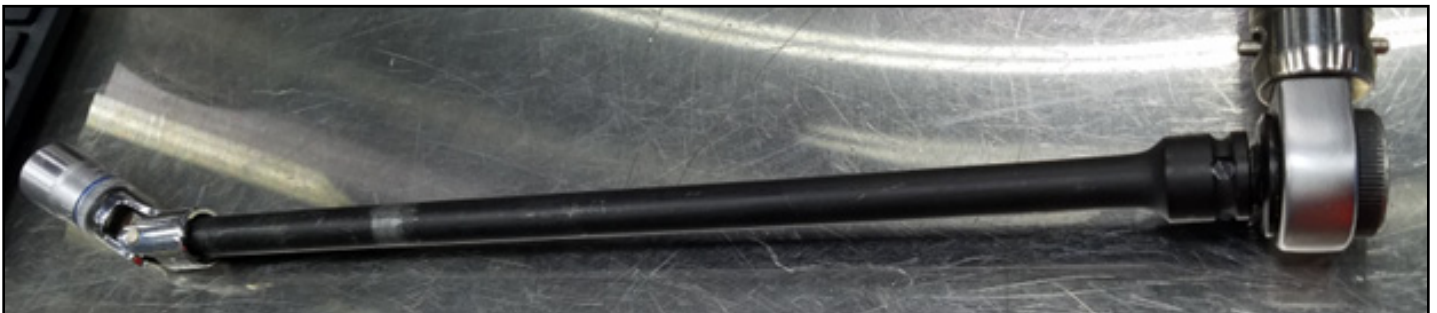
Assembly completed, passenger side nut torque is 17 Nm.

Driver side nut torque is 19 Nm (upper limit) to compensate potential loss in torque because of extension use. (fig 4a, 4b)
