# HYUNDAI

## Technical Service Bulletin

GROUP <b>BODY ELECTRICAL</b>	NUMBER <b>17-BE-019</b>
DATE <b>DECEMBER, 2017</b>	MODEL(S) <b>MULTIPLE MODELS</b>

**SUBJECT:** UNABLE TO SET OR VIEW NAVIGATION CLOCK

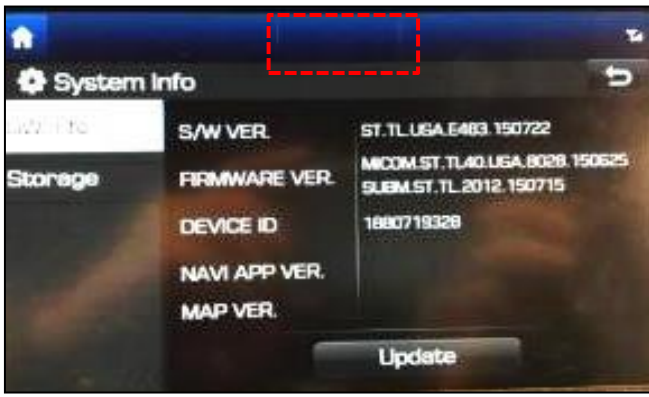
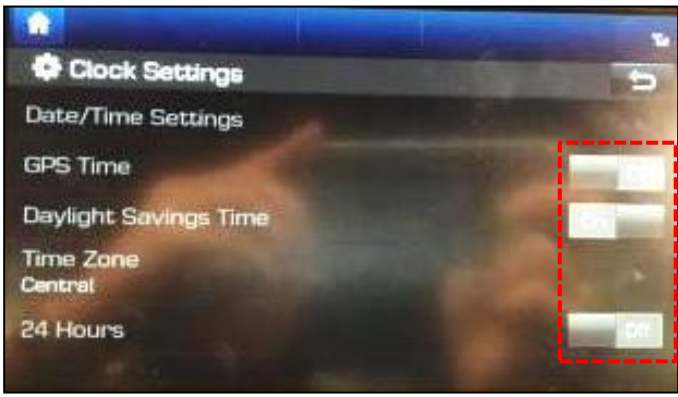
<b>No Clock Displayed at Top Center of Screen</b>	<b>Date/Time Settings Grayed out</b>

Replace navigation assembly

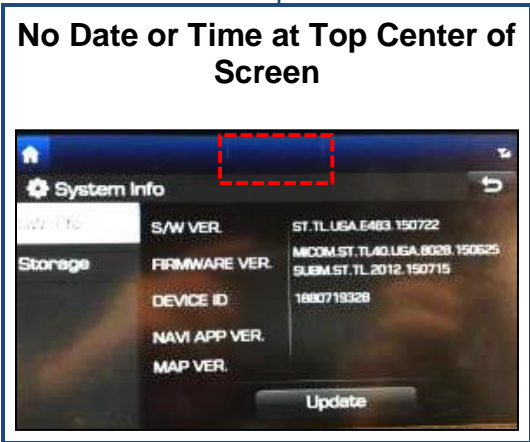
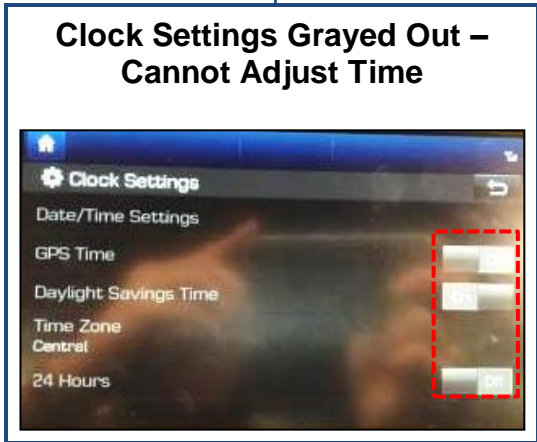
Confirm symptom(s)

Replace navigation assembly
