MODEL
2016MY
Optima (JFa)

NUMBER
164 (Rev 1, 12/11/2017)

TECHNICAL SERVICE BULLETIN

SUBJECT: SERVICE ACTION: PANORAMIC SUNROOF
INSPECTION AND REPAIR (SA270)

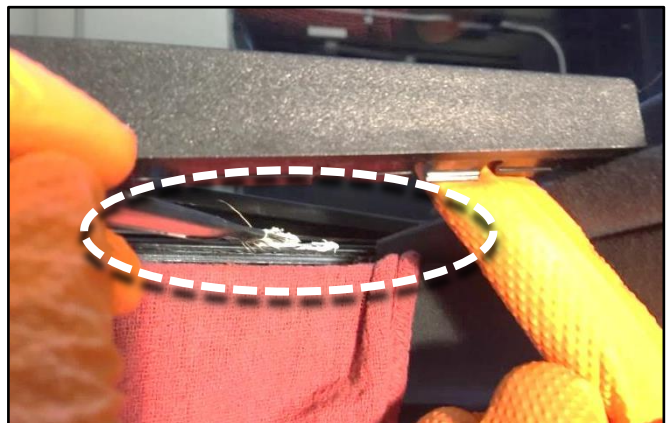
3. While holding the decorative cover, use an acid brush and apply a sufficient amount of lubricant on the top of the sunshade guide rail.

Protect the headliner as necessary to avoid lubricant contamination.

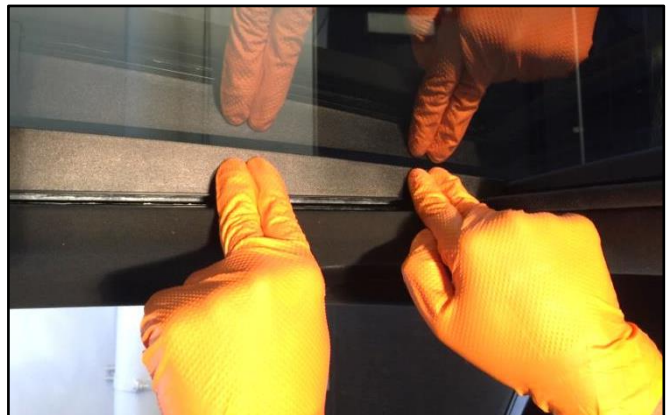
5. Carefully reattach the decorative cover by pushing the cover in until it snaps into place.

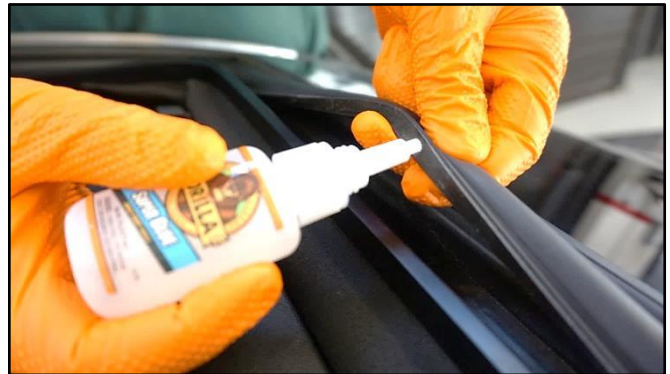
3. Apply a thin bead of adhesive to the weather strip.

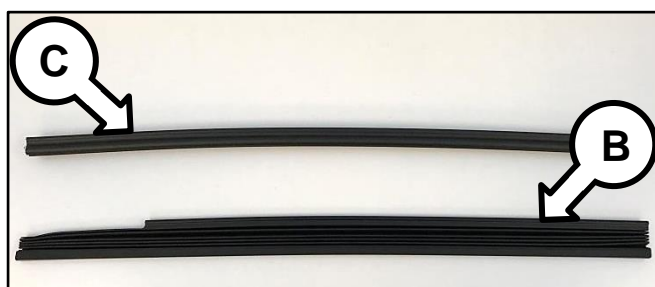
2. Completely remove the folding cover (B) and separate it the sliding bracket (C).

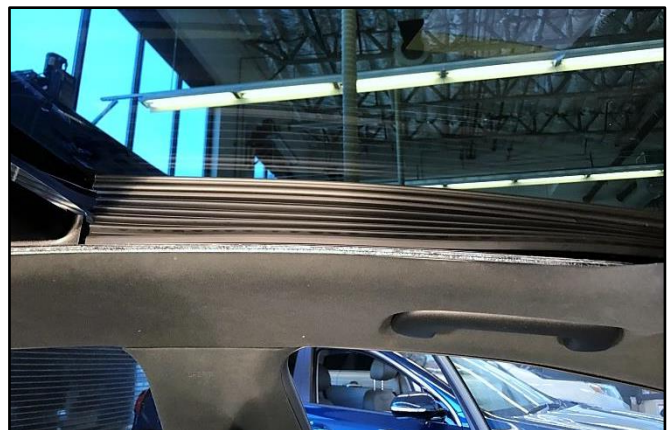
8. Verify proper operation of the sunroof and ensure there is no damage to the folding cover.

7. Repeat steps 1 through 7 of this procedure for the other side's folding cover.

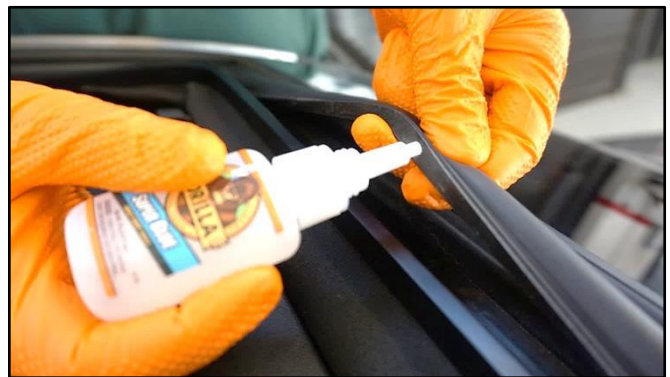
3. Apply a thin bead of adhesive to the weather strip.

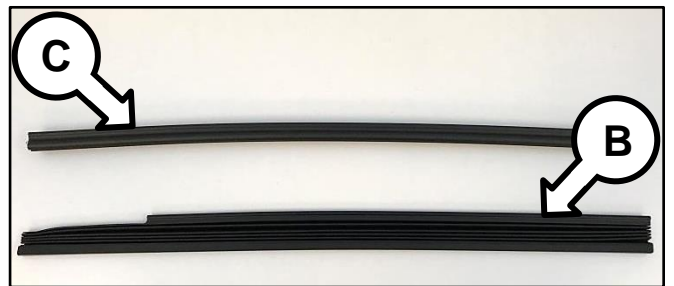
2. Completely remove the folding cover (B) and separate it from the sliding bracket (C).

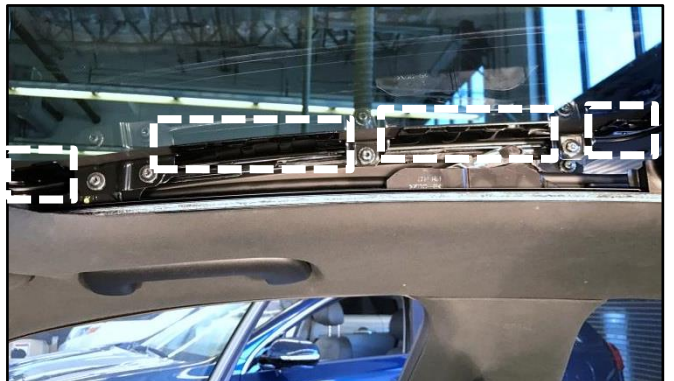
3. Reinstall the sliding bracket to the upper sliding rail (C) without the folding cover (B) attached. Ensure the sliding bracket is completely secured at all four (4) locations shown.

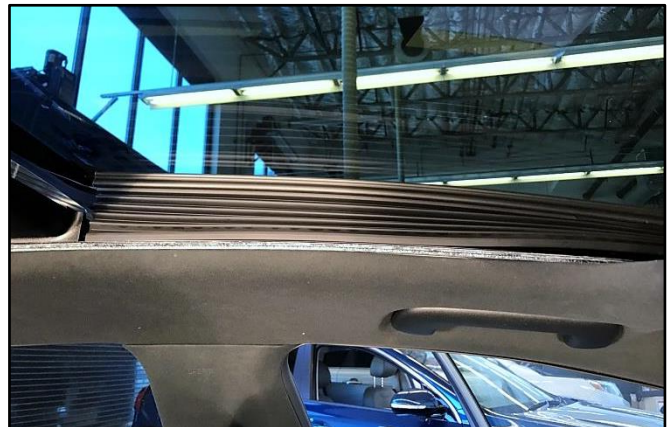
8. Verify proper operation of the sunroof and ensure there is no damage to the folding cover.

7. Repeat steps 1 through 7 of this procedure for the other side's folding cover.
