**MODEL:** Karma Revero

**TITLE:** Front Dome Light Replacement

# Technical Service Bulletin

**TB-17-82-17**

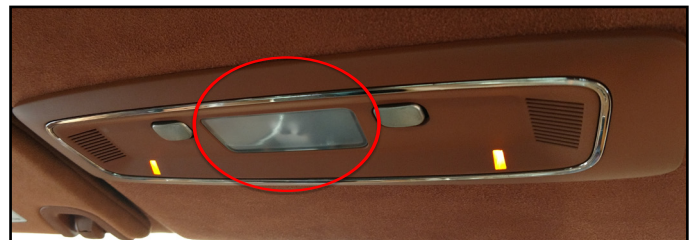
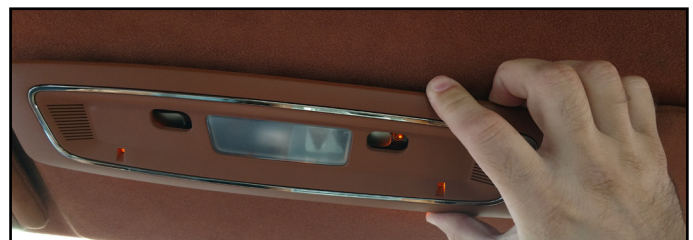
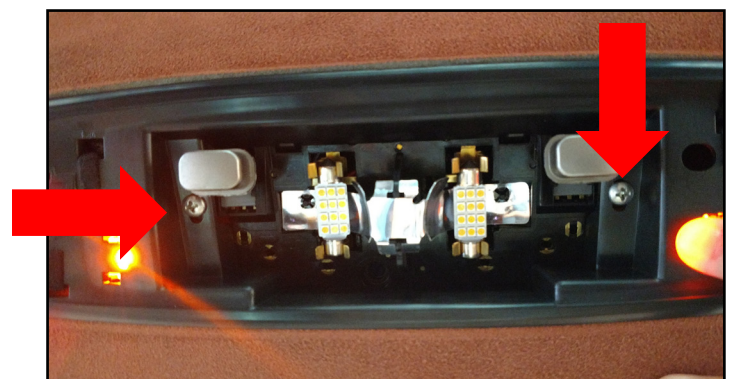
Remove the bezel, by gently pulling off by hand. install is the reverse by placing it and pushing firmly up to engage and fasten.

Remove the now exposed Phillips head screws. Install torque is 2.0 +/- 0.5 Nm

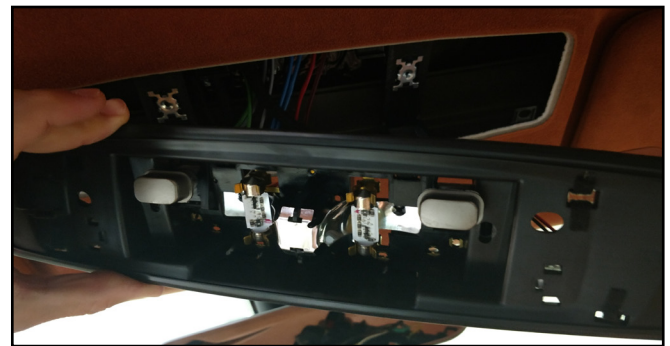
Lower the dome lamp.  
disconnect the connector in the  
headliner, and replace with the new unit.

Disconnect the dome lamp connector from the  
headliner harness.

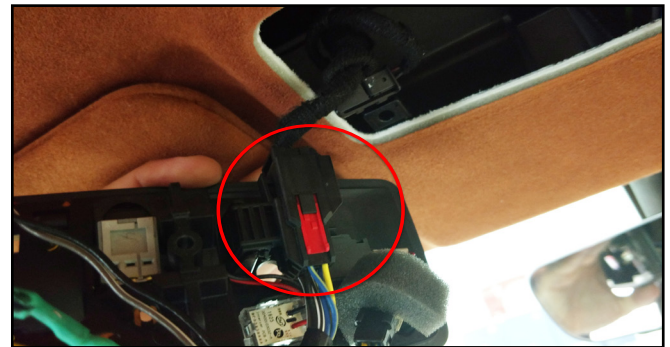
Replace with the new dome light assembly as  
indicated. Install is the reverse of removal.

Reconnect the 12V system and verify operation of  
the installed light assembly.
