Front seat backrest, too much play

REF NO:	ISSUING DEPARTMENT:	CAR MARKET:		
TJ 32508.2.1	Technical Service	United States and Canada		
	PARTNER:	ISSUE DATE:	STATUS DATE:	
3 US 7	7510 Volvo Car USA	2017-06-13	2017-06-14	
FUNC GROUP:	FUNC DESC:			
8522	Front seat excl. upholstery	Page ⁻	1 of 14

TJ 32508

Title	Front seat	Page	1 (12)
Action	Product fix	Operation number:	98674-2

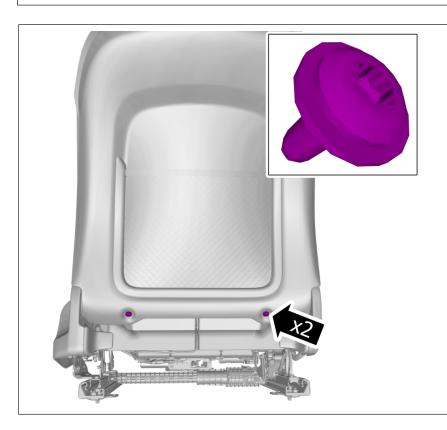
Remove the screws.
