Technical Service Bulletin

01 MIL on (DTC P030000, P154500, P155800 or P3033100) intake air hose leaking

01 17 20 2029233/4 June 9, 2017. Supersedes Technical Service Bulletin Group 01 number 16-67 dated July 13, 2016 for reasons listed below.

Model(s)	Year	VIN Range	Vehicle-Specific Equipment
R8	2008 - 2014	All	4.2L and 5.2L engines

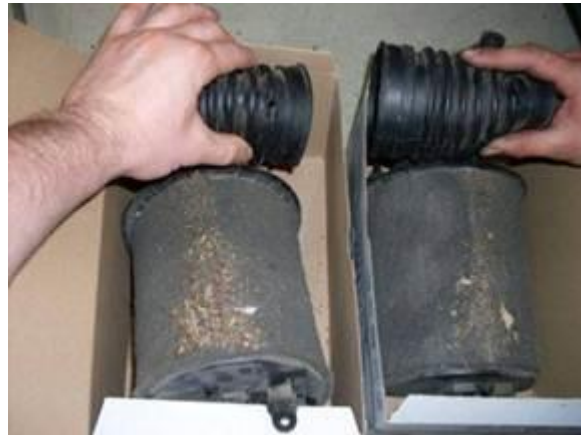
Because the air intake is close to the ground (behind the front wheel), excessive dirt can get into the intake air when the vehicle is driven in unusual conditions. Excessive dirt (Figure 1) can clog the air filter, which may cause illumination of the MIL, misfiring, throttle valve drive/control and fuel trim-related DTCs because:

Figure 1. Example of excessive dirt on air filters.

1. Check for cracks or damage on both of the intake air hoses.
2. If either hose is damaged, replace both hoses and both air cleaner elements.

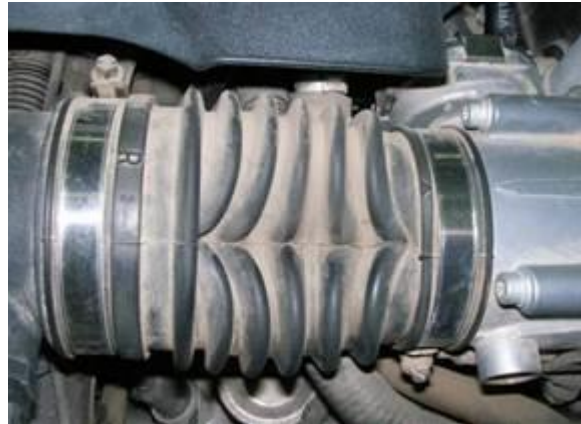
- When the air filter is clogged, not enough intake air is available to the engine, resulting in excessive vacuum in the air duct hose between air filter and throttle valve (Figure 2). The excessive vacuum can damage the air duct hose and cause it to collapse and become deformed. Repeated deformation of the hose causes it to crack.

Figure 2. Vacuum in the air duct hose between air filter and throttle valve.

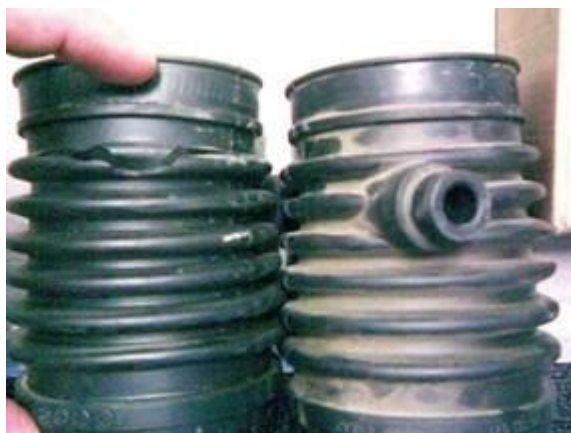
- Bypass air gets in through the crack in the intake hose (Figure 3) which can cause the MIL to become illuminated and can cause fuel trim-related DTCs to be set.

Figure 3. Crack in the intake hose.
