# Emissions Recall

## Code: 23T4

| <b>Subject</b> | <b>2.0L TDI Engine (GEN 3) Emissions Control Software – <u>USA ONLY</u></b> |
| <b>Revision Summary</b> | <b>Updated work instructions.</b> |

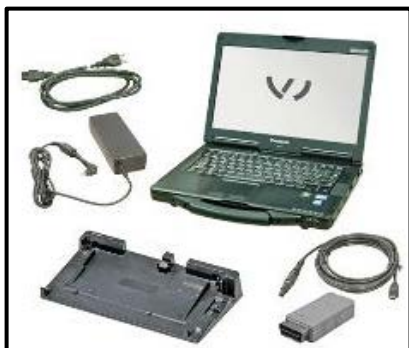
- VAS6150X – Diagnostic Tester (or equivalent)
- VAS5054X – Remote Diagnosis Head (or equivalent)

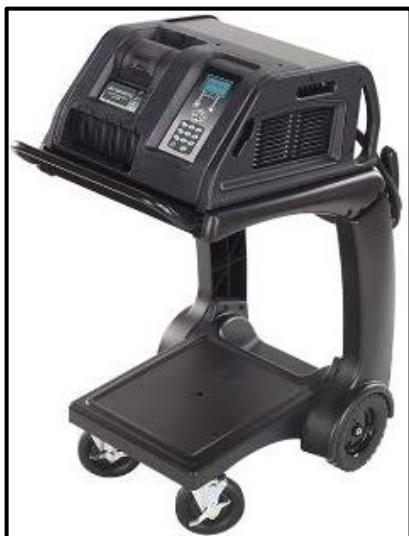
- GRX3000VAS – Battery Tester/Charger

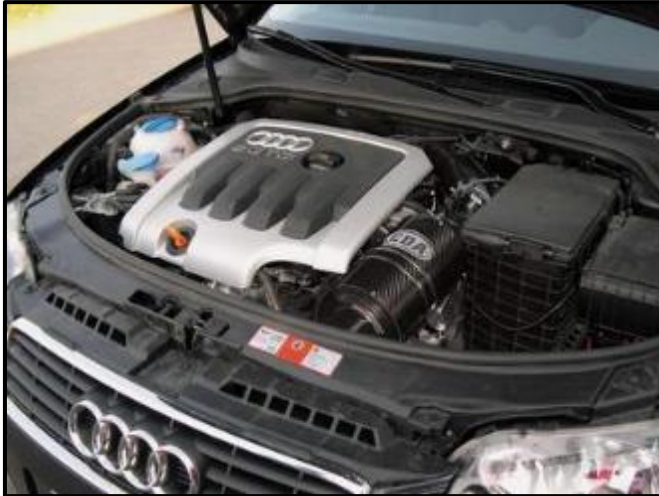
- Perform a visual inspection of the intake, exhaust, and emissions systems.
  - o If the visual inspection of the intake, exhaust, or emissions equipment reveals damage or concerns, **STOP**, create an ATA ticket and contact the Audi Technicians Helpline.
  - o If the visual inspection of the intake, exhaust, or emissions equipment reveals no damage or concerns, continue the work procedure.

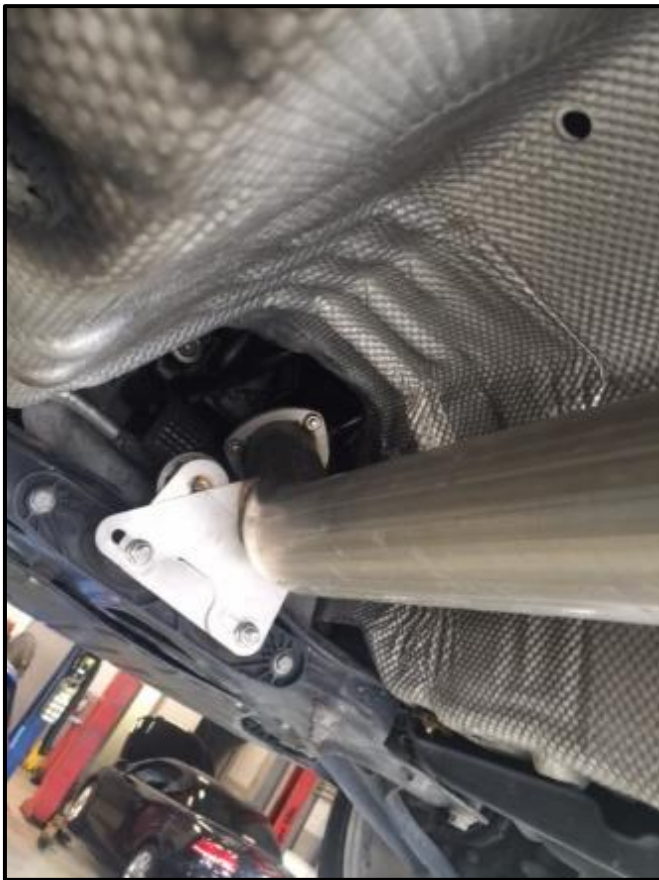
- Check for vehicle modifications from original equipment.
  - o If vehicle modifications from original equipment related to emissions components are found, **STOP**, create an ATA ticket and contact the Audi Technicians Helpline.
  - o If vehicle modifications from original equipment related to emissions components are not found, continue the work procedure.

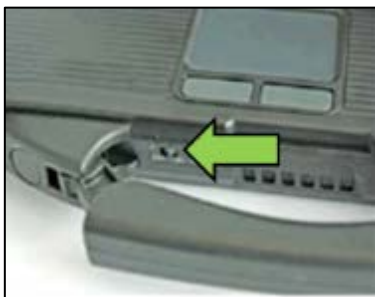
**VAS 6150 & VAS 6150A**  
(Front panel behind handle)

- Performing a software update using a Bluetooth connection increases the risk of losing connection during the update, which could result in damage to the control module. It also greatly increases the time required to perform the update. Requests for additional time or parts will be denied if the GFF log shows the update was performed using Bluetooth.
- ✓ **The Bluetooth function of the scan tool is physically switched off <see pictures below>.**

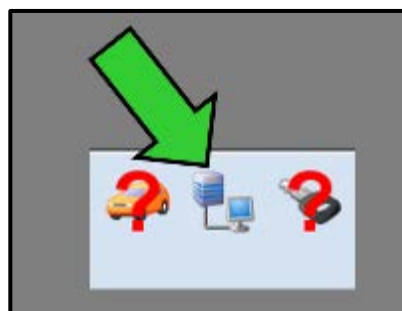
- ✓ Check the icon <arrow> within the ODIS software that you have a connection.

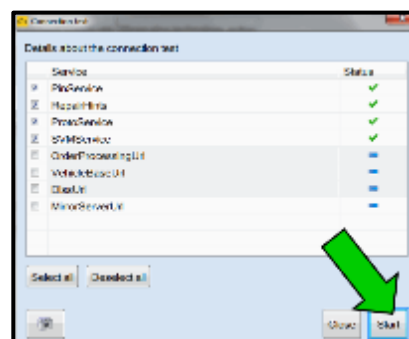
- ✓ Start a connections test <arrow> and verify that all connections pass.

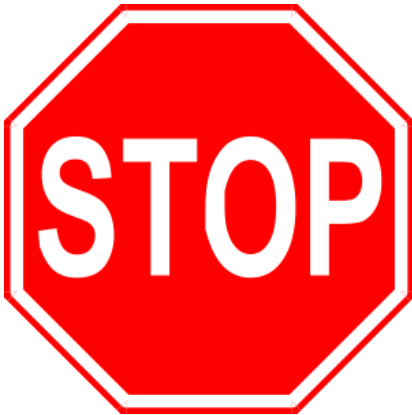
- Open the hood.
- Open the battery cover.
- Attach the GRX3000VAS Tester/Charger to the vehicle battery.
- Switch the ignition on.
- Apply the parking brake.
- Switch the headlights off.
- Connect the VAS6150X Diagnostic Tester (or equivalent) to the vehicle.
- Start the ODIS program.

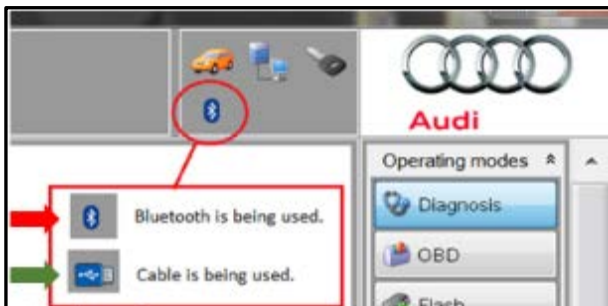
- Confirm that scan tool is communicating with the diagnostic head by USB <Green Arrow>.
  - o If the Bluetooth symbol is shown <Red Arrow> then disconnect the diagnostic head from the vehicle and reconnect the USB cable to the diagnostic head and then reattach to the vehicle.

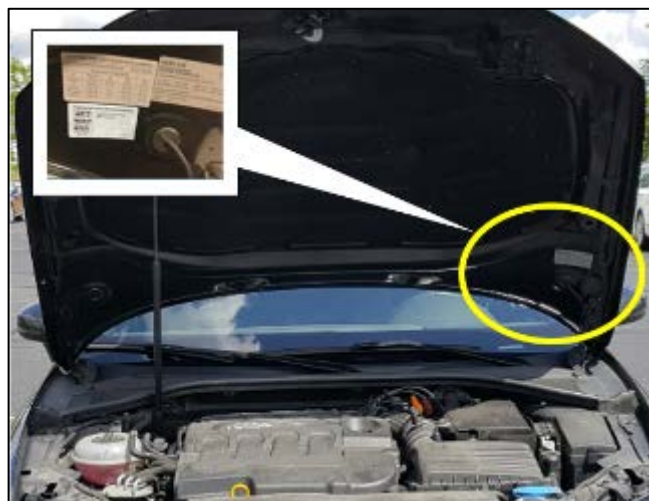
- Open the hood.
- Clean the surface where the label is to be installed <circle>.
- Install the Supplemental Vehicle Emissions Control Information Label, **03L 010 005 J**, in the location shown.

New Vehicle Emissions Control Information (VECI) label MUST NOT be placed over original VECI label.

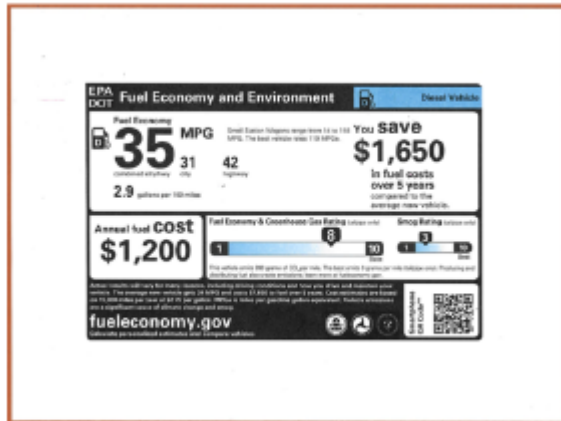
- Install new Fuel Economy Label <example pictured left> to the right of the new Monroney Label. If necessary, use the passenger front window <example pictured below>.

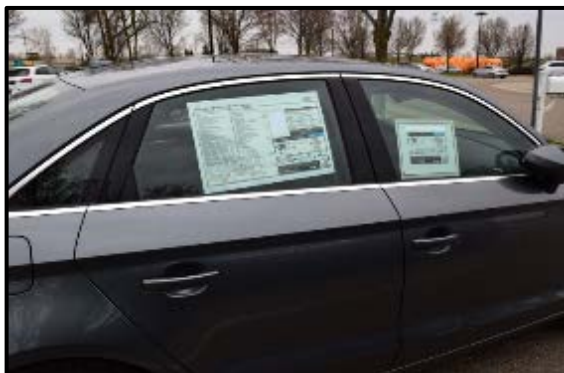
- Example of properly Installed Monroney and Fuel Economy Labels <pictured left>.
