Technical Service Bulletin

91 SOS Warning Displayed On Instrument Cluster (DTC B105313)

97 17 57 2048360/1 July 13, 2017.

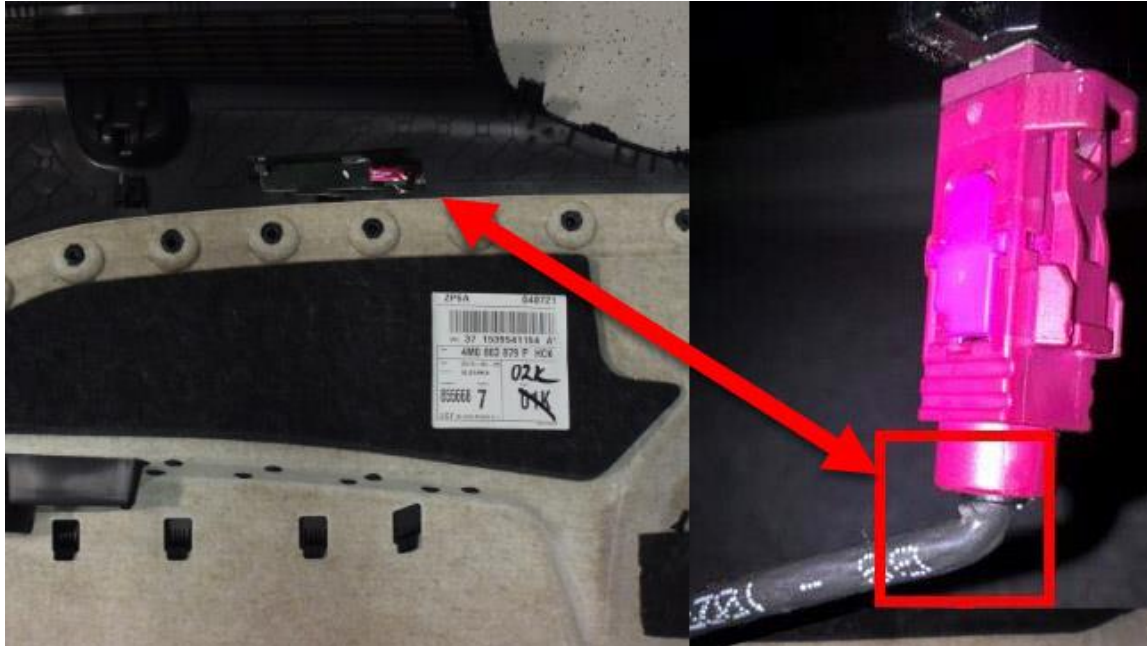
Figure 2. Coaxial wire kinked at R263 SOS Antenna.

The contact on the wiring of the emergency call aerial may have been damaged in production.

- Perform visual inspection of coaxial wiring, if wiring is under tension or kinked (Figure 2), continue with TSB.

3. Repair existing coaxial harness:

- Unplug the FAKRA connector from the R263 SOS Antenna.
- Remove 200mm (7 ¾ inches) of coax wire from the existing harness. Measure from the front of the FAKRA connector (Figure 3).
- Using the VAS 6720, install a new female FAKRA Terminal (Figure 4B) onto the vehicle's coaxial harness. Install a new Fakra Housing (Figure 4A) onto the newly installed terminal.

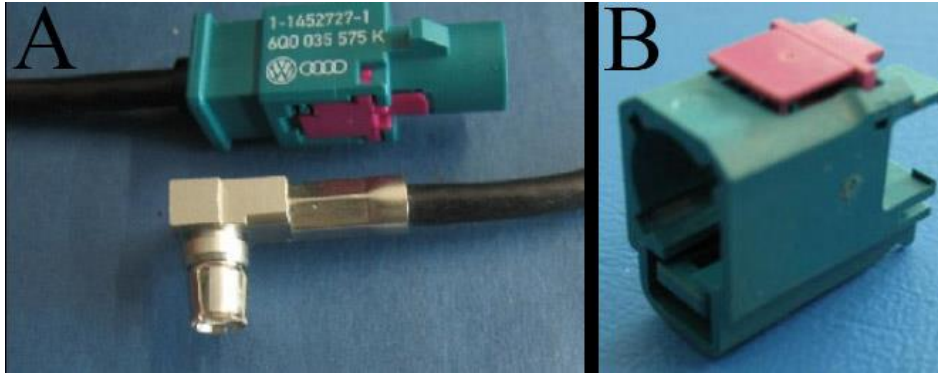
Figure 5. A: Adapter antenna cable 000098691. B: 4E0035674K Connector housing for angled-antenna-bush-plug.

- Install a 90 degree right angle adapter antenna cable (Figure 5) between the newly installed Fakra connector from step 3 and the SOS antenna. To complete the 90 degree right angle adapter cable assembly, you will need to install the connector housing for angled-antenna-bush-plug (5B) onto the adapter antenna cable (5A).
- Re-install all components

Tip: The cable must be free of tension around the area of the connector.
