<b>Topic</b>	64-14-04TT – Front Window Contacts Rear Window Glass, Window Misaligned
<b>Market area</b>	United States 444 Volkswagen of America, Inc. (6444)
<b>Brand</b>	Volkswagen
<b>Date</b>	July 7, 2017

### Front Window Contacts Rear Window Glass, Window Misaligned

Model(s)	Year	Eng. Code	Trans. Code	VIN Range From	VIN Range To
Beetle, Beetle Convertible	2012-2015	All	All	AT_CM600001	AT_FM634051

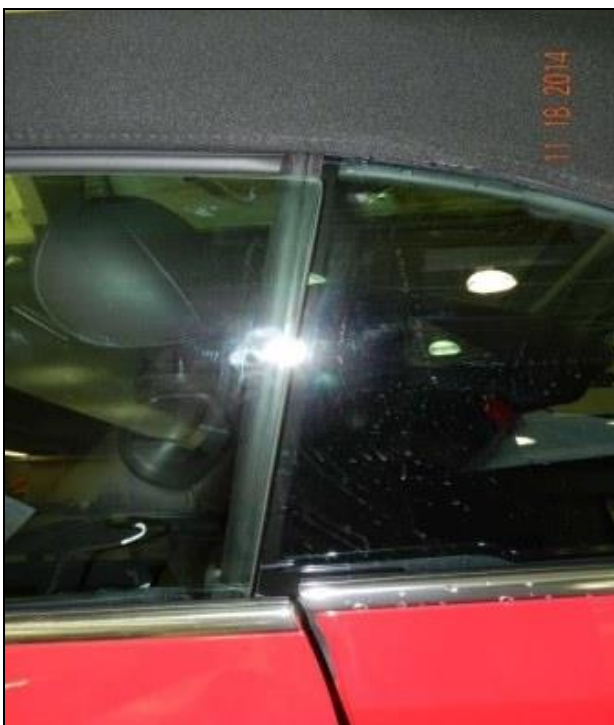
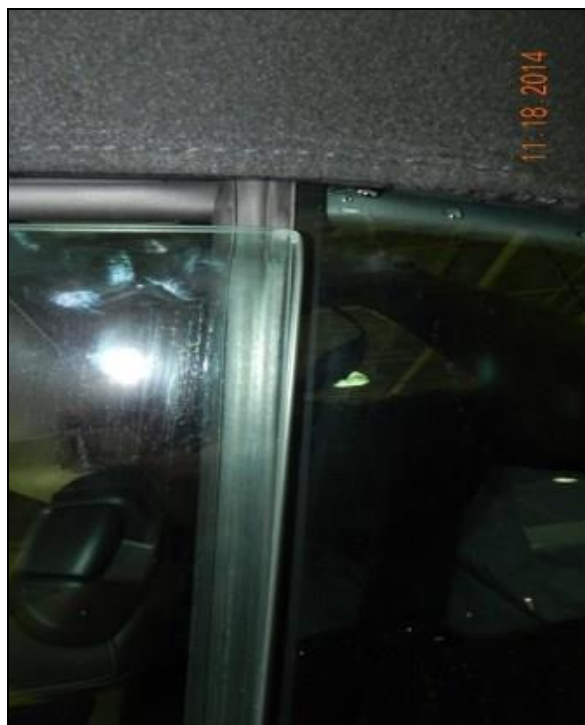
Complaints of the front window glass contacting the rear glass may be caused by the front window glass becoming loose in the regulator clamps. (See Figs. 1 and 2)

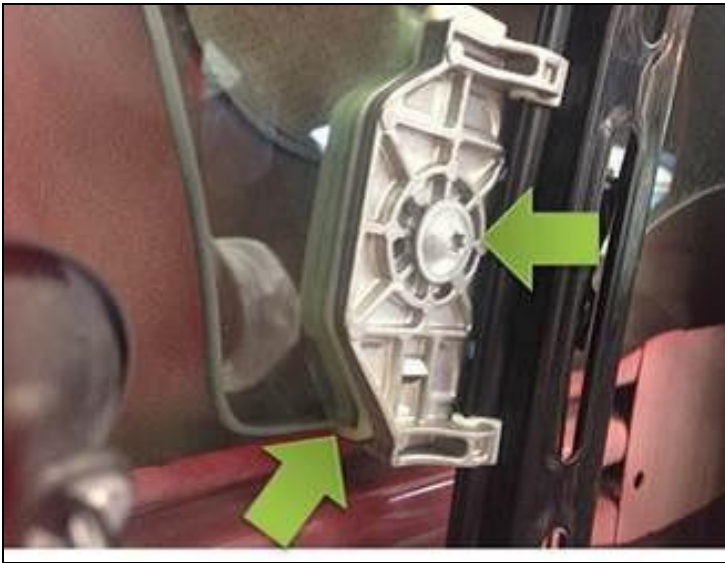
Figure 3

This occurs due to insufficient torque on the fixation bolt for the glass clamp on the regulator elevator. The glass can slip in the clamp and lose its alignment to the rear side window, causing contact between the front door window and the rear window glass. (See Fig. 3)

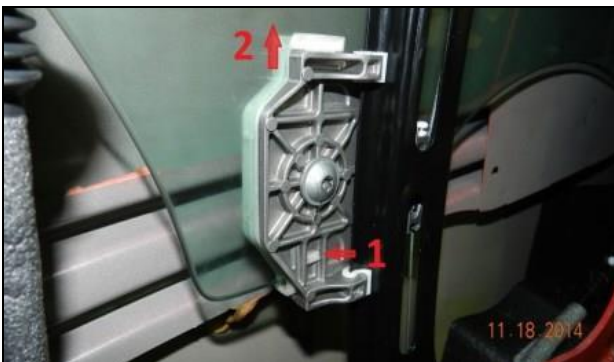
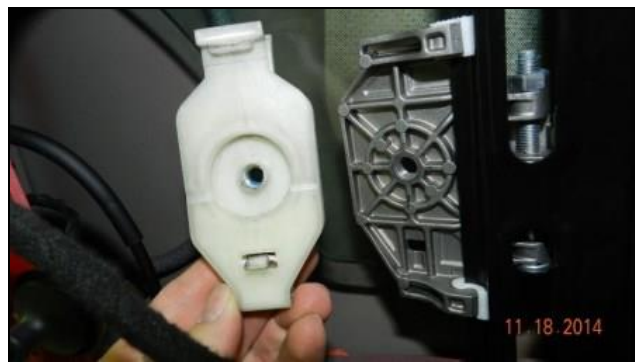
- Remove the front door trim panel to gain access to the window regulator; see Repair Manual Group 70, Interior Trim in Elsa.
- Remove the Door Inner Cover; see Repair Manual Group 57, Front Doors, and Central Locking System in Elsa.
- Raise or lower the window so the rear glass clamp is accessible.
- Remove the bolt for the regulator clamp then remove the plastic clamp from the elevator and window glass by releasing the clip toward the bottom of the clamp then sliding the clamp up. (See Figs. 4 and 5)

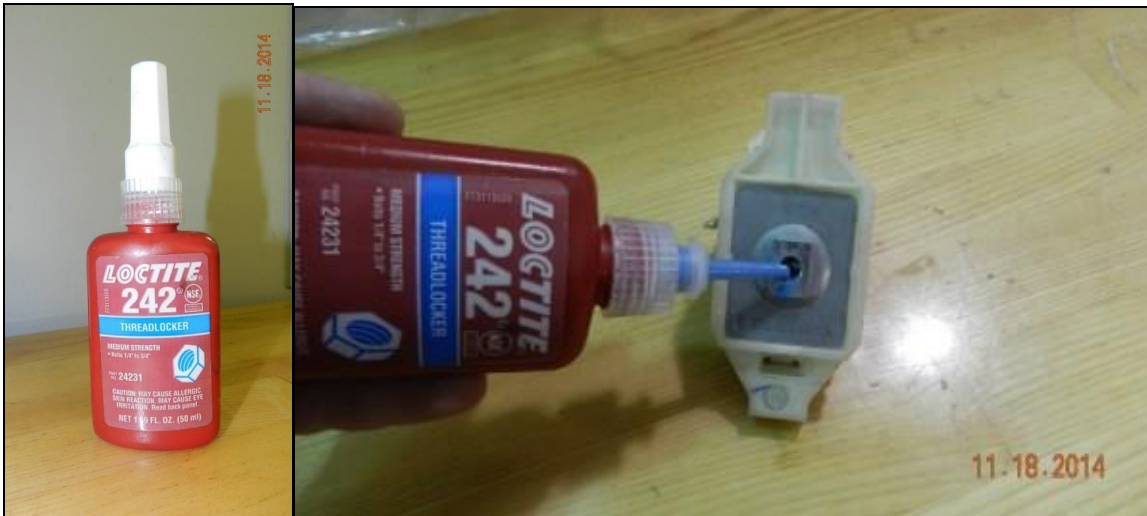
Figure 5

- Apply a few drops of Loctite brand 242 medium strength thread locking compound (blue) to the threaded insert in the plastic regulator clamp. (See Fig. 5)

Thread locking compound should not be solely applied to the clamp bolt as the effectiveness may be reduced. Apply directly to the threads on the back of the regulator clamp.

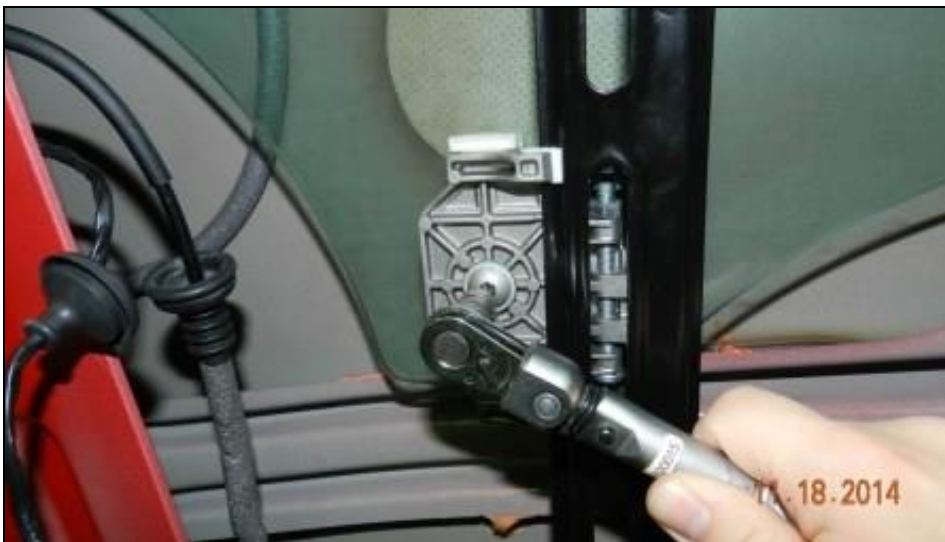
Figure 6

- Reinstall the plastic clamp on the regulator in the reverse order of removal and reinstall the clamp bolt.
- Adjust the front door window accordingly; see Repair Manual Group 64 Glass, Window Regulators in Elsa.
- Once the window glass is properly adjusted, torque both the front and rear regulator clamp bolts to **7 Nm** using torque wrench 1783 (VAG1783). (See Fig. 6)
