Technical Bulletin

13 17 02 July 13, 2017 2044350 Supersedes Technical bulletin 13-16-01 (V131601) dated May 31, 2016 to include additional engine codes and model year applicability.

Sealing Flange Installation

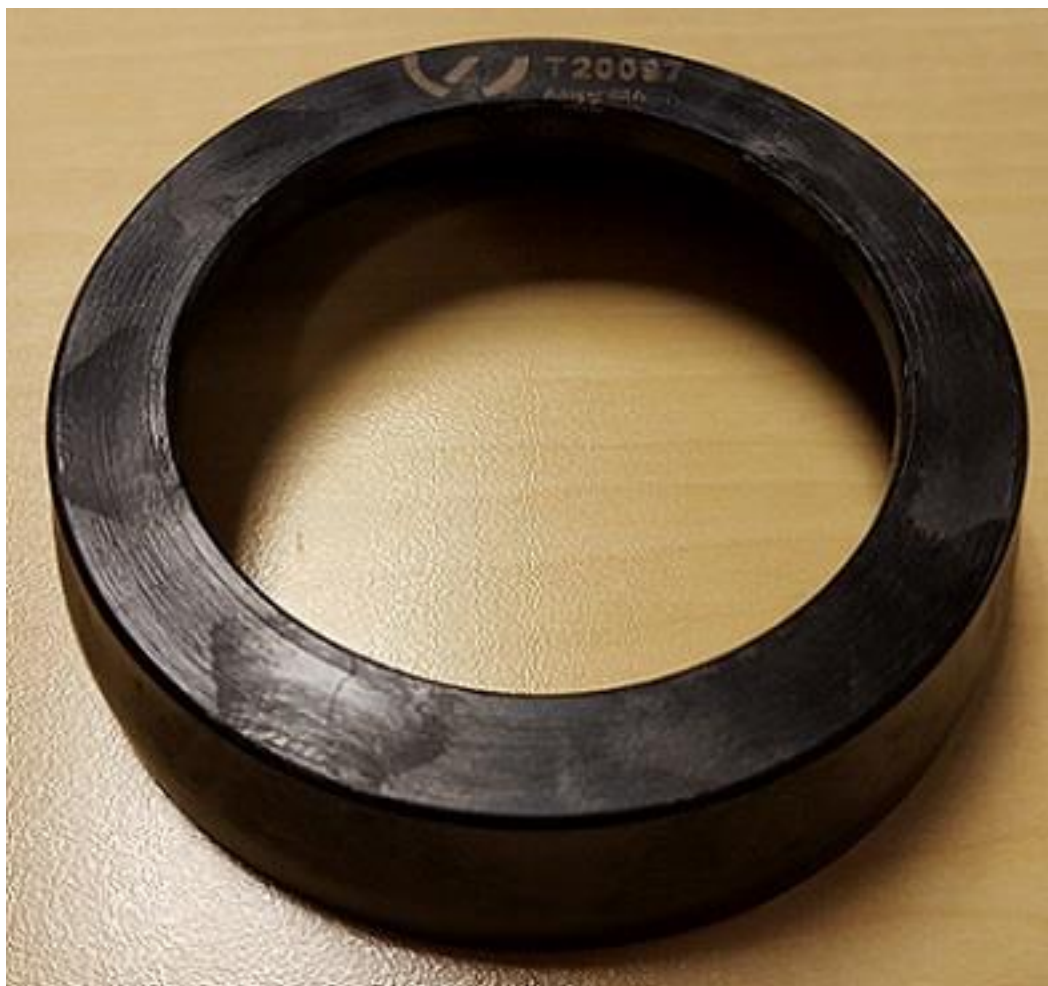
To properly install the sealing flange, the lip must be correctly oriented. To do this you must use Sealing Flange Guide Sleeve T20097 Figure 1.

Figure 1. T20097 Sealing Flange Guide Sleeve

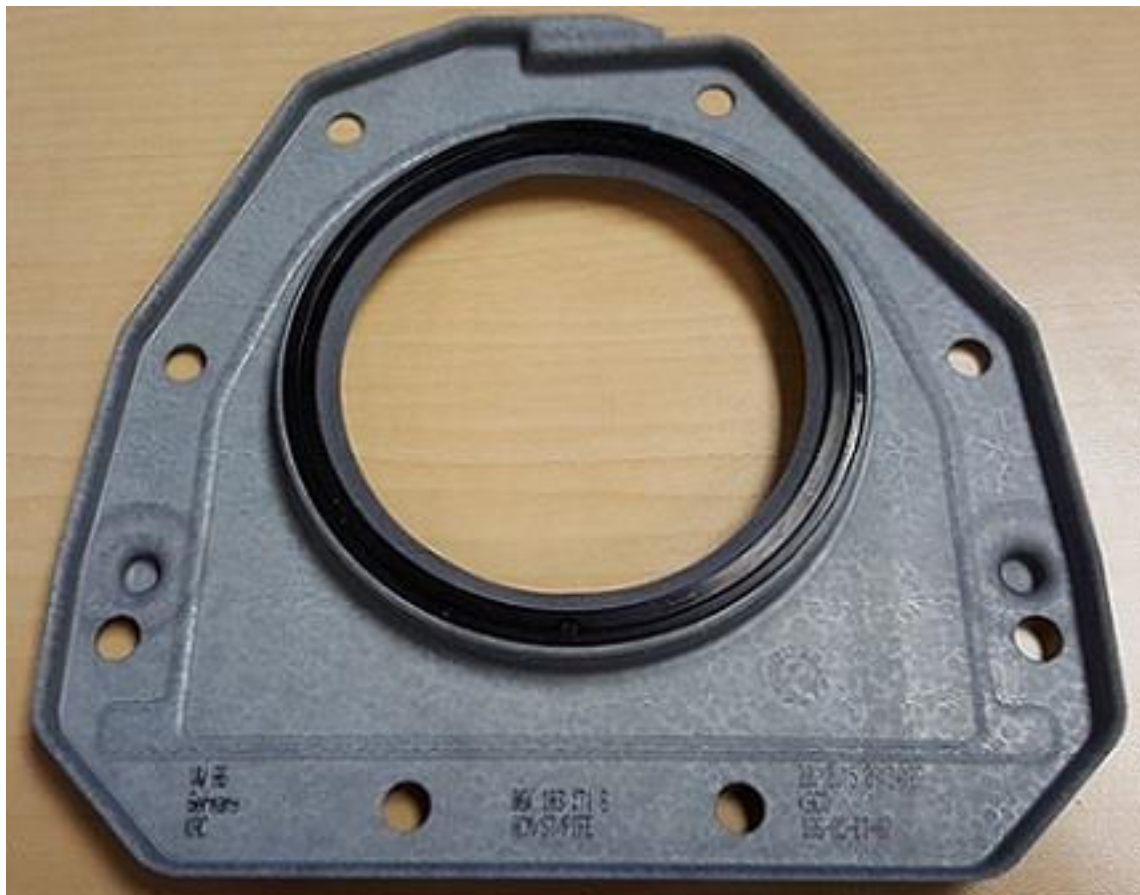
Figure 2. Front of sealing flange seal

Install T20097 into the **front** (Figure 2.) of the seal and let sit for 5 minutes allowing the lip to take shape Figure 3.

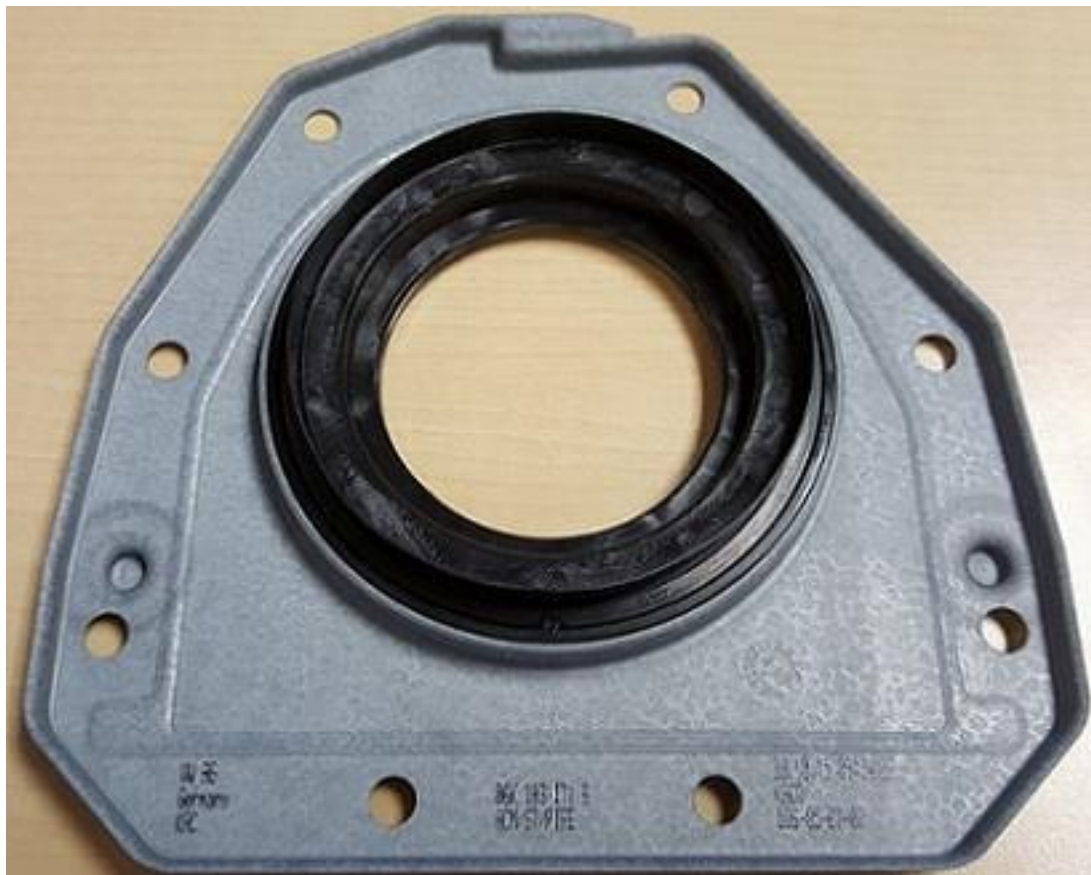
Figure 3. T20097 installed into front of sealing flange seal

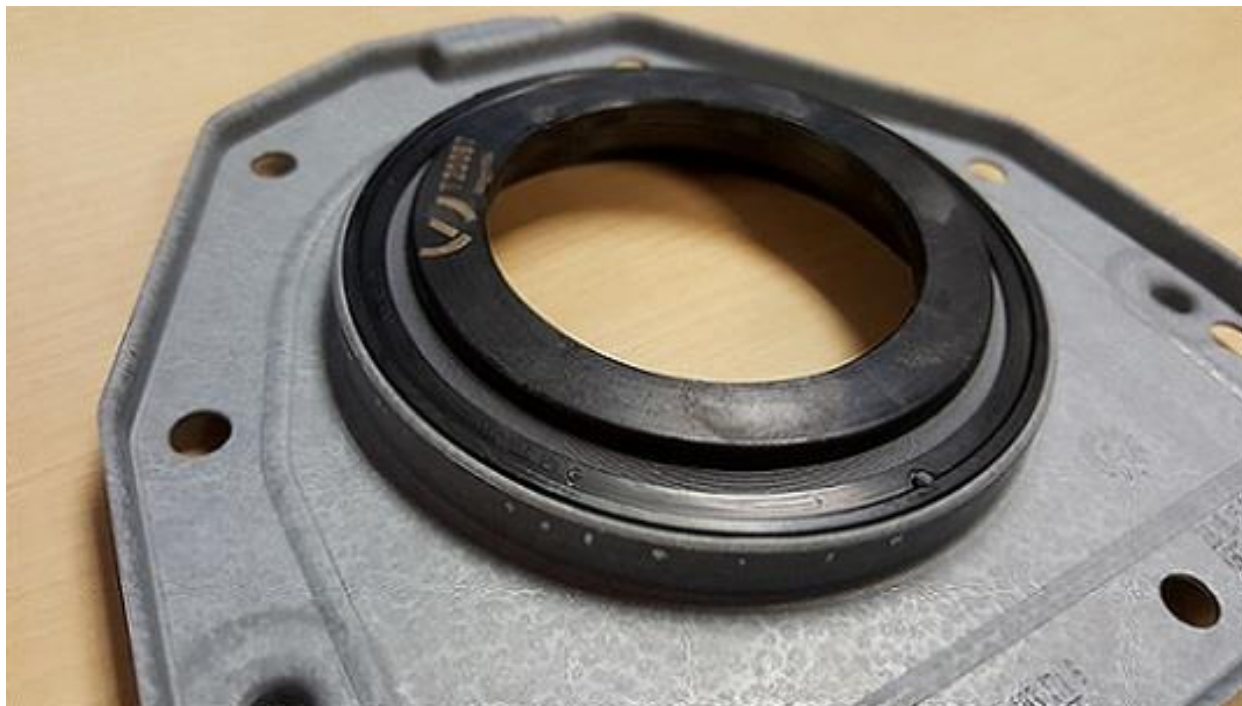
Figure 4. T20097 installed into the rear of the sealing flange seal

After the 5 minutes have passed, remove T20097 from the sealing flange seal and reinstall it to the **back** of sealing flange seal Figure 4.

Once T20097 has been inserted into the back of the rear the sealing flange seal (Figure 4.) the T20097 and sealing flange seal can be installed onto the engine/crankshaft per the repair manual.

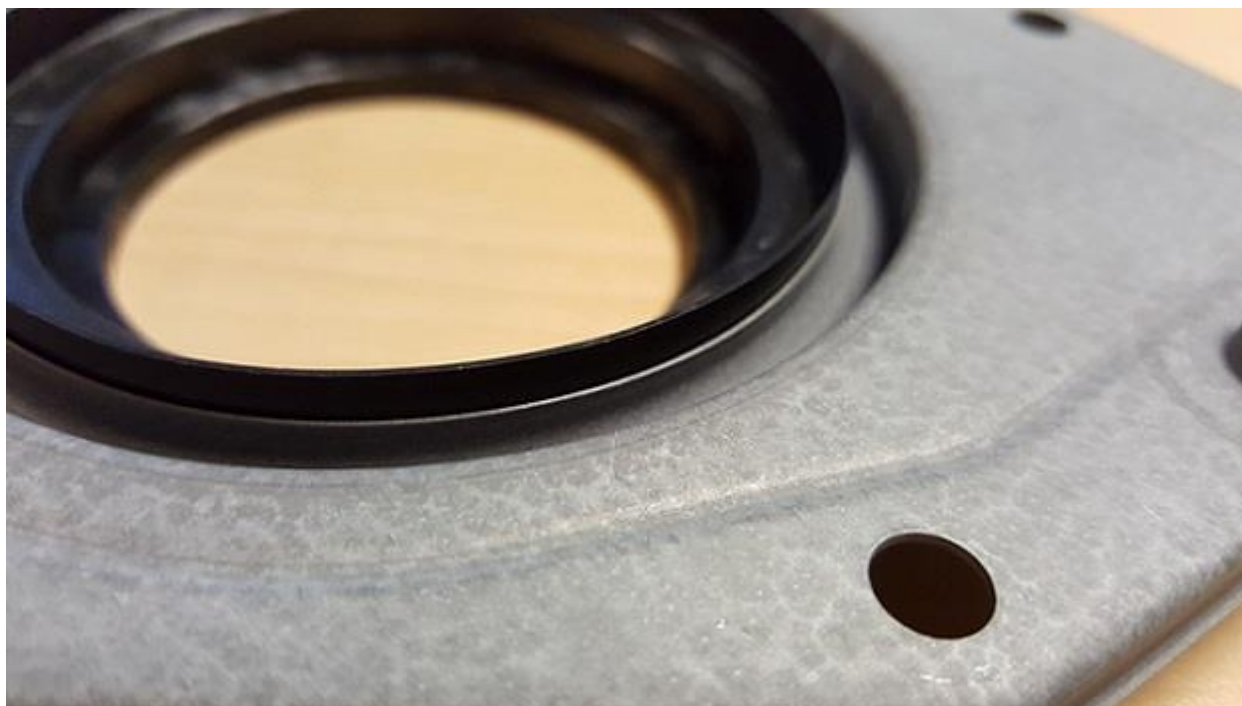
Figure 5

A properly oriented sealing flange seal lip will be facing toward the engine block as illustrated in figure 5.
