Technical Service Bulletin

70 Noises from B-pillar area

70 17 63 2048430/2 August 17, 2017. Supersedes Technical Service Bulletin Group 70 number 17-62 dated July 19, 2017 for reasons listed below.

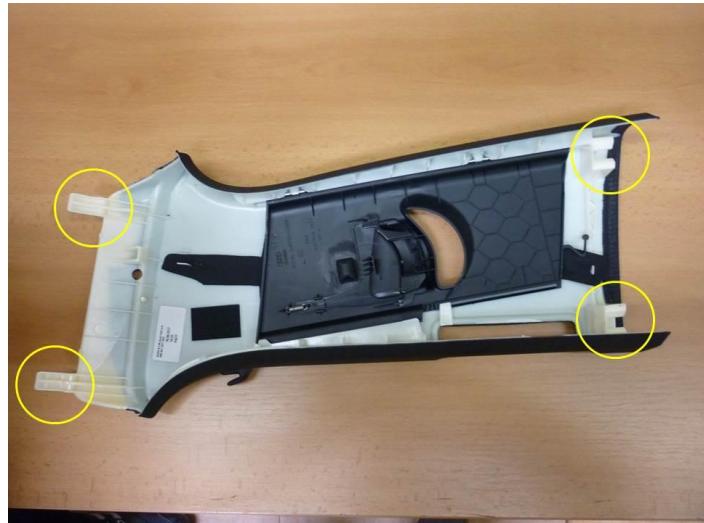
The customer hears various noises coming from the B-pillar area or door area when driving on rough roads or when the vehicle flexes.

The inner B-pillar trim mounting points and their contact to the body may be the source of the noises.

Figure 1. Mounting points of the B-pillar trim.

Remove the B-pillar trim and apply a sufficient amount of Krytox paste G 052 141 A2 to the mounting points of the B-pillar trim (Figure 1). Apply this repair solution to the other side as well should there be noises from both the right and left inner B-pillar trim.
