# Technical Service Bulletin

## 44 Tire wear, Goodyear Eagle 285/45 R20 All Season

44 17 66 2048563/1 August 17, 2017.

Model(s)	Year	VIN Range	Vehicle-Specific Equipment
Q7	2017 - 2018	All	Goodyear Eagle tires

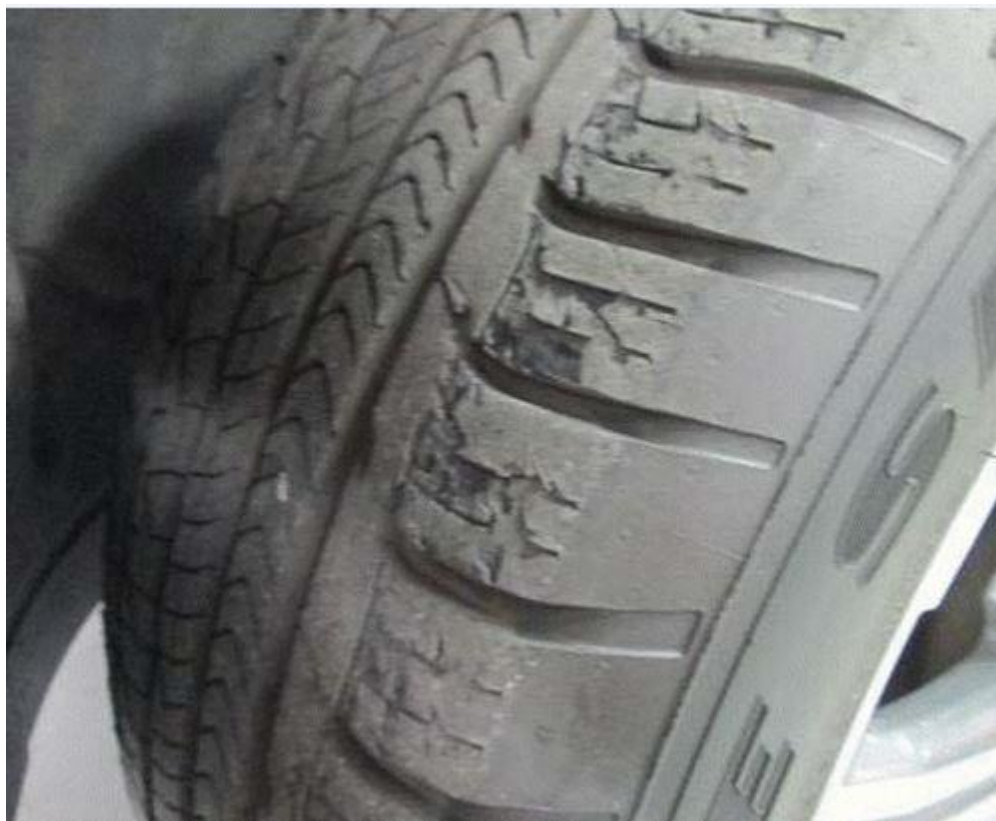
The tire has abnormal wear on the outer edges. The tire pressure and the alignment are according to specifications.

High ambient temperatures in connection with rough roads lead to increase wear only on the outer edges of the tire.

The following photograph shows an irregularity on the outer side and on the inner side of the tire (Figure 1). For this specific type of concern the tire must be replaced.

**Figure 1.** Irregularity on the outer side and on the inner side of the tire.

- The remaining tread depth is above 6.5mm (8/32<sup>nds</sup>" )
- Wear on outer/inner edges is the same as Figure 1, then proceed as follows:
  1. Replace all 4 tires with:
    - *Pirelli Scorpion Verde 285/45 R20 112 H XL AOE.*
  2. Upload pictures of the tires to DOC-IT for claim validation (4 pictures: one for each tire with visible marks FL, FR, RL, and RR).
  3. Submit tires through Warranty Claim Portal on Dealer Tire website >> Workmanship and Materials >> tearing of tread.

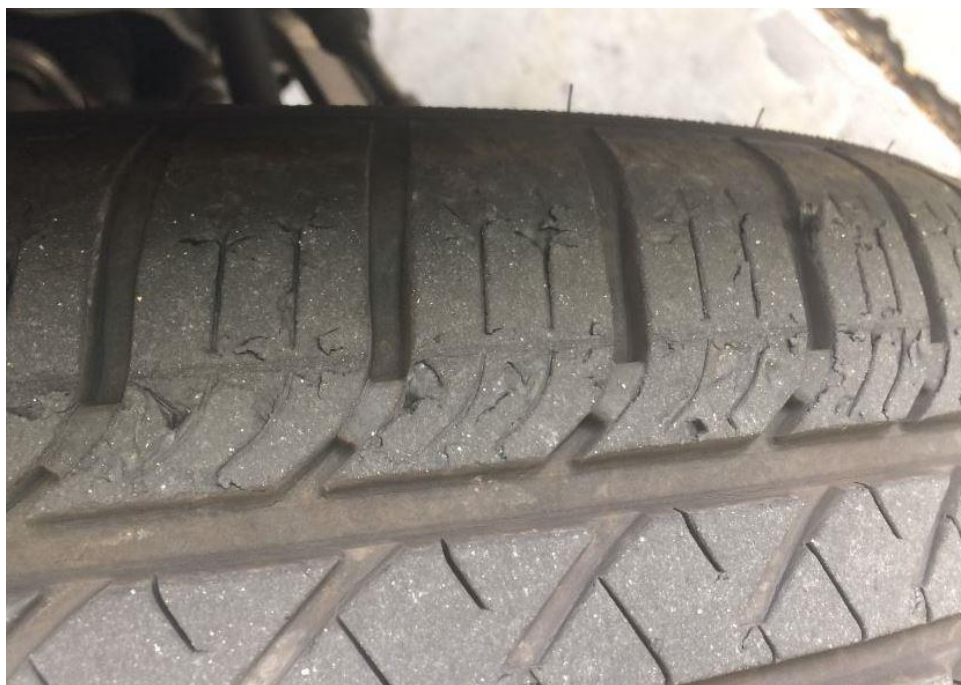
The following photograph shows a normal condition and the tire cannot be replaced.

**Figure 2.** Normal condition.

4. If tires are similar to Figure 2, do not replace the tires and proceed with tire rotation.
