# Technical Bulletin

**87 17 01** February 27, 2017 **2044165** Supersedes Technical Bulletin V871627 dated December 1, 2016 to add associated labor operations to warranty section and add additional model year applicability.

### Air Conditioning Does Not Cool and or Compressor is Noisy

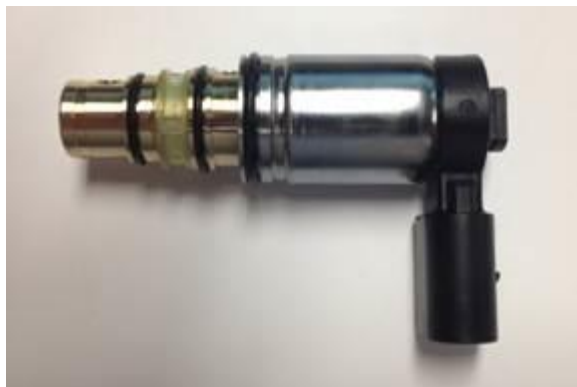
**Figure 1** N280 Refrigerant Regulating Valve 1K0260839

The condition may be caused by a faulty A/C compressor regulator valve -**N280**- (Sanden). The internal components of the valve can be obstructed and incapable of full function. This loss of refrigerant regulation from -**N280**- can cause noise from the air conditioning compressor and/or affect the HVAC cooling.

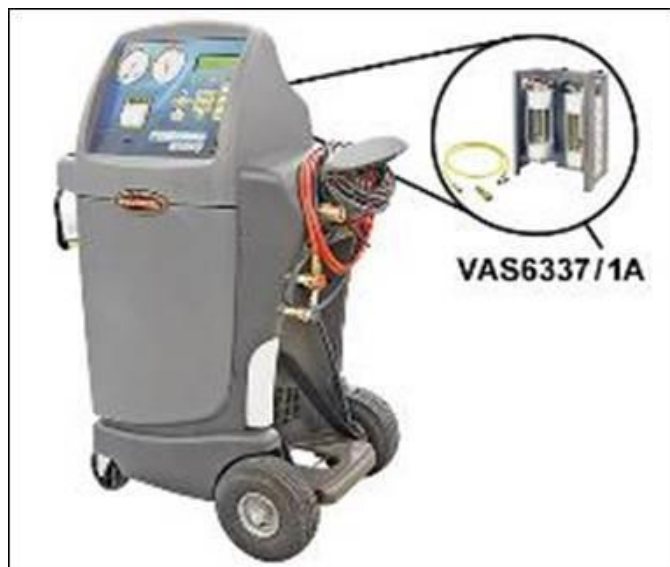
**Figure 4.** Robinair A/C Service Unit.

Connect both the refrigerant service station (Figure 4) and the diagnostic tester to the vehicle.

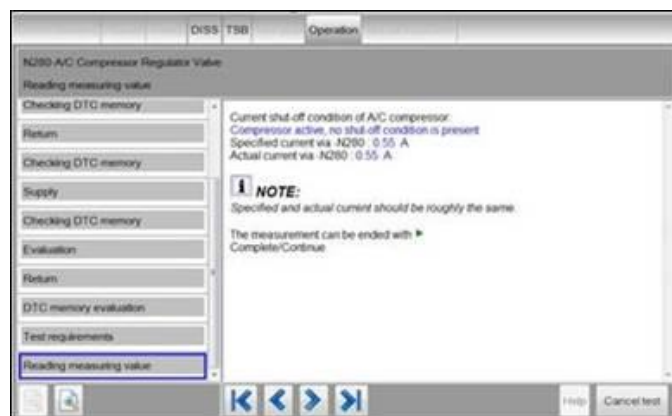
**Figure 5.** Checking N280 signal value Measuring Value Block.

Monitor the measuring value for the air conditioner compressor regulating valve N280 signal (Figure 5).

The actual and specified values will be plausible and will show a normal regulating range of current for cooling request (0.400 A – 0.820 A).

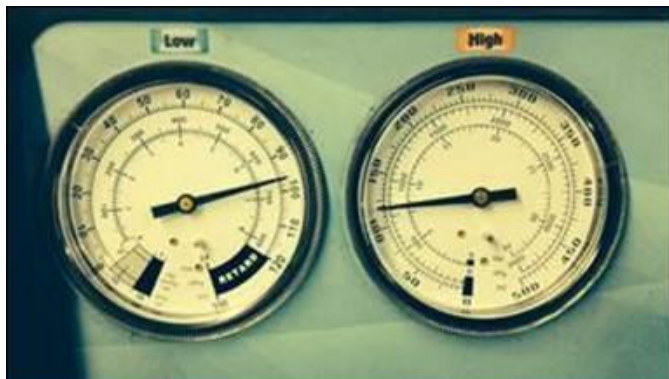
**Figure 6.** Equalized pressure condition. No pressure generated from compressor.

After verifying, the compressor should be on and operating. Check the gauge readings on the Robinair® service station. If the gauges show no pressure generation from the compressor continue to the next step.

**(Example of no pressure generation is when the pressure readings on the high and low sides are equalized in Figure 6).**

**⚠ Note: If the gauge readings are showing normal compressor operation per the Elsa Repair Manual, this bulletin does not apply and further diagnosis is required.**

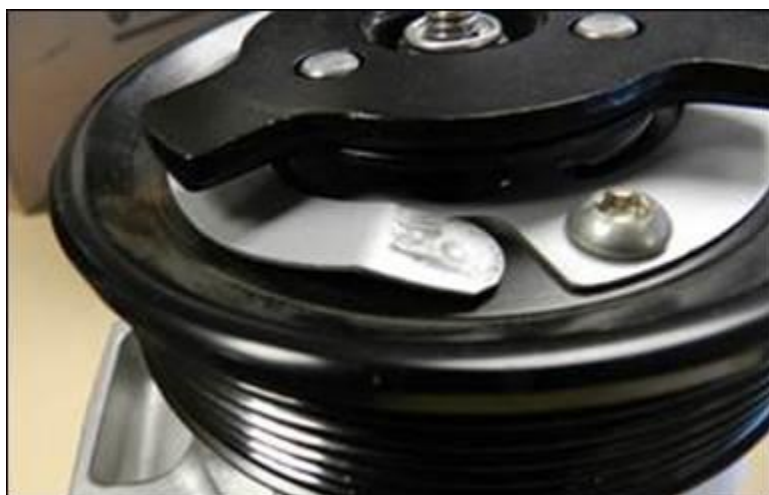
**Figure 7a.** Example of torque limiter over load protection activated.

Check that the compressor torque limiter has not been activated (Figures 7a and 7b).

**⚠ Note: If the torque limiter has been released the N280 regulating valve is not at fault. The compressor needs to be replaced.**

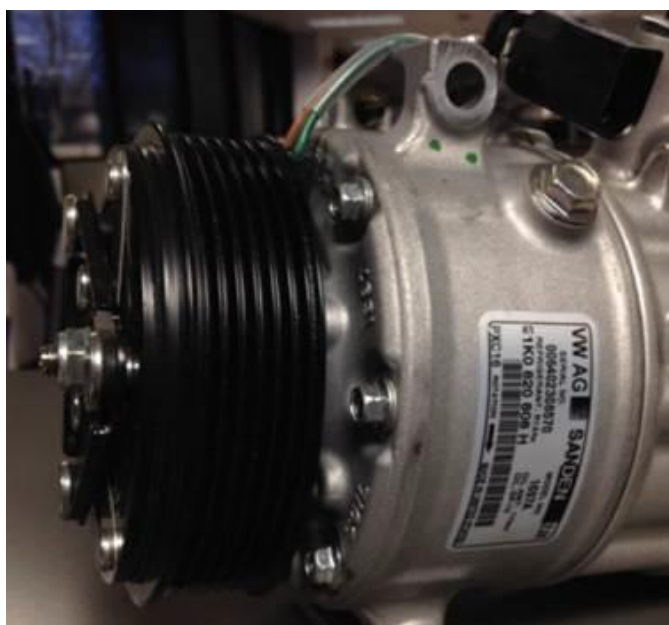
**Figure 8.** MY2016 AC compressor with clutch (Sanden)

For MY2016 vehicles with Sanden AC compressor 1K0820808H make sure the compressor clutch is engaged when the AC is switched on.

If clutch is not engaging perform diagnosis of the compressor clutch J44 test.

**Check that adaptation channel 9 and is set at 1 for clutch enabled. (See TT 87-16-01).**

**⚠ Note: If the AC compressor clutch is not engaging this bulletin does not apply.**

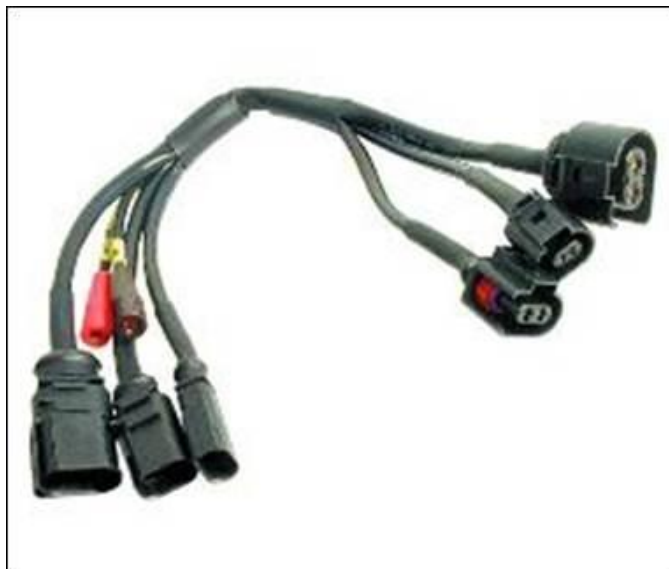
**Figure 9.** VAS 5256 breakout harness.

Shut off the engine. Connect the breakout harness VAS 5256 (Figure 9) between the N280 valve and its connector.

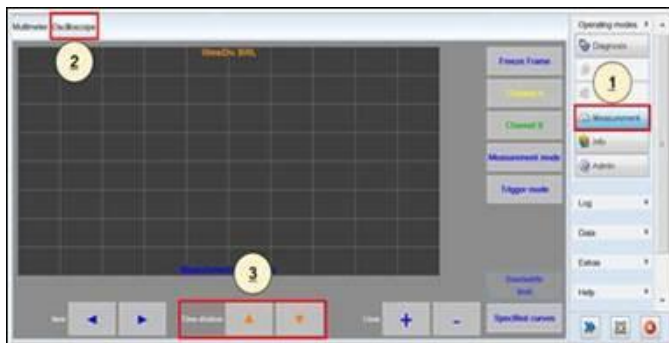
**Figure 10.** Select Measurements from operating mode menu”.

Go to Operating Mode “Measurements” to check the N280 signal from the control module.

Select Measurements.

Select oscilloscope.

Change time division to 2ms/Div (Figure 10).

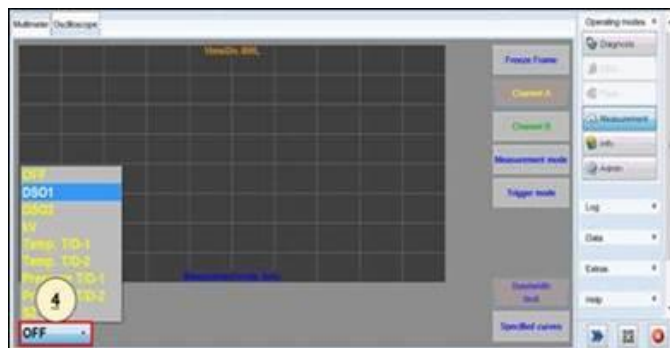
Select the correct DSO channel according to the test leads hooked to the vehicle (Figure 11).

Figure 11. Setting up DSO channel”.

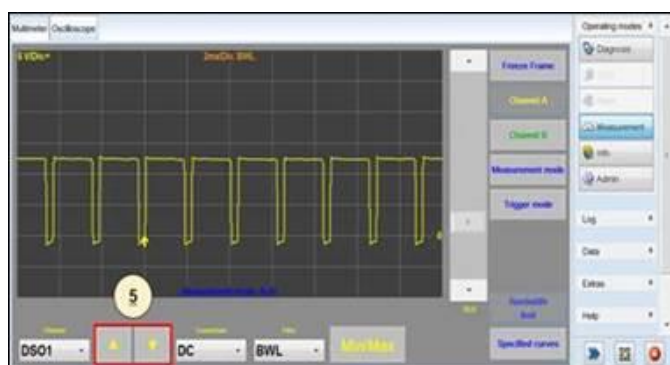
Change the voltage to 5VDiv.

Check the signal wave form (Figure 12). The square wave signal should be between 75% and 100%.

If the wave form signal is good, the mechanical integrity of the N280 valve needs to be inspected.

Figure 12. Checking the N280 signal wave form.

**GO TO: Removing/Installing the N280 Regulating valve.**

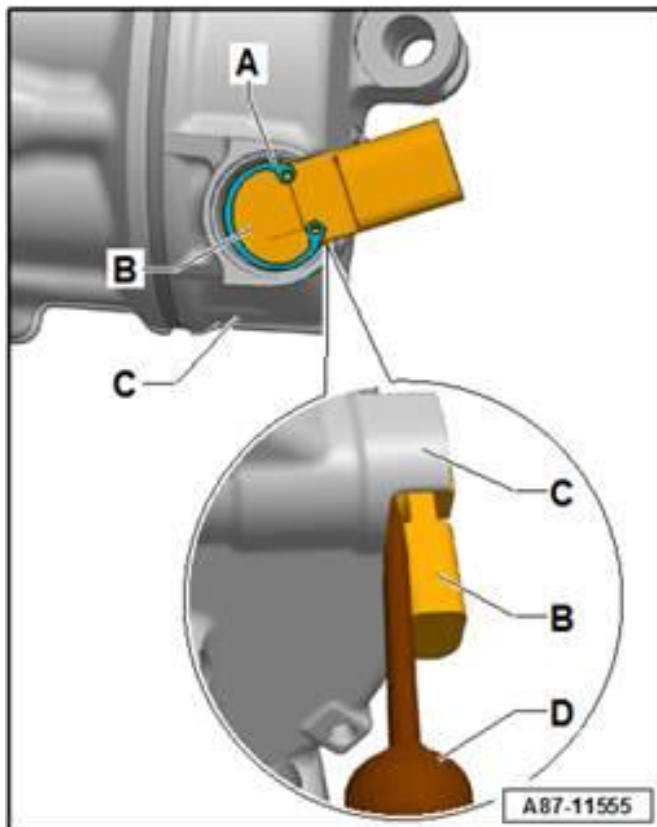
Figure 13. Circlip / N280 removal

1. Remove circlip-A- carefully.

2. Carefully remove the A/C Compressor Regulator Valve -N280- -B- from the A/C compressor mount -C-, using a suitable screwdriver -D-, for example (Figure 13).

**Circlip must be reused.**

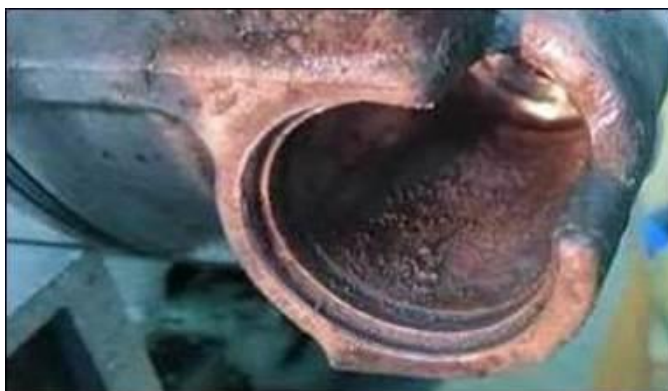
Figure 14. Corrosion in the N280 valve bore.

Assess the condition of the N280 valve bore and the valve filter screen (Figure 14). If severe contamination is found in valve bore there is a risk of damaging the replacement valve on installation. In these cases the A/C compressor must be replaced.

**A slight amount of debris or corrosion does not present a risk and does not justify replacement of the AC compressor.**

- If little or no corrosion or contamination is found perform Repair Procedure A: Replacing the N280 regulating valve.
- If corrosion and contamination is found, perform Repair Procedure B: A/C compressor replacement.
- Document the all workshop findings of this procedure on the repair order.

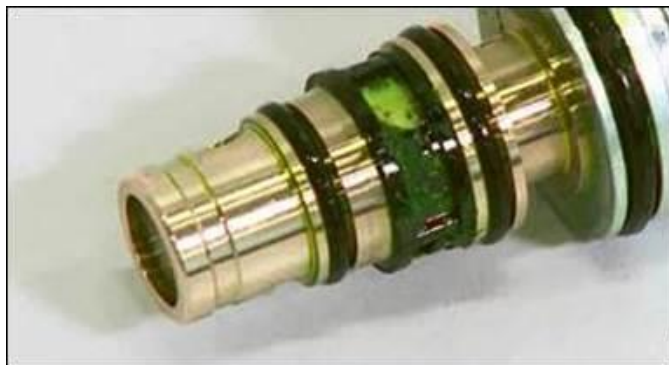
**Figure 15:** Severe contamination at the N280 valve filter screen.

Should severe contamination be found at the valve filter screen (Figure 15) and A/C compressor replacement becomes necessary, ensure that the refrigerant circuit is flushed in the course of repair.

**Small random particles on the filter screen does not constitute “severe” contamination and does not justify replacement of the A/C compressor.**

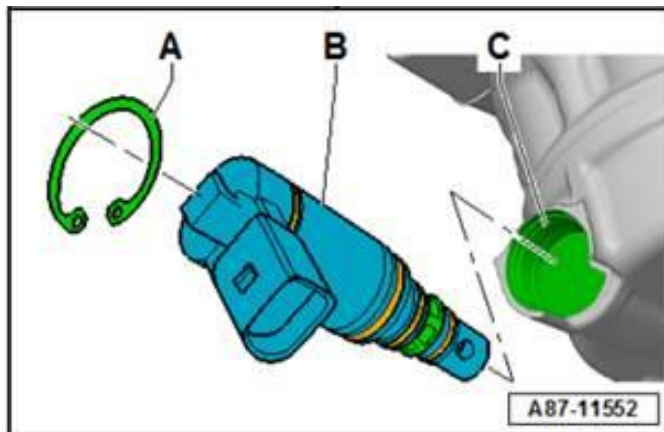
**Figure 16:** Prepare mount for N280 installation.

Risk of damaging another N280 Valve or compressor may result due to dirt contamination or damage to the sealing surfaces in the mount.

- If necessary, carefully clean the A/C compressor mount -C- using only a clean, lint-free cloth. **DO NOT** use compressed air.
- Make sure while cleaning the mount -C- that no dirt gets into the area underneath the O-ring sealing surface -F- or the existing channels and none of the mount sealing surfaces become damaged.

1. Check the A/C compressor mount -C- and the circlip groove for dirt, and if necessary, clean them carefully and thoroughly with a clean, lint-free cloth (Figure 16).

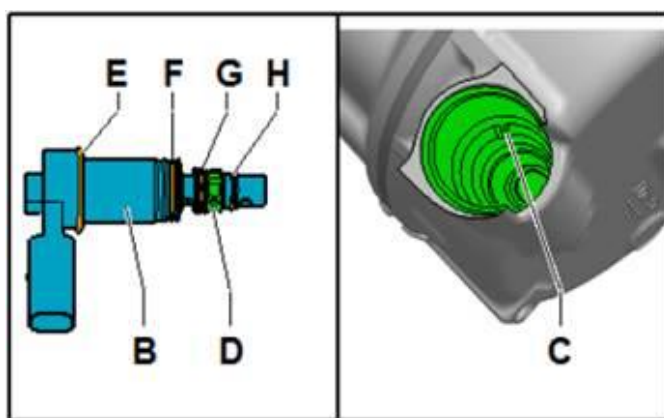
**Figure 17.** Check and prepare N280 o-rings

1. Check the O-rings -F-, -G-, -H- and -E- (if applicable) of the A/C Compressor Regulator Valve -N280- -B- for damage.
2. Coat the O-rings -F-, -G-, -H- and -E- (if applicable) of the A/C Compressor Regulator Valve -N280- -B- lightly with refrigerant oil and check for proper seating (Figure 17).

3. Insert the A/C Compressor Regulator Valve -N280- -B- until the stop in the A/C compressor mount -C-.
4. Re install circlip -A-.
5. Install the removed parts in the opposite order.
6. Evacuate and refill the refrigerant circuit.

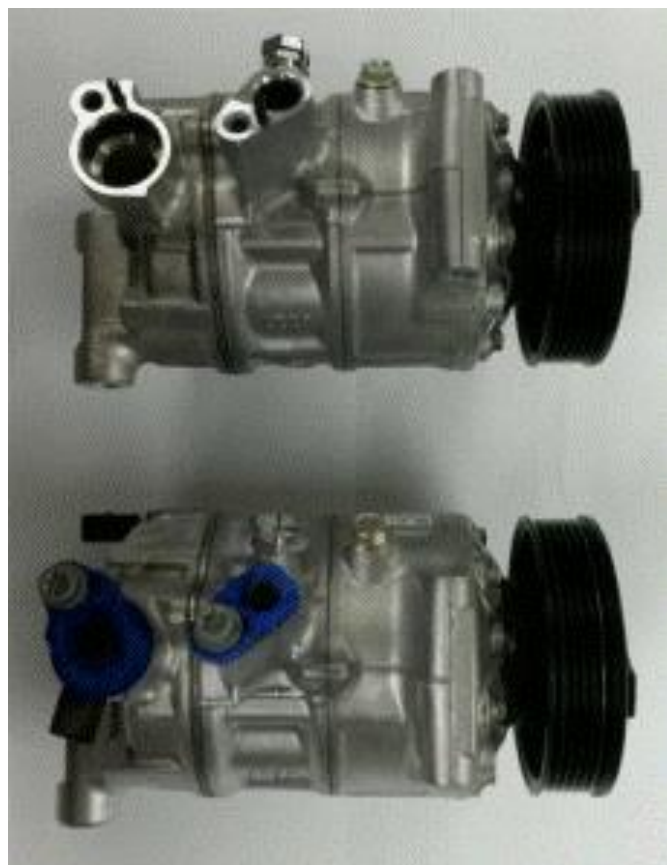
**Figure 18**

When installing a new compressor transfer the compressor shipping caps to the original compressor as shown in Fig 18.

All replaced compressors must have the shipping caps re-installed before being returned to the WPRC.

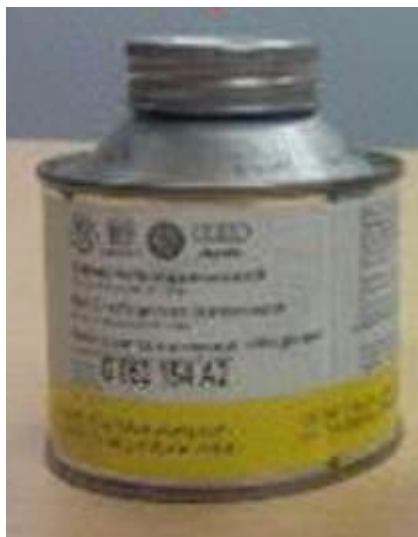
**Figure 19:** Sanden compressor manufacturer PAG oil G 052 154 A2.

The replacement Sanden compressor will come with the specified type of PAG oil G 052 154 A2 (Figure 19).

**The compressor comes with a full charge of oil for the entire refrigerant circuit. However the amount of PAG oil supplied with the replacement compressor may not be the exact amount to replenish the refrigerant circuit. Drain and measure the PAG oil in the replacement compressor to determine the required amount. If the amount needs to be adjusted, do so using the correct type of PAG oil specified in ETKA. Refer to Elsa for the correct oil capacity for the compressor being installed.**

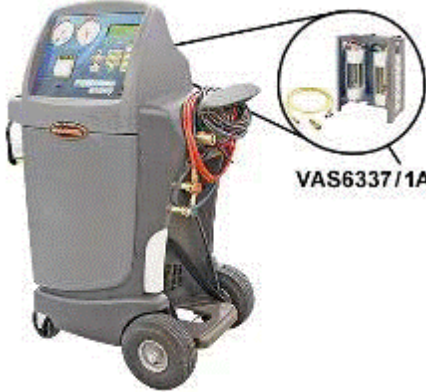
<p>A grey Robinair A/C Service Unit on wheels with a control panel and hoses. A callout circle shows a detail of the VAS6337/1A flush tool.</p> <p><b>Robinair A/C Service Unit</b></p>	<p><b>TOOL NO:</b></p> <p><b>ROB134APF</b></p>

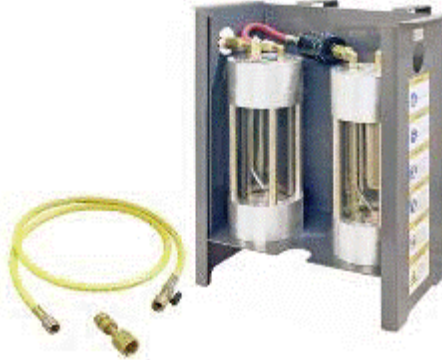
<p>A grey metal Air Conditioning Flush Tool with two vertical chambers and a yellow hose with connectors.</p> <p><b>Air Conditioning Flush Tool</b></p>	<p><b>TOOL NO:</b></p> <p><b>VAS 6337/1A</b></p>

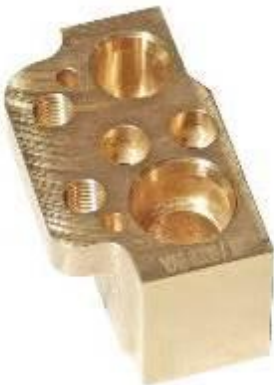
<p>Refrigerant Circuit Adapter 18</p>	<p>VAS 6338/18 (MY2013-2015)</p> <p><b>Note: For MY2016 the expansion valve must drilled out and used to flush the refrigerant circuit. A new expansion valve must be installed.</b></p>
