Tech Tips

TT 26-17-02

2015 Golf, Golf Sportwagen, Jetta, Passat, Beetle, with Engine Codes CVCA/CRUA 2.0L TDI. Adblue® Pressure Faults P20E8, P208B, P218F, P249C

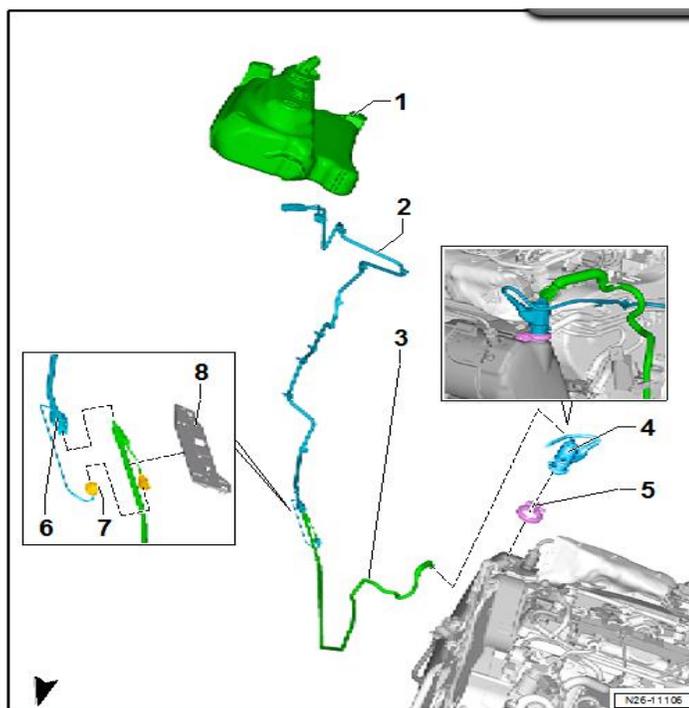
AdBlue® pump pressure faults, control range/performance P20E8, P208B. Before replacing the AdBlue® pump, please inspect all lines from the AdBlue® pump to the dosing valve under the hood. Check the rear line where it meets the front line under the vehicle. There is a protective cover, item 8 in figure below, that will need to be removed to inspect the AdBlue® line. If there are any leaks in the AdBlue® system, the system will be unable to be reset. Fault codes P218F and or P249C may set after a repair is performed and there is still a leak. Please see figure below for line connection. Or refer to Repair Manual Group 23, Selective Catalytic Reduction System / Overview-Reducing Agent Delivery Line in Elsa. . Once the repair is completed, get the vehicle up to operating temp. Particle filter outlet temperature sensor 1, bank 1 raw value must be more than 150 C. Then go to ECM control module OBD adaptation, select Adaptation for metering quantity adjustment. Change value from a 4 to a 2, click apply. Then perform basic settings for (1) Resetting adaptation values of reduction agent sys. comp. change. Click on the blue forward button 2X's, then select measured values for status of basic settings. Click the blue forward button again. Left click on Resetting adapt. values of reduction agent system, comp. change. Click start and you will see basic settings ended. Then road test until the MFI message miles to no start goes out.
