# Technical Service Bulletin

## 46 Brake pulsation diagnostic guidelines

46 17 68 2022584/8 March 15, 2017. Supersedes Technical Service Bulletin Group 46 number 17-63 dated January 12, 2017 for reasons listed below.

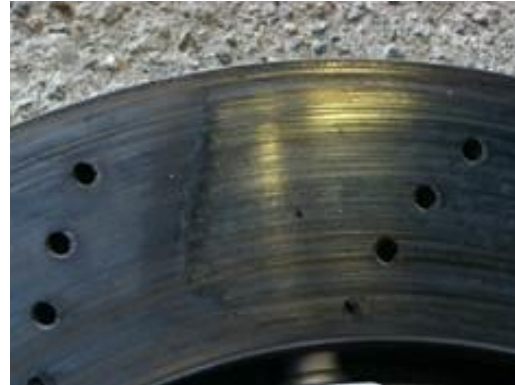
**Condition:** Brake pad material smeared on the brake disc (Figure 2). This condition can create DTV.

**Common cause:** An overly-aggressive driving style, which results in frequent sharp braking without proper cooling off periods.

*Figure 2. Deposits on the brake disc.*

**Service:** Replace brake discs and pads.

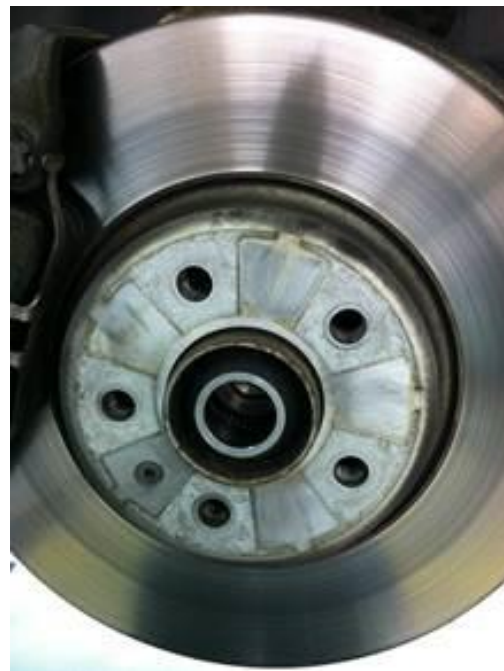
**Condition:** Blue-tempered or overheated brake discs (Figure 3).

**Common cause:** Failed component(s) causing constant brake application. This can also be caused by an overly-aggressive driving style, which results in frequent sharp braking without proper cooling off periods.

*Figure 3. Brake disc with heat marks.*

**Service:** Replace brake disc and pads.

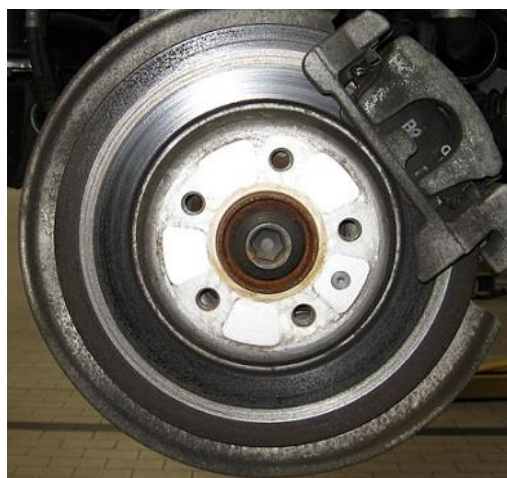
**Condition:** Corrosion/rust build-up on the brake discs (Figure 4). This condition can create DTV.

**Common causes:**

- Exposure to road salt during winter months, high humidity, or moisture.
- Vehicle not being driven for prolonged periods of time.
- A gentle driving style with very light brake application may not be enough to remove build-up (such as rust or corrosion) on the brake discs and pads.

**Figure 4.** Corrosion/rust build-up.

**Service:** With careful consideration of the traffic situation, perform 2-3 ABS stops from speeds above 50mph. Between each stop, allow the brake components to cool by driving the vehicle for more than one minute at speeds greater than 50mph. Do not perform ABS stops if brand new pads and/or discs are installed. Replace brake disc and pads if the condition is not eliminated.

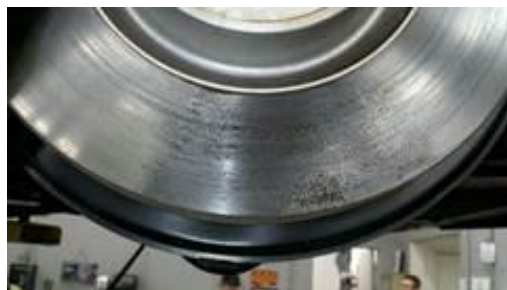
**Condition:** Pad material transfer or corrosion marks from brake pads on the brake disc, also known as “pad marks” (Figure 5). This condition can create DTV.

**Common cause:** These marks can appear if the vehicle has not been driven for a prolonged period of time or if the brakes are exposed to high humidity or moisture.

**Figure 5.** Pad marks on the brake disc.

**Service:** With careful consideration of the traffic situation, perform 2-3 ABS-stops from speeds above 50mph. Between each stop, allow the brake components to cool by driving the vehicle for more

than one minute at speeds greater than 50mph. Do not perform ABS stops if brand new pads and/or discs are installed. Replace brake disc and pads if the condition is not eliminated.

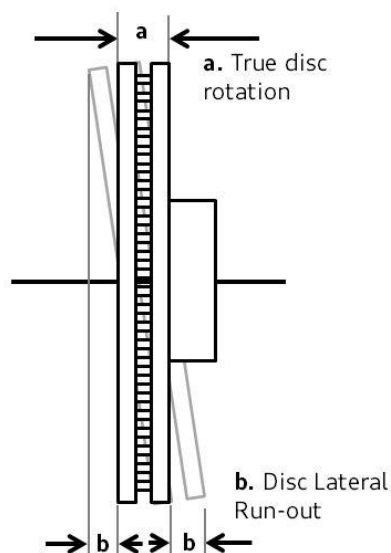
**Figure**

**Condition:** Excessive brake disc or wheel hub run-out (Figure 6). Measure according to the *Run-out Measurement Instructions* listed below.

**Common causes:**

- **Over-torqued or improperly-torqued wheels** (torque sticks, impact gun, etc.) can distort the brake disc and hub, causing a run-out condition. Refer to Elsa for proper torque values and procedures for the VIN.
- **Wheels that are not Audi-approved** may not have the same contact surface on the back of the wheel and may not have the correct center bore dimension, which can distort the brake disc and hub, causing a run-out condition.
- **External impact or rust build-up** between brake disc and hub.

**6. True disc rotation (a) and disc lateral run-out (b).**

**Service:** Replace brake disc(s) and/or hub(s) if measurements exceed the maximum value listed in the *Run-out Measurement Instructions*.

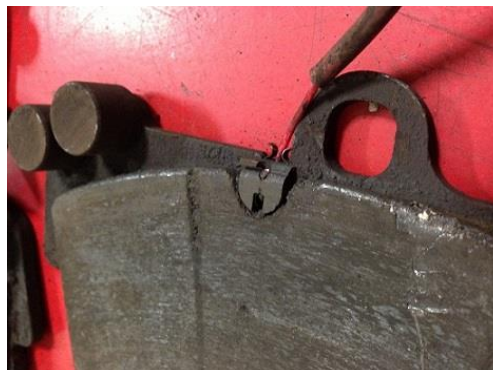
**Condition:** Worn brake pads (Figure 7).

**Common cause:** As brake pads and discs reach their wear limit, their dampening characteristics are reduced.

*Figure 7. Worn brake pad.*

**Service:** Replace worn brake pads and discs.

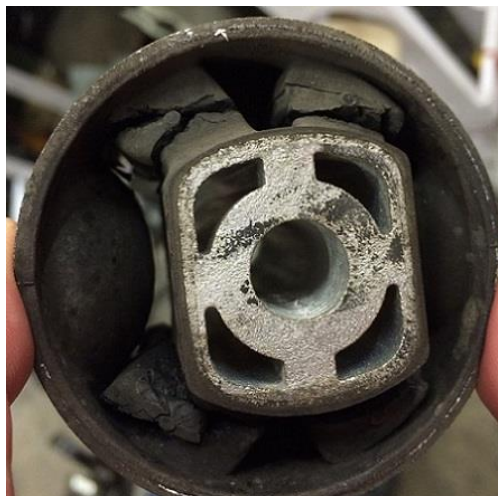
**Condition:** Faulty, damaged, or aftermarket suspension components (ball joints, links, tie rods, bushing, etc.) can significantly amplify vibration/pulsation or lead to body vibrations which only become noticeable when braking (Figure 8 and Figure 9).

*Figure 8. Damaged suspension bushing.*

**Service:** Diagnose these components accordingly.

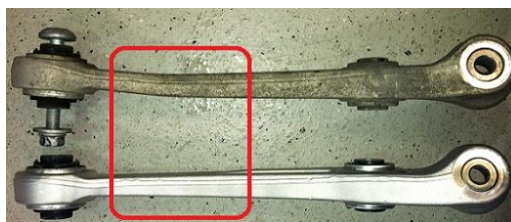
*Figure 9. Damaged suspension link.*

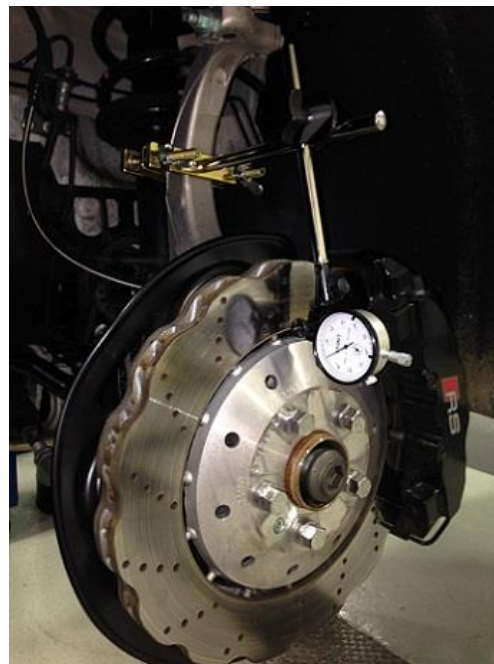
- All surfaces that will be measured must be free of rust/corrosion build-up or pad material transfer.
- VAS6079/1 (or similar measurement tool) is securely attached to the vehicle (Figure 11).
- The brake disc is secured to the hub with 5 bolts.
- Axle bolt/nut is installed and properly torqued.
- Run-out measurements should be taken with all parts installed on the vehicle

**Figure 11.** Example of run-out measurement tool VAS6079/1 properly secured to a solid suspension component.

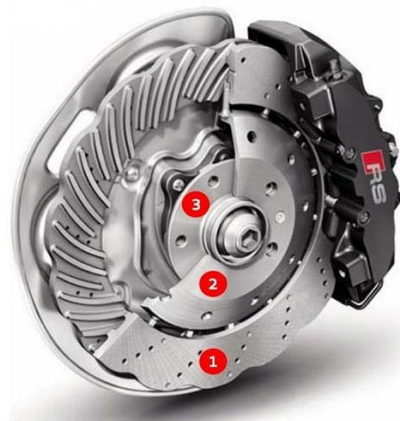
**Disc braking surface** (Figure 12, point 1):

- Disc hub and wheel hub run-out impact this value.
- Maximum run-out: **0.06 mm / 0.002"**

**Disc hub (center of the brake disc)** (Figure 12, point 2):

- Wheel hub run-out impacts this value.
- Disc hub run-out impacts the disc braking surface run-out.
- Maximum run-out: **0.03 mm / 0.0012"**

**Wheel hub (without the disc installed)** (Figure 12, point 3):

- This value impacts the disc hub and disc braking surface run-out. High run-out can distort the brake disc.
- Maximum run-out: **0.02 mm / 0.0008"**

**Figure 12.** Run-out measurement locations: disc braking surface (1), disc hub (2), wheel hub (3).
