# Technical Service Bulletin

## 64 Faint images appear in windshield

64 17 40 2047061/1 March 2, 2017.

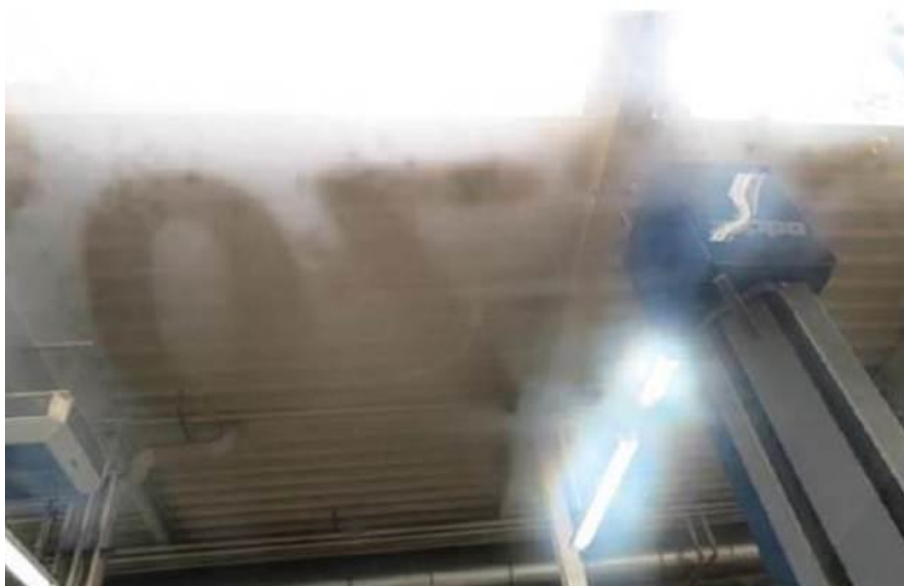
At certain sunlight entry angles or with fog on the inside of the windshield faint images can be seen. The images vary from production sticker afterimage or an image of the suction cups used to install the windshield in production.

Residue from suction cups or labels can transfer to the glass and, while not visible under normal conditions, can be seen under certain lighting or moisture conditions (Figure 1).

**Figure 1.** Faint images on window.

This residue can be removed using the cleaning cloth (Figure 2) from the window seal set D 096 330 A2. Apply moderate pressure while cleaning.

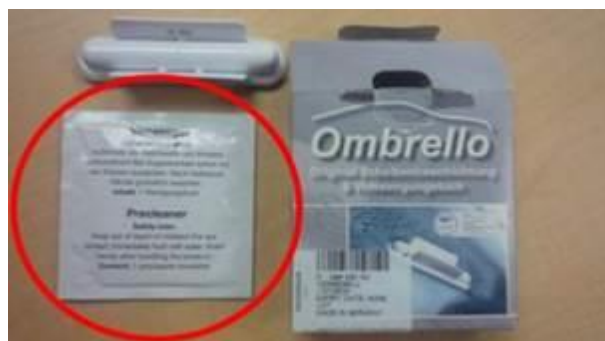
**Figure 2.** Cleaning cloth from the D 096 330 A2 window seal set.

Only use the cleaning cloth. Do not use the applicator that is included in this kit for this purpose.
