Technical Service Bulletin

19 Coolant marks on coolant pump with coolant level warning light on or detected during service work - 4.0 TFSI

19 17 84 2045456/2 March 23, 2017. Supersedes Technical Service Bulletin Group 19 number 16-73 dated September 22, 2016 for reasons listed below.

Model(s)	Year	VIN Range	Vehicle-Specific Equipment
A8, S6, S7	2013 – 2017	All	4.0 TFSI
RS 7	2014 – 2017	All	4.0 TFSI

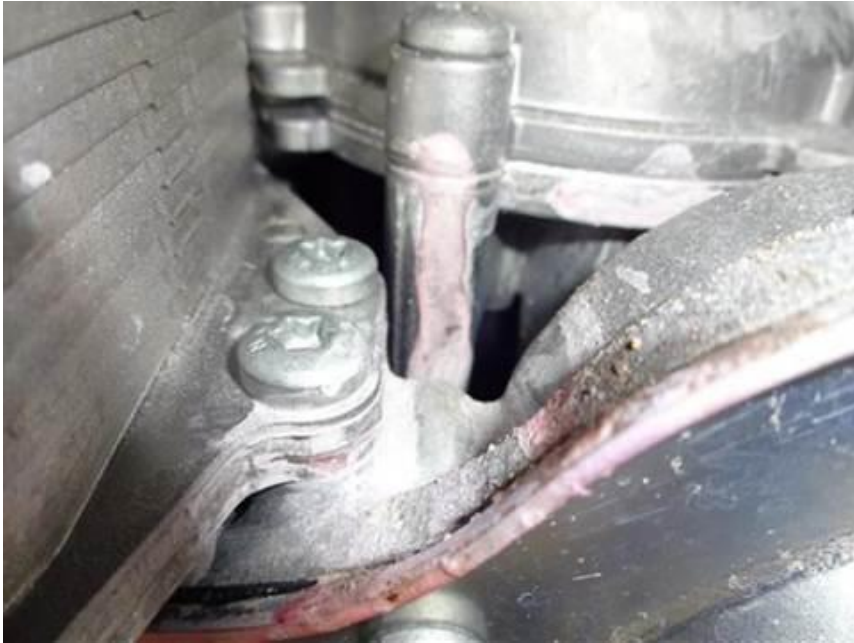
Dried coolant marks on the drive of the coolant pump (Figure 1).

Figure 1. Coolant marks shown around coolant pump.

The coolant pump is sealed off with a slip ring seal to the input shaft. To prevent the seal from drying up a minor coolant leak is necessary to lubricate the seal. In some cases, the excess coolant can be discharged to the outside via the vent hole.

With time, the discharged coolant dries up and leads to coolant deposits. This coolant pump does not have to be replaced and was not responsible for the coolant loss.

The coolant loss can be from other leaking components. In those cases, the coolant runs to the lowest point and is first visible on the coolant pump.

Remove the coolant marks from the coolant pump and the surrounding components and bleed the cooling system according to ElsaPro. Check the cooling system for leaks according to the repair manual.

If no new coolant loss is detected, do not perform any repairs.

If a leak is found, repair as necessary.
