Technical Service Bulletin

23 MIL on, rough running, no start (DTCs P0087, P0088, and/or P0191) (TDI only)

23 17 40 2036668/4 March 29, 2017. Supersedes Technical Service Bulletin Group 23 number 15-35 dated June 30, 2015 for reasons listed below.

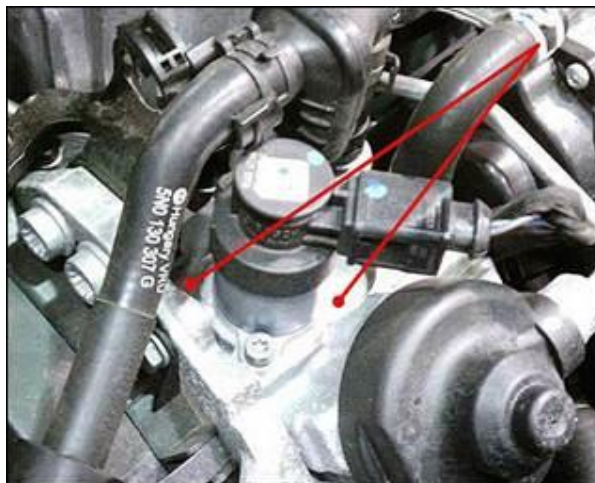
Before the N290 fuel metering valve is removed, the area surrounding the valve (Figure 1) must be sprayed with a cleaner and dried with compressed air to ensure that all debris is removed from the area.

Figure 1. Area surrounding the valve.

Fuel system components may be damaged if any debris enters the fuel system.

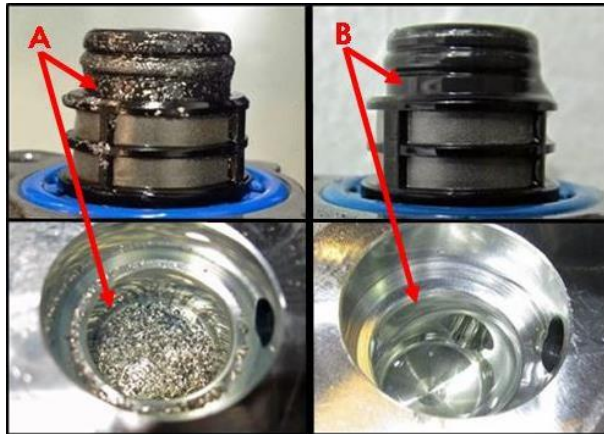
1. Remove the N290 fuel metering valve and inspect the valve and valve bore for the presence of metallic particles (Figure 2). Proceed with the appropriate section below.

Figure 2. Fuel metering valve and valve bore with metallic particles (A), and without metallic particles (B).

If metallic particles are found on the N290 fuel metering valve or in the valve bore:

1. Contact the Audi Technical Assistance Center (TAC) and open a TAC ticket before continuing with the repair. Before contacting TAC, attach the following to the TAC ticket:
 - GFF diagnostic log
 - Clear pictures showing the metallic particles in the N290 fuel metering valve and bore (Figure 3 and Figure 4).

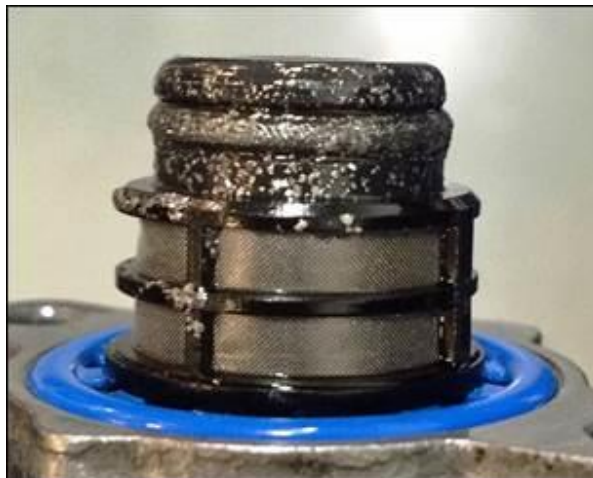
Figure 3. Example of a clear picture showing the metallic particles in the N290 fuel metering valve.

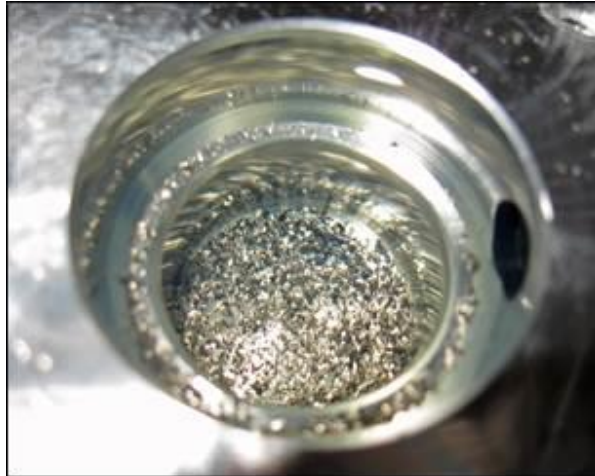
Figure 4. Example of a clear picture showing the metallic particles in the valve bore.
