# Emissions Recall

## Code: 23T4

| <b>Subject</b> | <b>2.0L TDI Engine (GEN 3) Emissions Control Software – <u>USA ONLY</u></b> |
| <b>Revision Summary</b> | <b>Additional steps added for New inventory sales requirements.</b> |

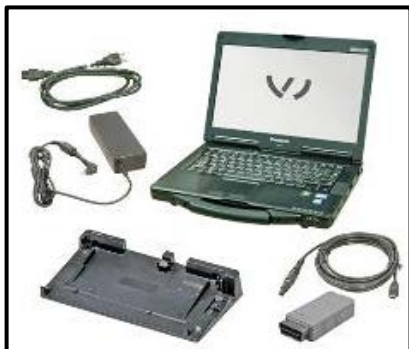
- VAS6150X – Diagnostic Tester (or equivalent)
- VAS5054X – Remote Diagnosis Head (or equivalent)

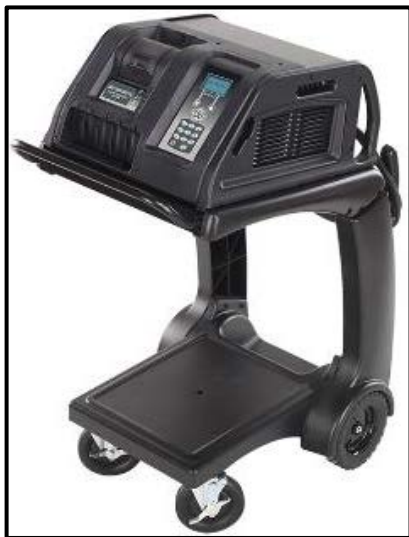
- GRX3000VAS – Battery Tester/Charger

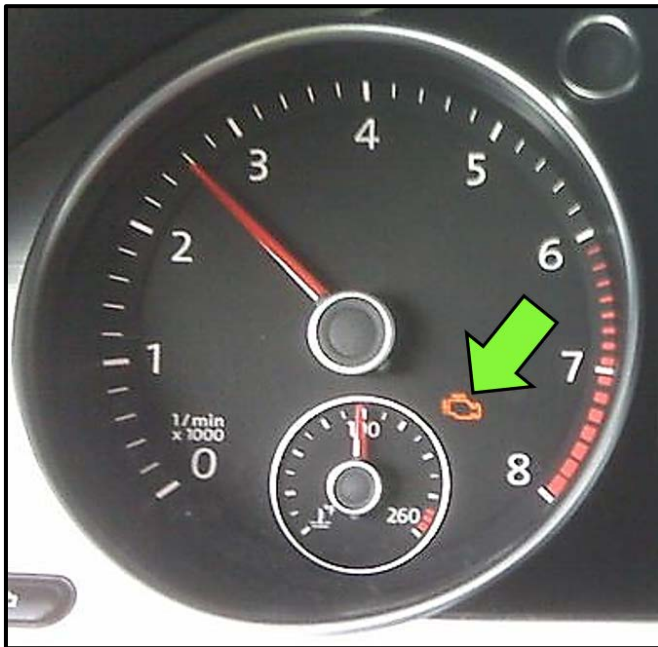
- Check for illumination of the MIL <arrow>.
  - If MIL is illuminated, STOP, obtain GFF diagnostic log, create an ATA ticket and contact the Audi Technicians Helpline.
  - If MIL is not illuminated, continue work procedure.

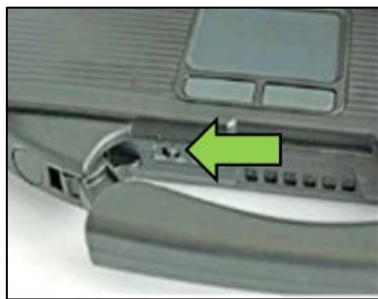
**VAS 6150 & VAS 6150A**  
(Front panel behind handle)

- Performing a software update using a Bluetooth connection increases the risk of losing connection during the update, which could result in damage to the control module. It also greatly increases the time required to perform the update. Requests for additional time or parts will be denied if the GFF log shows the update was performed using Bluetooth.
- ✓ **The Bluetooth function of the scan tool is physically switched off <see pictures below>.**

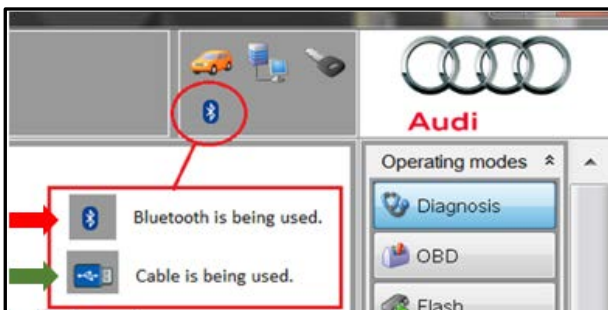
- Confirm that scan tool is communicating with the diagnostic head by USB <Green Arrow>.
  - o If the Bluetooth symbol is shown <Red Arrow> then disconnect the diagnostic head from the vehicle and reconnect the USB cable to the diagnostic head and then reattach to the vehicle.
