Emissions Recall

Code: 23T4

Subject	2.0L TDI Engine (GEN 3) Emissions Control Software – <u>USA ONLY</u>
Release Date	April 14, 2017
Revision Summary	Clarified installation position of labels.
Affected Vehicles	U.S.A.: 2015 MY Audi A3 2.0L TDI <i>Check Campaigns/Actions screen in Elsa on the day of repair to verify that a VIN qualifies for repair under this action. Elsa is the <u>only</u> valid campaign inquiry & verification source.</i> <ul style="list-style-type: none">✓ Campaign status must show “open.”✓ If Elsa shows other open action(s), inform your customer so that the work can also be completed at the same time the vehicle is in the workshop for this campaign.
Problem Description	The Environmental Protection Agency and California Air Resources Board have determined that Audi A3 vehicles equipped with a 2.0L 4-cylinder TDI engine do not comply with applicable emissions regulations. The emissions control systems on the vehicles will not control emissions under off-cycle conditions as effectively as during the federal test procedure. The extent of the emissions increase under off-cycle conditions depends upon how the vehicles are driven.

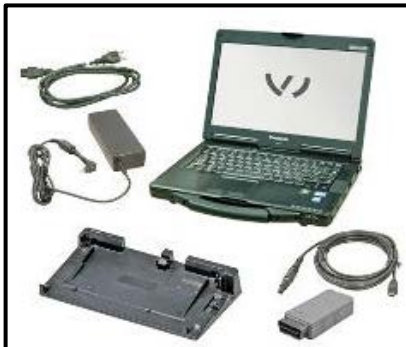
- VAS6150X – Diagnostic Tester (or equivalent)
- VAS5054X – Remote Diagnosis Head (or equivalent)

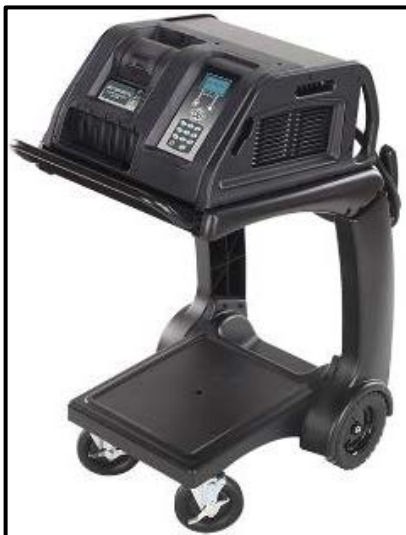
- GRX3000VAS – Battery Tester/Charger

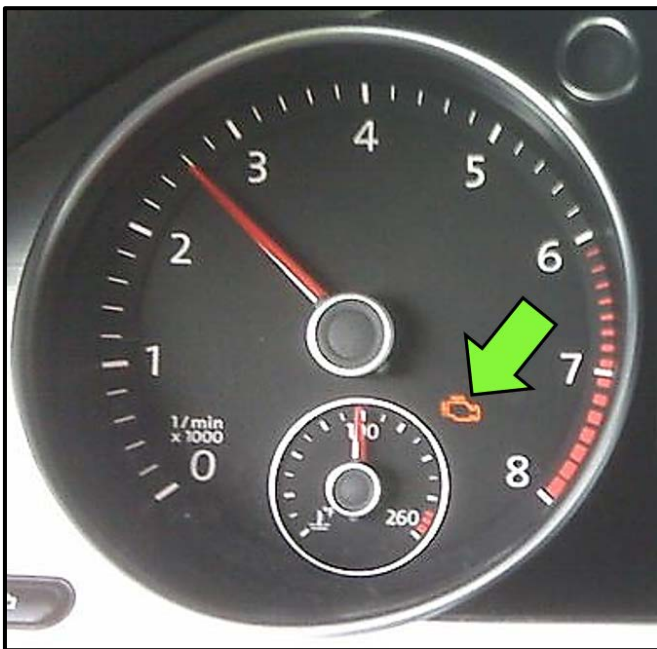
- Check for illumination of the MIL <arrow>.
 - If MIL is illuminated, STOP, obtain GFF diagnostic log, create an ATA ticket and contact the Audi Technicians Helpline.
 - If MIL is not illuminated, continue work procedure.

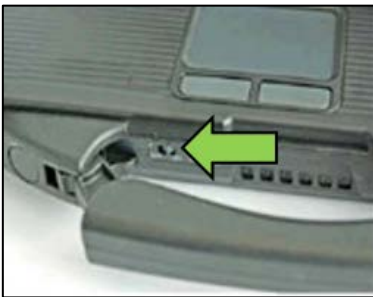
VAS 6150 & VAS 6150A
(Front panel behind handle)

- Performing a software update using a Bluetooth connection increases the risk of losing connection during the update, which could result in damage to the control module. It also greatly increases the time required to perform the update. Requests for additional time or parts will be denied if the GFF log shows the update was performed using Bluetooth.
- ✓ **The Bluetooth function of the scan tool is physically switched off <see pictures below>.**

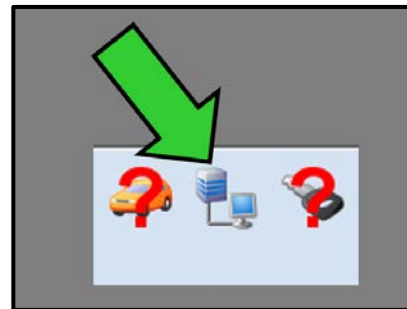
- ✓ Check the icon <arrow> within the ODIS software that you have a connection.

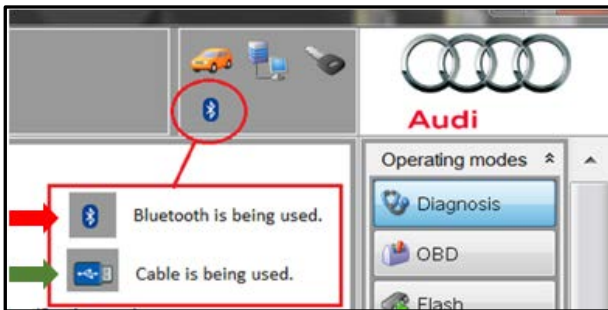
- Confirm that scan tool is communicating with the diagnostic head by USB <Green Arrow>.
 - If the Bluetooth symbol is shown <Red Arrow> then disconnect the diagnostic head from the vehicle and reconnect the USB cable to the diagnostic head and then reattach to the vehicle.

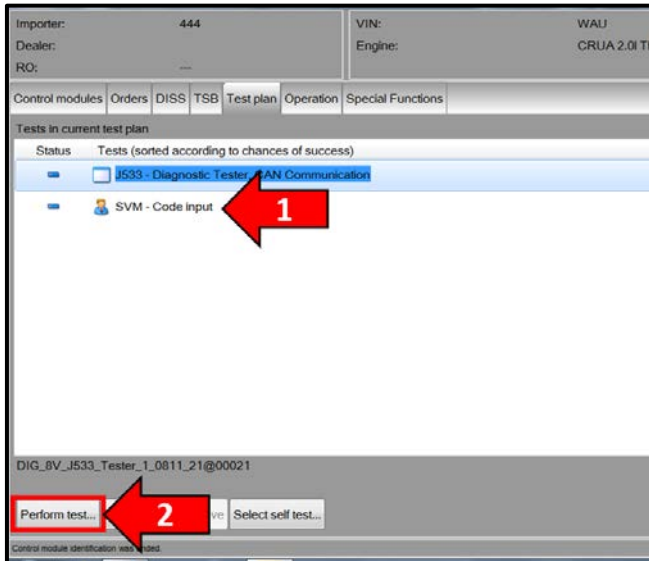
- From the Test plan screen, Select “SVM Code input” test plan <arrow 1>, then select “Perform test” <arrow 2>.
- Follow the on-screen prompts.

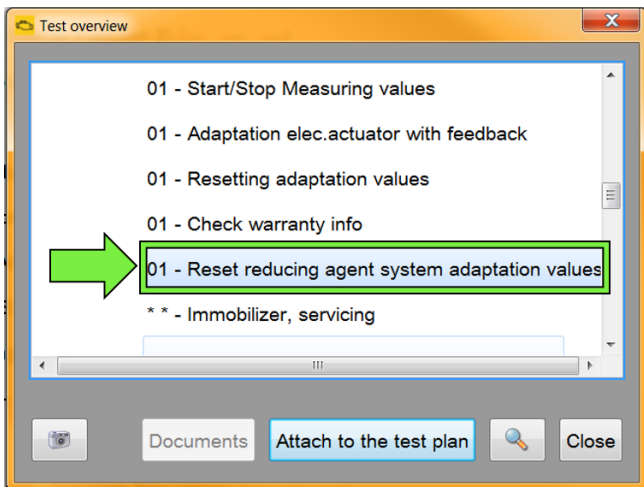
After flashing, the vehicle will not start due to adaptation values for reducing agent missing. Perform test plan to reset reducing agent adaptation values prior to attempting to start vehicle.

- Perform “Reset reducing agent system adaptation values” <arrow>.

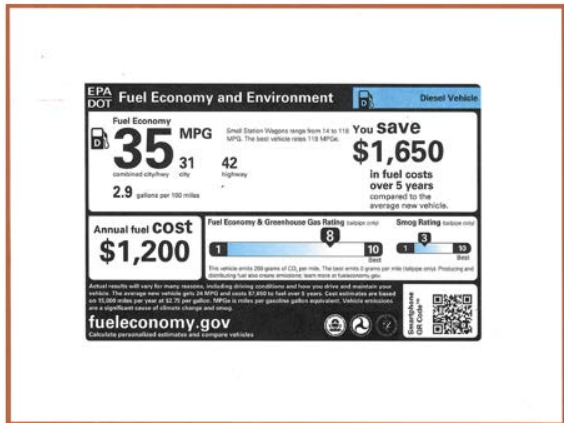
- Install new Fuel Economy Label <example pictured left> to the right of the new Monroney Label. If necessary, use the passenger front window <example pictured below>.

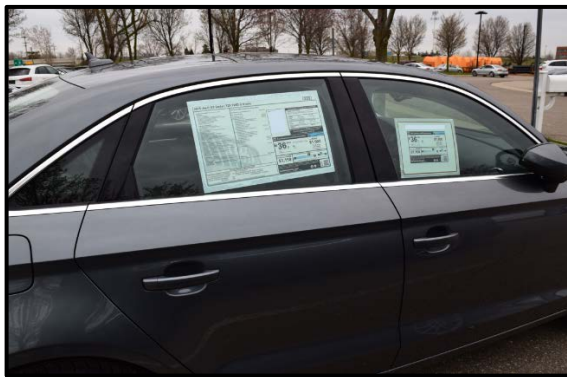
- Example of properly Installed Monroney and Fuel Economy Labels <pictured left>.
