# Technical Service Bulletin

## 30 Clutch plate diagnosis guidelines

30 17 22 2019850/7 May 10, 2017. Supersedes Technical Service Bulletin Group 30 number 16-21 dated July 21, 2016 for reasons listed below.

Model(s)	Year	VIN Range	Vehicle-Specific Equipment
All	2009 - 2017	All	With manual transmission

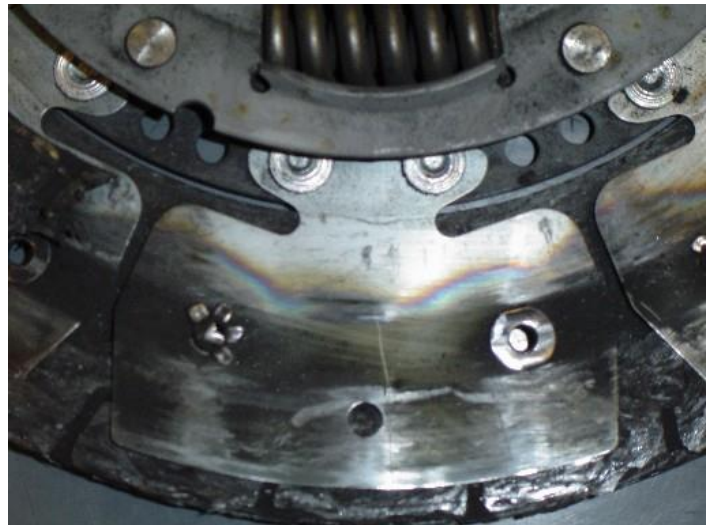
- Lining partly removed due to overheating (Figure 1).

*Figure 1. Lining partly removed due to overheating.*

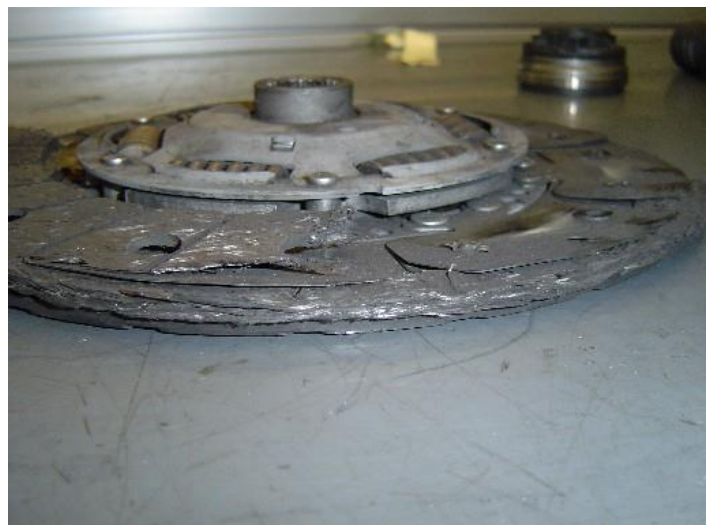
- The lining burst off because of an overspeed condition (Figure 2).

*Figure 2. Burst lining from an overspeed condition.*

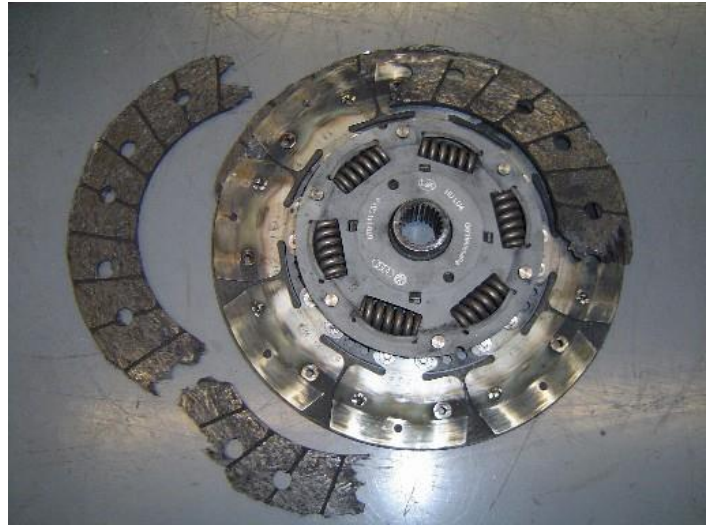
- The lining is ground to the rivets, which causes a broken clutch lining (Figure 3).

*Figure 3. Broken clutch lining.*
