# SS 1033304 - Western Star 5700 Side Window Defrost Performance

## Western Star 5700 Side Window Defrost Performance

Western Star 5700 model

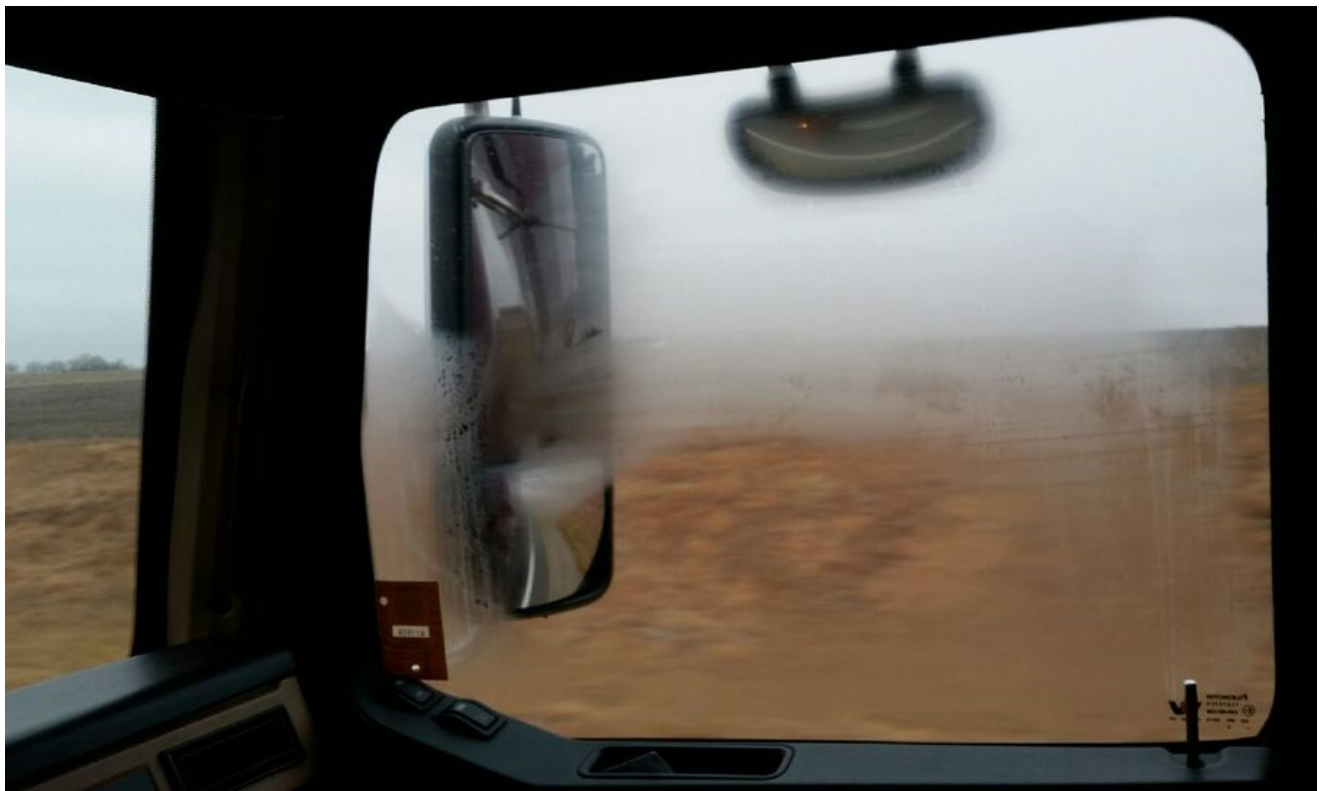
Customer complaint for fogging on side windows while driving in colder environments.

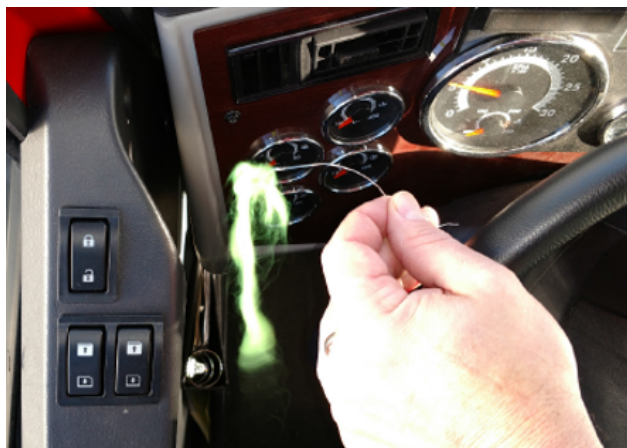
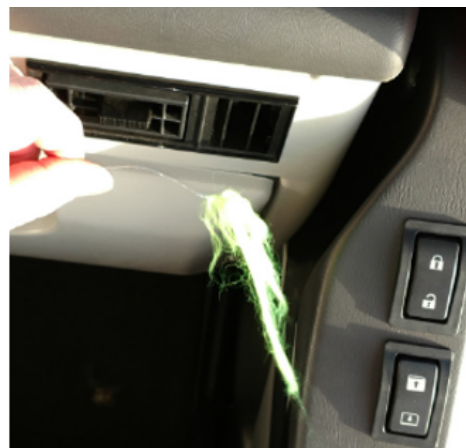
The air blown through the dash side window demist louver doesn't turn outboard to the front half of the side windows. On the passenger side the air flows to the middle of the side window glass and to the aft edge of the side window glass on the drivers side.

Demister deflector 22-76247-000 was created to move the direction of airflow to the forward half of the side window glass. The deflector mounts to the backside of the existing dash louver as shown below. Quantity 2 is needed per truck (one per side).
