**UPGRADE  
BULLETIN:  
171128REV**

**PRODUCT(S)  
AFFECTED:**  
Fleetwood  
Pace Arrow  
and  
Holiday Rambler  
Navigator XE

Exhaust Gas  
Recirculation  
(EGR) Valve  
Clearance  
Enhancement

**ISSUE DATE:**  
December 2017

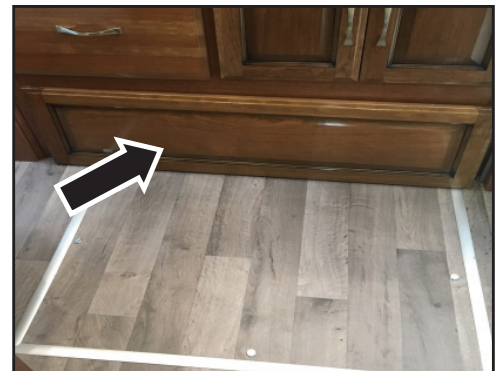
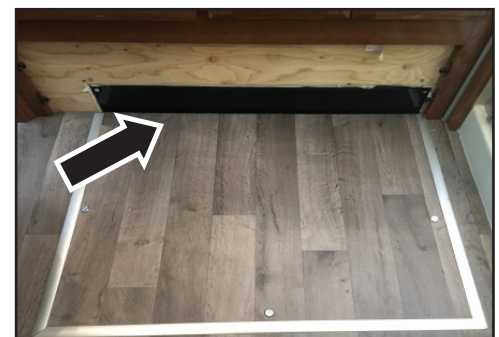
1. Park the motorhome on dry, level pavement. Place the transmission into NEUTRAL.
2. Ensure the PARK brake is set and wheels are blocked to prevent movement. Maintain control of keys while work is performed.
3. The engine access cover is located in the rear bath. First, the decorative vertical wood panel on the front of the lavatory cabinet will need to be removed to gain access to the repair area. This panel is held on by four "bull nose" keepers. Gently grasp and pull off the panel. Set aside for reinstallation. See Figures 1a and 1b.

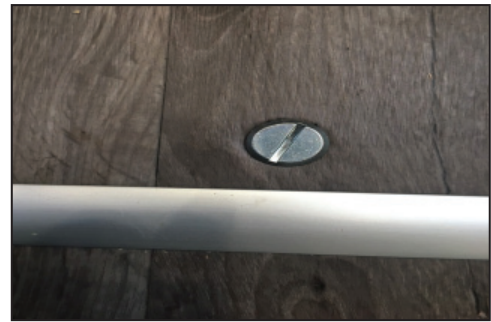
Figure 2

4. Locate the four screws in the floor for the engine cover. See Figure 2. Using an “Apex” bit, remove all four screws. See Figure 3.

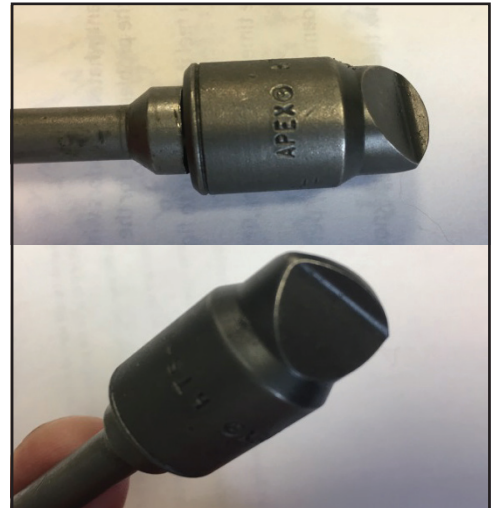
Figure 3

The slot in the top of an engine cover screw is contoured to match the circular shape of a quarter. A quarter secured in a pair of vise grips can be substituted for an Apex bit.

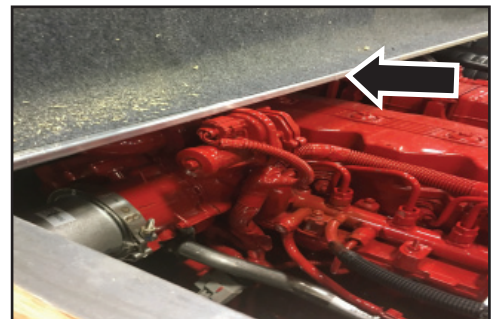
On motorhomes affected by this Product Upgrade, a section of nonstructural tube aluminum, designed as a temporary spacer for assembling the floor support framing during motorhome production, should be removed to provide proper clearance for the exhaust gas recirculation (EGR) valve.

5. Remove the engine cover to expose the engine and EGR valve. See Figure 4. The tube with the arrow pointing to it must be removed.
6. The tube shown in Figure 4 is welded on both ends and in the center. Using your hand, feel for the three welds. Cut the tube on both ends. A “SawAll” may be used for this job, but exercise caution to avoid cutting into the second tube. Use vice grips or channel locks to grasp the tube in the approximate center and rotate the tube upwards to finish fracturing the welds so the tube can be removed. It may be necessary to have another technician assist with breaking off the tube. Discard or recycle the tube that was removed. The completed repair should look like the photo in Figure 5.
