## SP 3-873-005

# SERVICE PROGRAM

Replacement of a RH head lamp circuit which can overheat and cause the diode to fail open, causing the head lamp to lose power.

This Service Program provides instructions to remove the connector from the RH head lamp circuit and install a diode harness with two diodes in parallel on certain model year 2014-2017 Xpert vehicles.

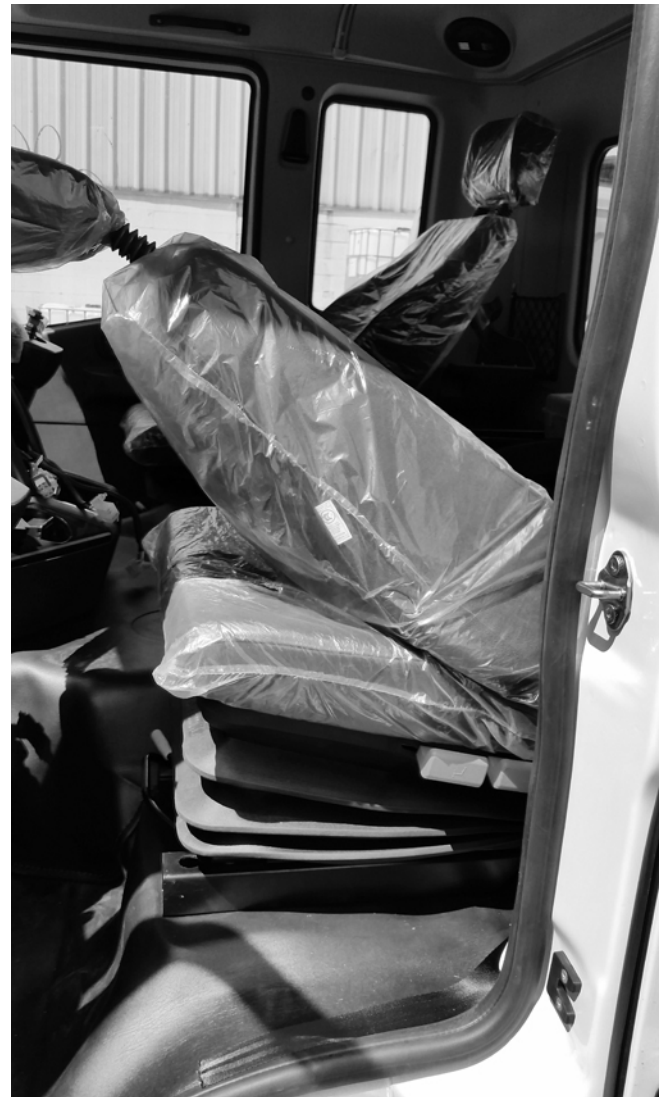
**Figure 1**

1. Disconnect all battery terminals, negative first and then positive.
2. Open the left side door and tilt the seat forward (see Figure 1).

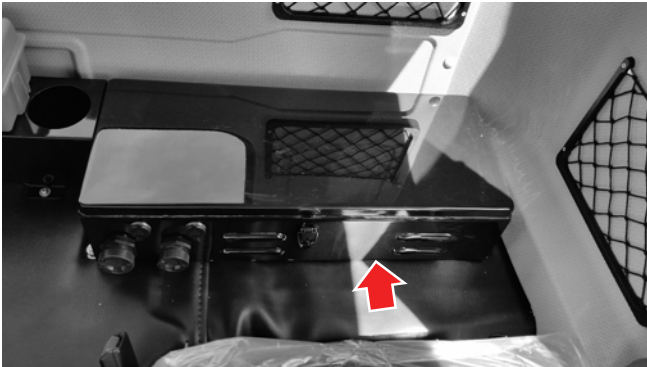
**Figure 2**

3. Locate the fuse box directly behind the left side seat (see *Figure 2*).

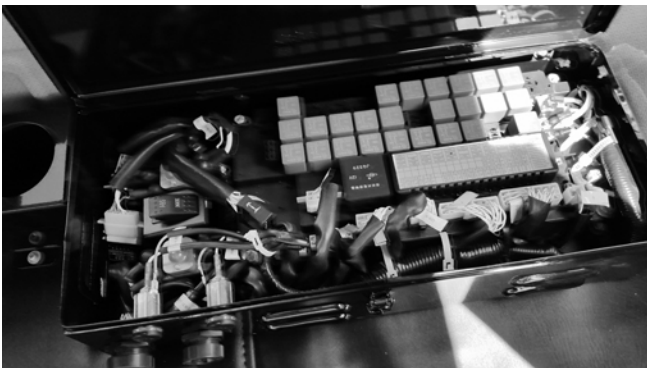
**Figure 3**

4. Open the fuse box for access to the fuse panel (see *Figure 3*).

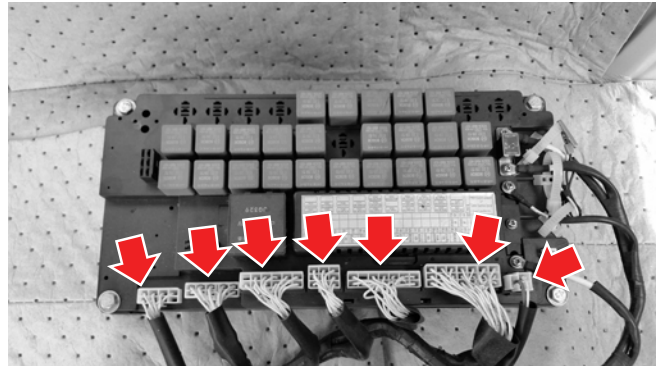
**Figure 4**

5. Disconnect the wiring harness connectors from the fuse panel (see *Figure 4*).

21. Plug in the wiring harness connectors that were disconnected in step 5.
22. Close the fuse box.
23. Connect the battery terminals that were disconnected in step 1, positive first and then negative.

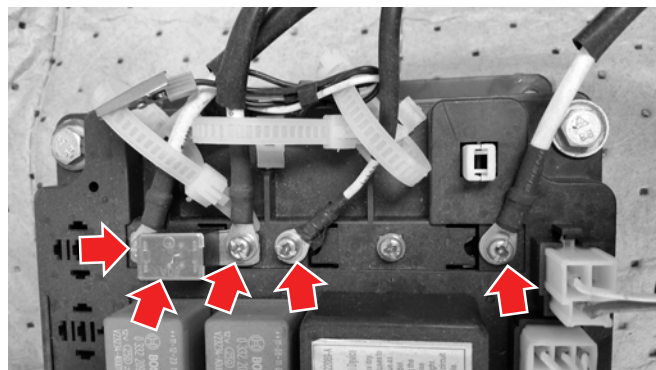
**Figure 5**

6. Locate the ring terminals and the circuit breaker (see *Figure 5*).

7. Make note of the wire numbers and their locations and the orientation of the circuit breaker for reinstallation.

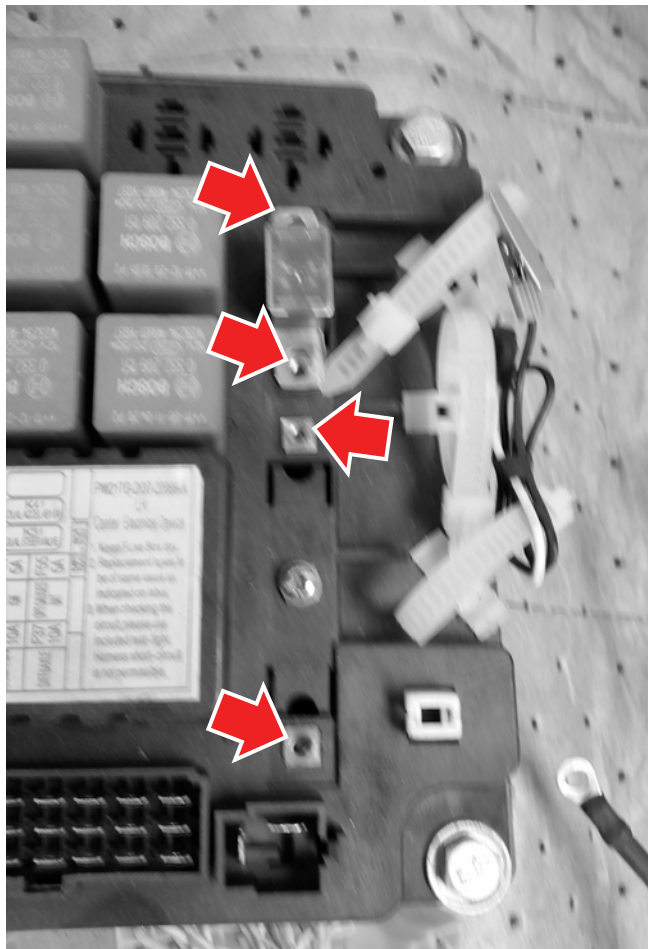
**Figure 6**

8. Remove the four screws and four washers retaining the ring terminals and set the screws, washers and the circuit breaker aside for reinstallation (see Figure 6).

20. Reinstall the ring terminals and circuit breaker into their original orientation and secure with four screws and four washers that were set aside in step 8.

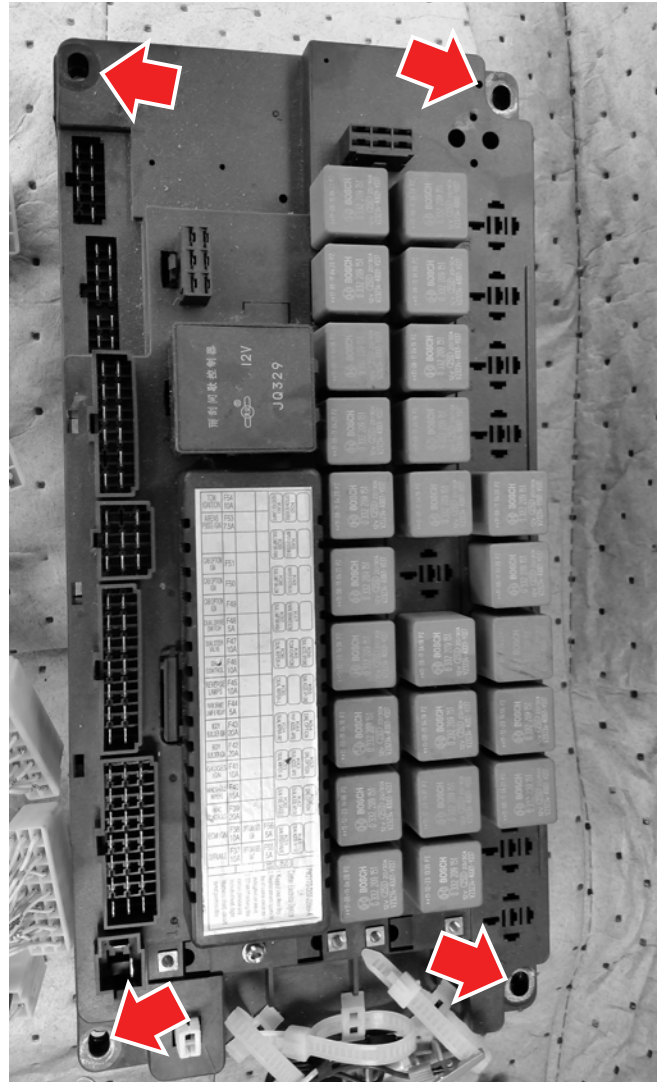
**Figure 7**

9. Remove the four fuse panel mounting bolts and four washers and set aside for reinstallation (see Figure 7).

18. Reinstall the fuse panel access cover onto the fuse panel and secure with eighteen screws that were set aside in steps 11 and 12.
19. Reinstall the fuse panel into the fuse box and secure with the four mounting bolts and four washers that were set aside in step 9, and tighten to 16 Lb./ft. (22 Nm.) of torque.

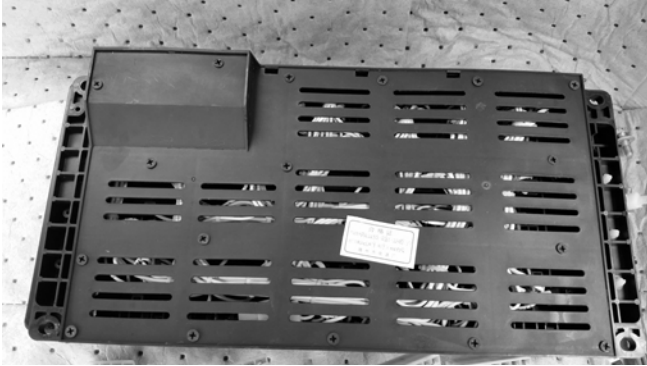
**Figure 8**

10. Remove the fuse panel from the fuse box and place the fuse panel on a work table face down (see Figure 8).

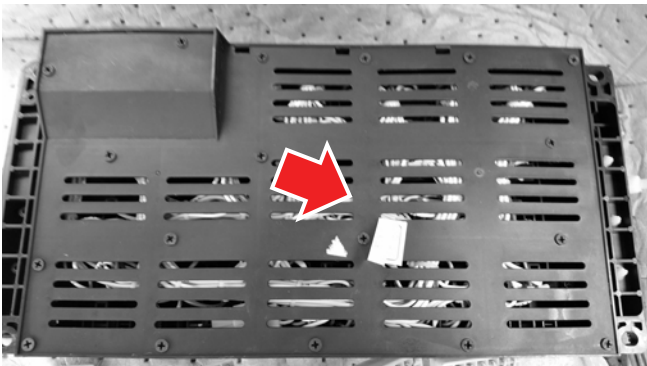
**Figure 9**

11. Remove or peel back the center decal to access one of eighteen fuse panel access cover screws (see Figure 9).

12. Remove all eighteen fuse panel access cover screws and set aside for reinstallation.

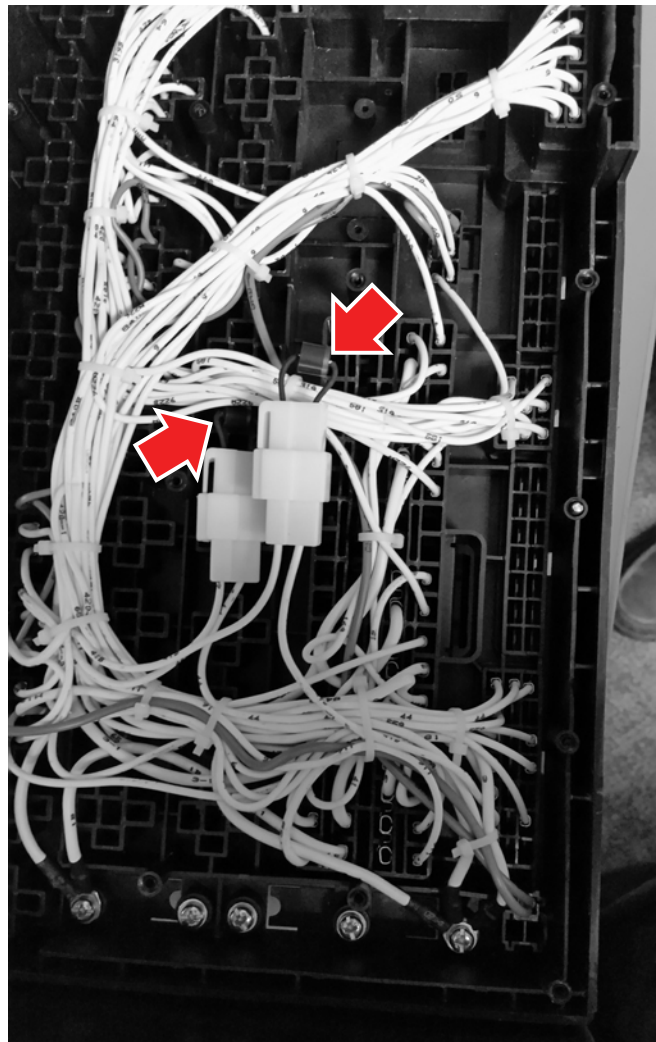
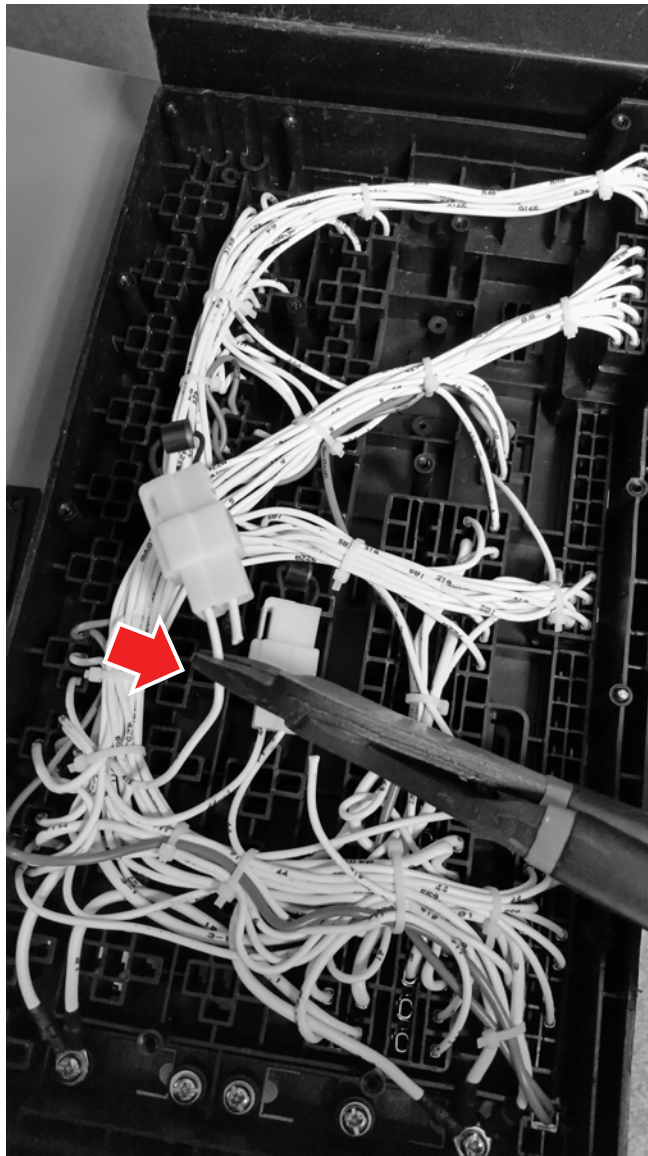
**Figure 10**

13. Remove the fuse panel access cover and set aside for reinstallation.
14. There are two diodes contained in the fuse panel. Locate the diode and wiring marked with circuit numbers 41B and 41B-1. Cut wire 41B and wire 41B-1 and discard the diode and connector (see Figure 10 and Figure 11).

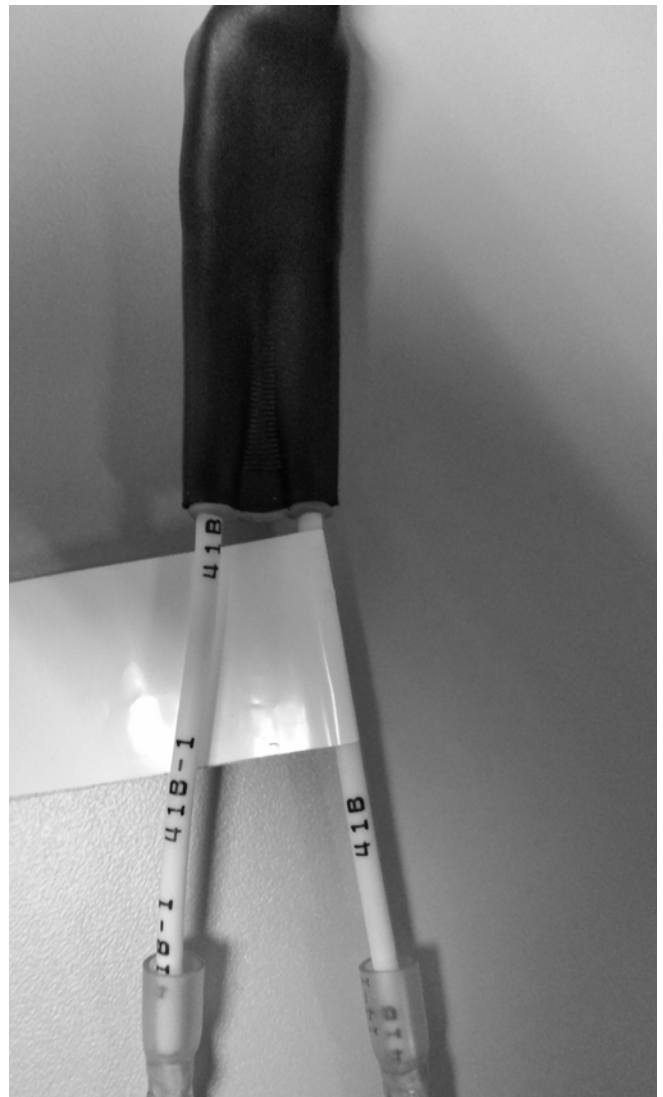
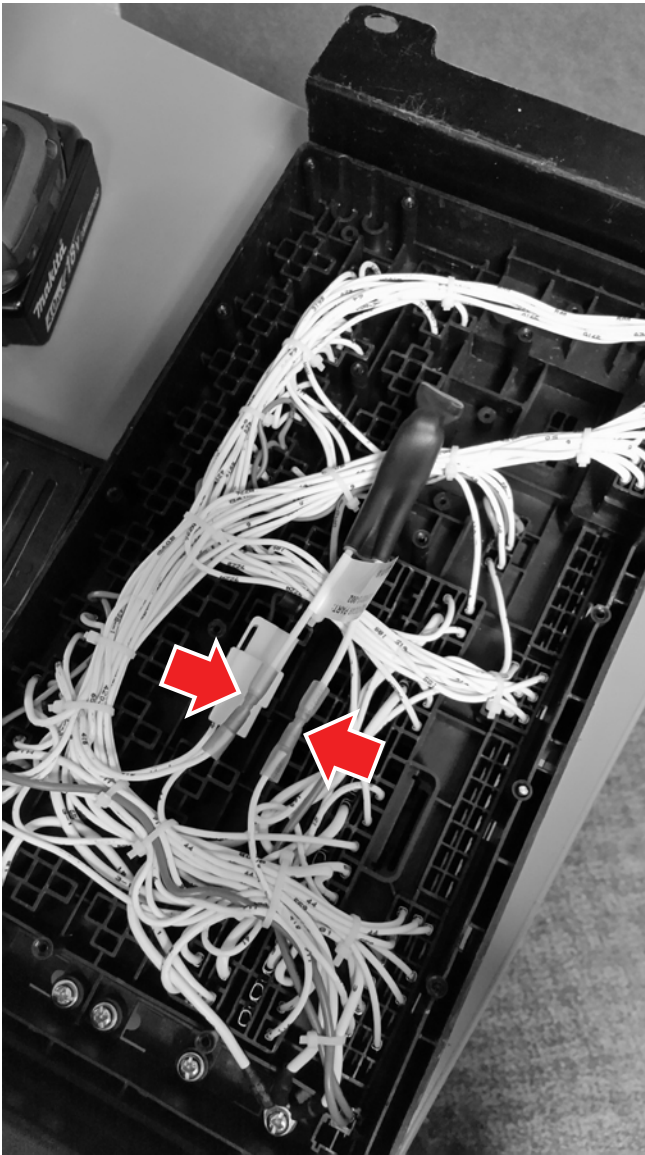
**Figure 12**

16. Match the wire numbers 41B of the new diode harness (A8590013-002) to the wire 41B of the fuse panel and the wire 41B-1 of the new diode harness to wire 41B-1 of the fuse panel and crimp the wires in place  
(see *Figure 12* and *Figure 13*).

15. Strip 1/4" (6.35 mm) of insulation from wires 41B and 41B-1.

17. Heat seal the connections installed in Step 15.
