TITLE:  
Oil leakage from plug in VVT pulley

<b>REF NO:</b> TJ 29131.7.0	<b>ISSUING DEPARTMENT:</b> Technical Service	<b>CAR MARKET:</b> United States and Canada	
<b>PARTNER:</b> 3 US 7510 Volvo Car USA		<b>ISSUE DATE:</b> 2017-10-16	<b>STATUS DATE:</b> 2017-10-19
<b>FUNC GROUP:</b> 2150	<b>FUNC DESC:</b> Transmission	Page 1 of 8

TJ Instruction VCC-475358-1

<b>Title</b>	Plug VVT unit	<b>Page</b>	1 ( 4 )
<b>Action</b>	Product fix	<b>Operation number:</b>	98532-2 98533-2 36050-2

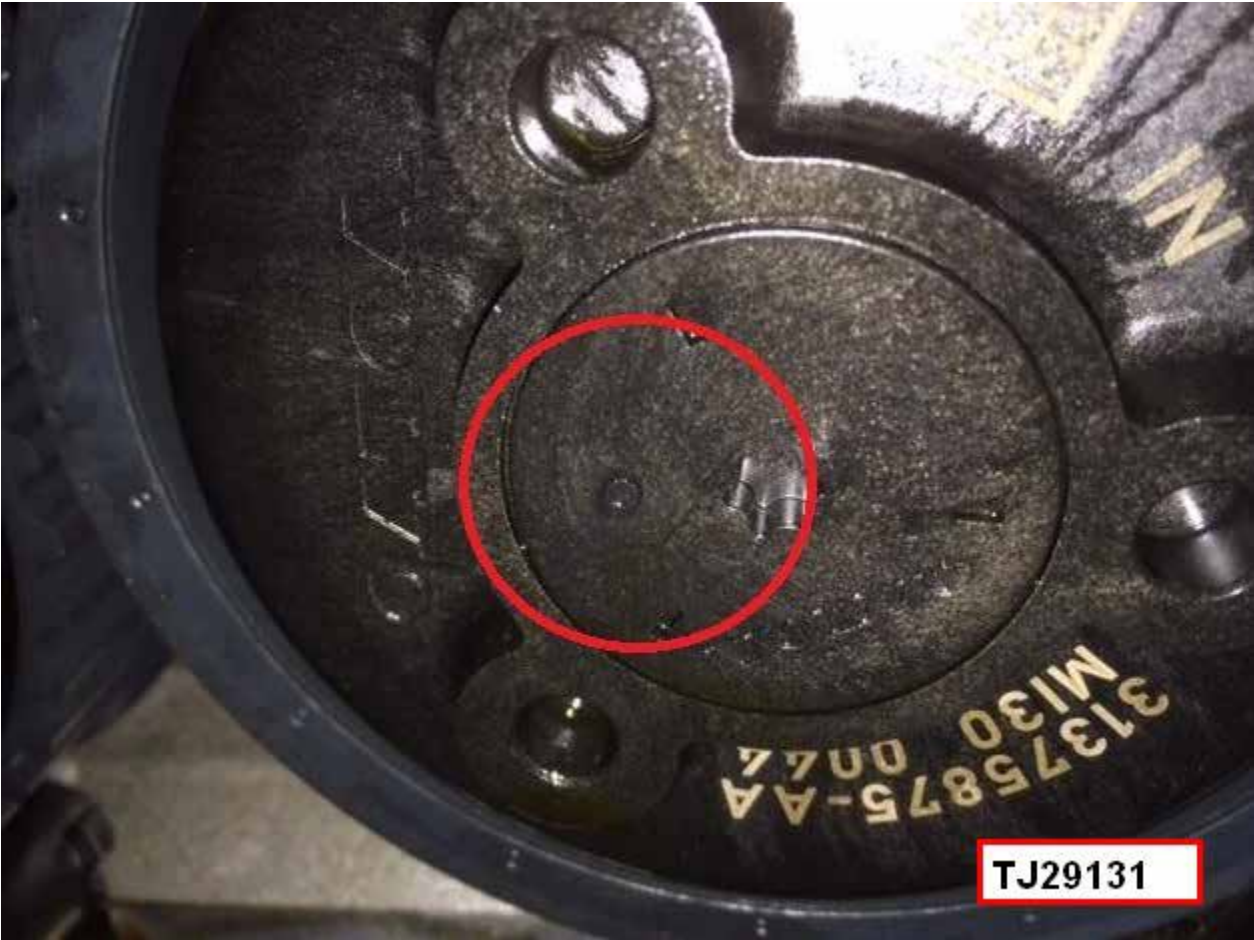
Customer may experience a low oil level warning in DIM and /or oil leakage from the engine. The oil may leak due to a crack in the plug from the VVT pulley (see attached photo).

Replace both plugs in both VVT-pulleys according to the attached instruction. Plug PN: 31375877  
If the timing belt is effected with oil, replace the timing belt according to VIDA instructions.
