Customer Satisfaction Program

52620 Transmission Oil Cooler Line Contact

Reference Number: N16205262

Revision: 02

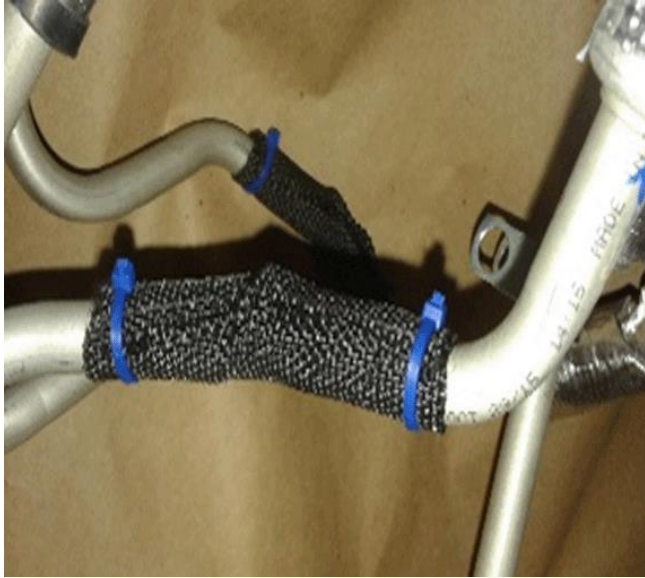
4567867

Transmission fluid cooler inlet pipe removed from vehicle for illustrative purposes.

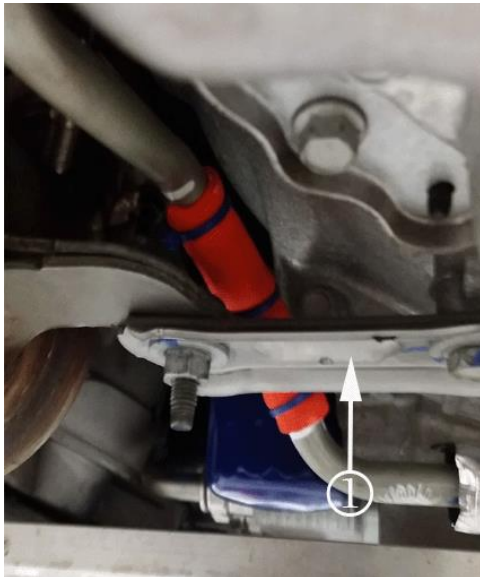
4567875

Orange sleeve shown for illustrative purposes only.

2. Determine if the transmission fluid cooler inlet pipe has a black sleeve on it where the pipe goes over the catalytic converter brace bracket (1).
 - If a black sleeve is NOT present, proceed to the next step.
 - If a black sleeve is present, proceed to steps 5-7, and 10.

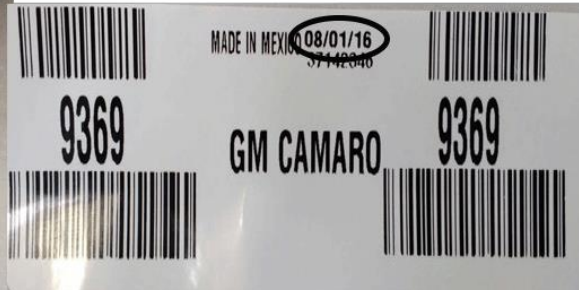
4567894

3. If the transmission fluid cooler inlet pipe does NOT have a sleeve or has an orange sleeve on it where the pipe goes over the catalytic converter brace bracket, inspect the date code on the build tag.
 - If the build date is on or before 06/10/16, proceed to the next step.
 - If the build date is after 06/10/16, proceed to steps 5-7, and 10.
4. Remove the transmission fluid cooler inlet and outlet pipe. Refer to *Transmission Fluid Cooler Inlet and Outlet Pipe Replacement (LT1 With M5U, With KNR)* in SI.
5. Remove the transmission support. Refer to *Transmission Support Replacement (Automatic Transmission)* in SI.

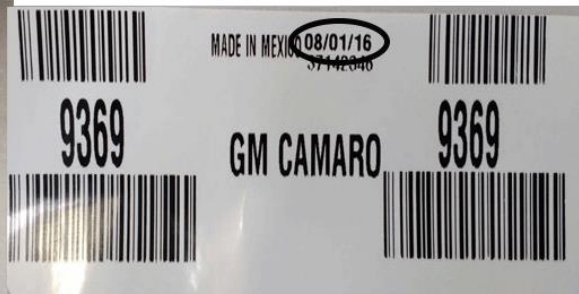
4567894

8. Verify the build date of the NEW transmission fluid cooler inlet and outlet pipe is after 06/10/16.
 - If the build date is on or before 06/10/16, scrap the transmission fluid cooler inlet and outlet pipe assembly and obtain another one.
 - If the build date is after 06/10/16, proceed to the next step.

Note: The replacement transmission fluid cooler inlet and outlet pipe will NOT have a sleeve on it.

9. Install the NEW transmission fluid cooler inlet and outlet pipe. Refer to *Transmission Fluid Cooler Inlet and Outlet Pipe Replacement (LT1 With M5U, With KNR)* in SI.
10. Lower the vehicle. Refer to *Lifting and Jacking the Vehicle* in SI.
