Title: Bunk Curtain Falling Off Track Sky-Rise

Applies To: LT, LoneStar, RH

This document will guide the user through repairing bunk curtains that come off the track.

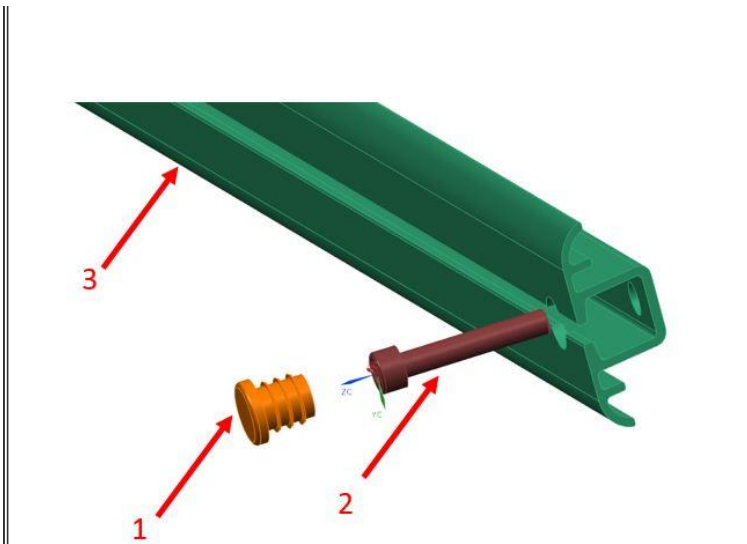
Figure 1: Curtain Track Sky-Rise

Step	Action	Decision
1	<p>DIAGNOSTIC: Location</p> <p>The curtain can fall off from the track center or from the ends of the track</p> <p>Where is the curtain falling off from?</p>	<p>Track Center: Make sure all plug buttons are installed (Figure 1). If so, follow procedure below.</p> <p>End of track: Install plug button (Figure 1) and retest.</p>

Item 1: Plug Button
 Item 2: Bolt M6x35
 Item 3: Track

5. Tighten all bolts evenly so the curtain trolley moves freely without binding.
6. Reinstall track on vehicle and torque M6x35 bolts to 5.1 -6.4 nm
7. Reinstall curtain to track
8. Reinstall plug buttons to the track.

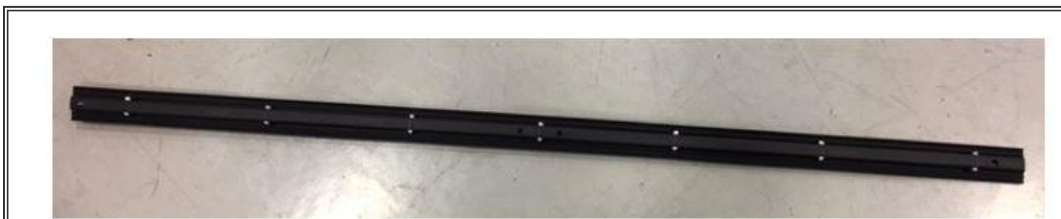
Figure 2: Track with M4 Pan Head Machine Screws Installed

1. Remove curtain from track
2. Unbolt track from vehicle.
3. On bench, drill seven 4mm holes evenly spaced along the track (Figure 2). Holes should be in the middle of the track (Figure 3) . Do not drill past 1/2 way to avoid even interference with curtain trolleys (Figure 5) and to leave clearance for the pan head machine screws (Figure 4, item 1).

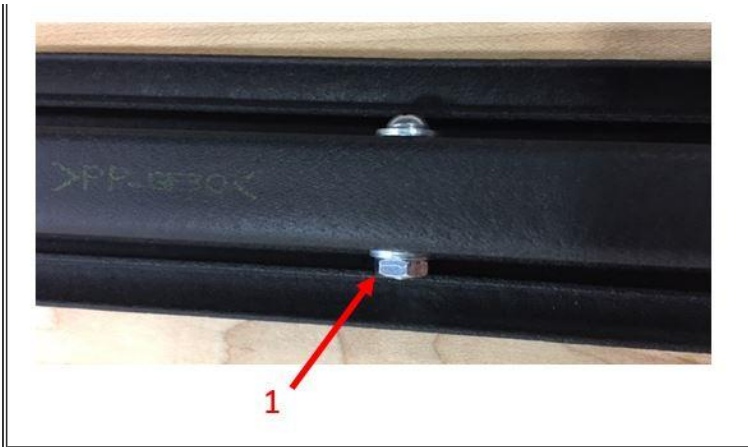
Figure 4: Track

Item 1: Pan Head Machine Screw and Nut
