Title: LT Day Cab A/C Concerns Leaks or Inoperative A/C

Applies To: LT Day Cab

This document will guide the user through diagnosing a complaint of inoperative A/C and provide direction and part numbers for replacement for vehicles built only between: 11/07/2016- 06/12/2017

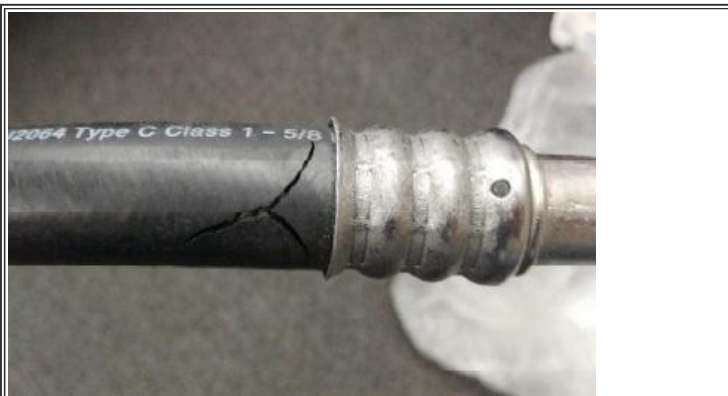
Figure #:1 Sample cracked A/C hose evaporator to compressor

1. Bring vehicle into shop and park on flat surface.
2. Shift transmission to Park or Neutral, set parking brake, and install wheel chocks.
3. Unlatch and open hood.
4. See LT/RH Technician Manual (Service and Diagnostic) for Evacuation Procedure.
5. Inspect low pressure (suction) A/C hose and crimps/fittings from evaporator to compressor for signs of failure/leaks/cracking. See Figure #1. Continue with remaining steps and if needed, replace hose at step 10.

9. If leak was found at Thermal Expansion Valve (TXV) step 6 OR if bolts were loose in step 8, replace the evaporator. See Parts List.
10. If failed A/C evaporator to compressor hose was found at step 5, replace hose.
11. If damaged, replace TXV and seals. Torque TXV mounting hardware 5.5 Nm (11.5 lb-ft).
12. Replace condensor dessicant kit. See Parts List.
13. See LT/RH Technician Manual (Service and Diagnostic) for Fill Procedure
14. Start vehicle to verify proper operation, no leaks, and no fault codes are present.
15. Close and latch hood.
16. Remove wheel chocks.

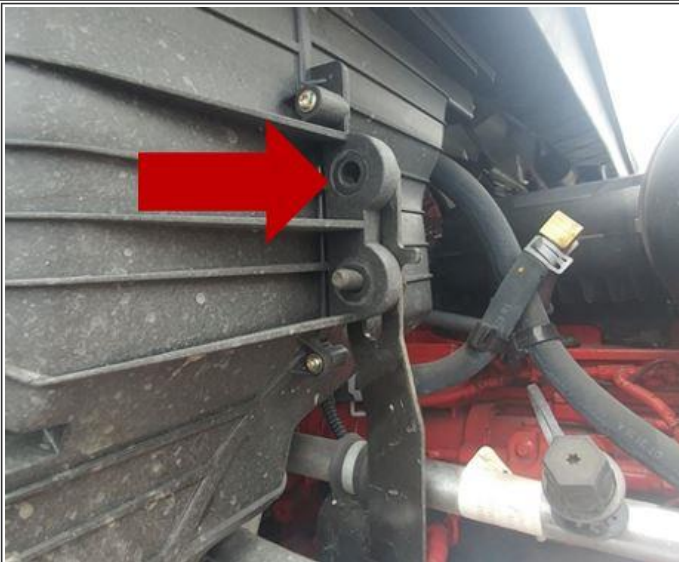
Figure #3: A/C hose support bracket bolts

8. Inspect two A/C evaporator to compressor hose support bracket bolts that go through the front of the HVAC Air Inlet Assembly. If missing, install and torque M8x20 bolt(s) to 23 Nm (17 lb-ft). See Parts List. See Figure #3.
