## FIELD SERVICE CAMPAIGN – 17115

Window Post Cap / Trim Replacement

CE Bus

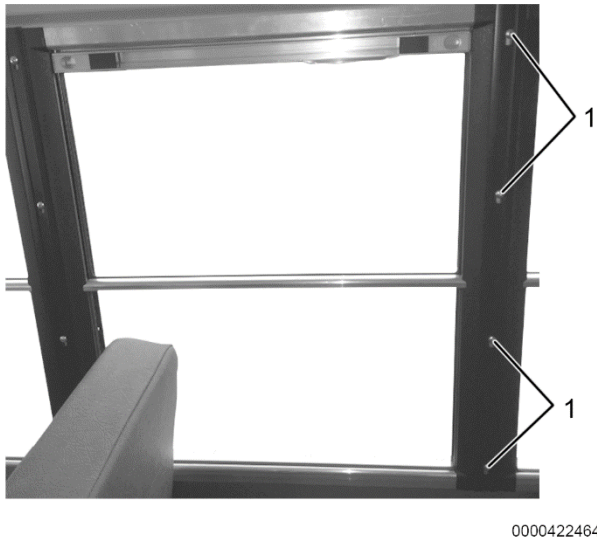
**Figure 1. Window Cap Screws**

Certain CE Buses may have been built with pre-production window caps / trim.

1. Cap screw (4)

4. Remove four screws (Figure 1, Item 1), set aside for reuse, do not discard.
5. Remove and discard interior post cap.

**NOTE: Cap should be flush with top of window.**

6. Position new interior post cap. Using torque wrench, install four previously removed screws and tighten to 11 - 15 lb-ft (15 - 20 N·m).

7. Repeat Steps 4 through 6 until all post caps have been replaced.
8. Remove wheel chocks.
