Title: Urea Quality Sensor (UQS) Supplemental Diagnostic and Service Information

Applies To: Navistar N9, N10, N13, A26 and Cummins ISB, ISL, ISX built from January 2016 to present

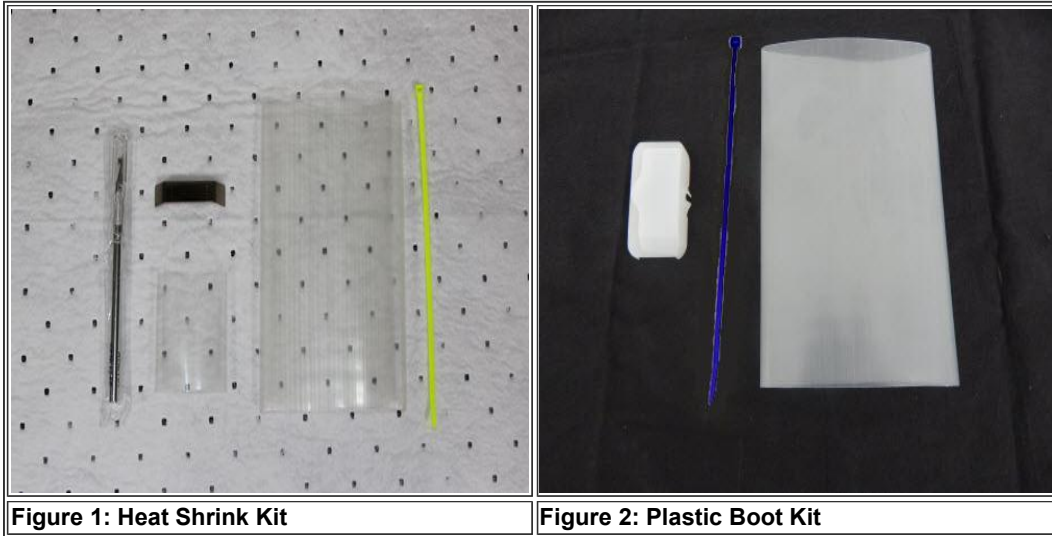
- If you have a UQS Boot Kit with only heat shrink boots and a green zip tie as pictured in **Figure 1** below, use the installation instructions found here: [UQS - Urea Quality Sensor Heat Shrink Boot Installation](#)
- If you have a UQS Boot Kit with the plastic boot and blue zip tie as pictured in **Figure 2** below, use the instructions found here: [UQS - Urea Quality Sensor Plastic Boot Installation](#)

The UQS boot kit was revised 8/18/17 with a plastic boot in place of the original heat shrink boot. The new boot has separate instructions.
