Countries: CANADA, UNITED STATES **Document ID:** IK0400155
Availability: ISIS, Bus ISIS, NotSIR **Revision:** 1
Major System: BRAKES **Created:** 9/8/2017
Current Language: English **Last Modified:** 10/26/2017
Other Languages: NONE **Author:** James Santos
Viewed: 274

Title: IC Bus Service Brake Switch Inspection

Applies To: 2017 IC Bus with Hydraulic Brakes

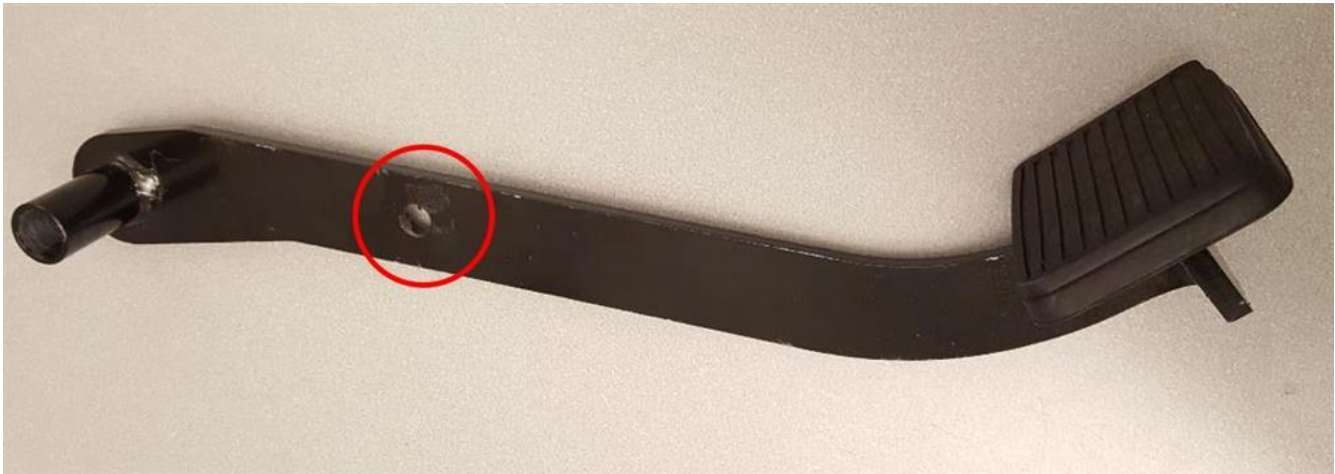
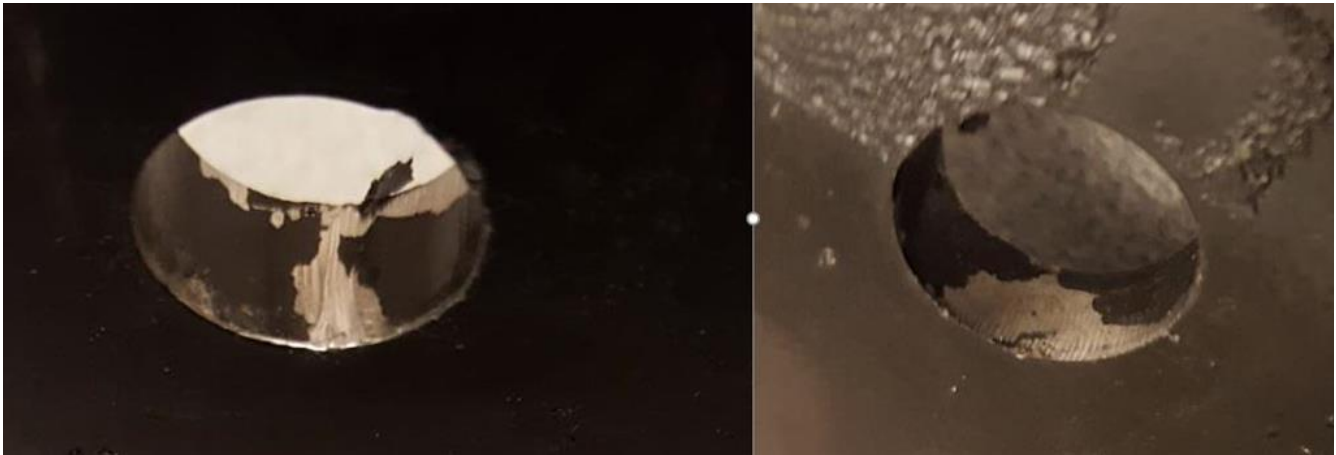
1. Procedure can be performed with pedal assembly installed. NOTE: Make certain brake pedal is supported during reaming process.
2. Inspect brake switch clevis pin hole for debris/burrs/paint. See images below:

3. Using a reaming tool, remove any paint, burrs, or debris from clevis pin hole. Target Hole Diameter is 14.0-14.1 mm
 4. Insert clevis pin into brake pedal assembly and ensure the clevis pin rotates freely in clevis pin hole. If pin does not rotate freely, more filing may be needed.
 5. Inspect clevis pin for damage, if damaged then replace with new pin. If no damage is found on pin, reinstall brake pedal assembly into vehicle.
 6. Verify repairs by rechecking for customer complaint.
-
