**Countries:** CANADA, UNITED STATES **Document ID:** IK0700102  
**Availability:** ISIS, IsSIR **Revision:** 0  
**Major System:** EXHAUST **Created:** 10/4/2017  
**Current Language:** English **Last Modified:** 10/4/2017  
**Other Languages:** NONE **Author:** Greg Scheff  
**Viewed:** 108

**Title:** DEF Coolant Line Leak Rear of Engine**Applies To:** LT Chassis with A26 Engines

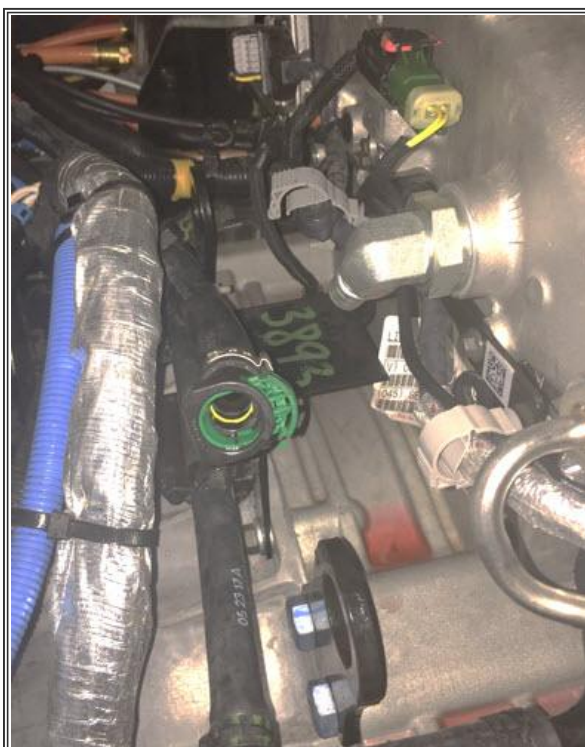
This document will guide the user through the proper connection of the DEF coolant line to the engine. This coolant line attaches to the rear coolant crossover manifold on the A26 and may not be properly locked, causing a loose connection.

**Figure #1: DEF Line at Rear of Engine**

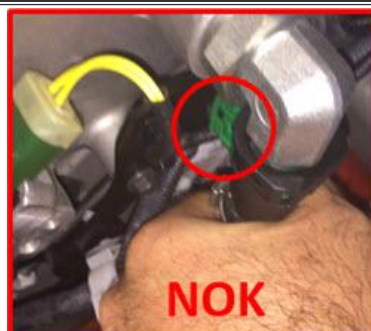
An external coolant leak may be observed at the rear of the engine.

**Figure #2: Improper positioning of the coolant line locking retainer. Retainer must NOT be facing the engine.**

1. Bring vehicle into the shop and park on a flat surface.
2. Shift transmission into park or neutral, set parking brake, and install wheel chocks.
3. Open the hood, and inspect for the source of the coolant leak.
4. If the coolant leak appears to be coming from the rear of the engine, removal of the engine cover assembly may be required to gain access.
5. Inspect the DEF coolant line connection at the rear of the engine (Figure 1).
6. Inspect the green locking retainer to see if it is properly locked and in position (Figure 2 and 3).

7. If the line is loose or disconnected, properly install the line back on the fitting (Figure 3), and position the locking retainer as shown.
8. Verify the line is secure, and the locking retainer is fully seated in place.

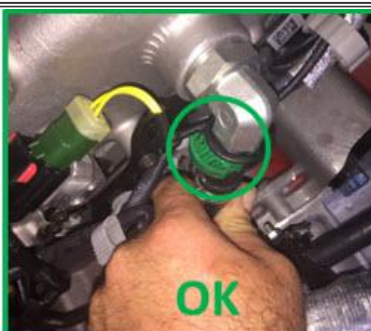
**Figure #3: Proper orientation of the locking retainer facing away from the engine.**
