**Title:** N13 SCR Chassis Overlay Instruction

**Applies To:** Prostar With N13

This document will guide the user through the installation process of a chassis harness overlay on a 2013 or later model Prostar with N13 engines. This can be performed once a wiring issue has been diagnosed with no obvious signs of where the short/open is at within the chassis harness.

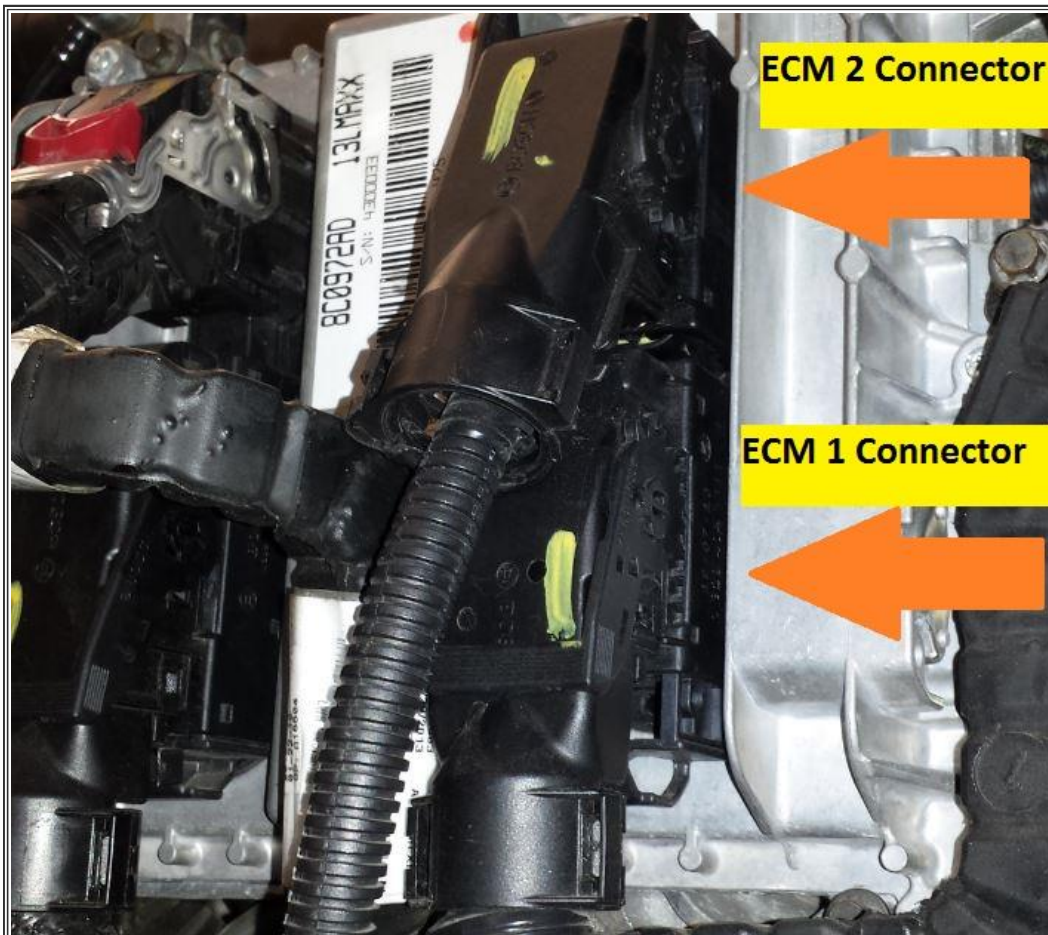
**Figure #2- ECM Connector and Overlay Wires**

Use tool # 12094429 from kit # ZTSE4443

| Circuit/Wire # | Connector | Cavity # |

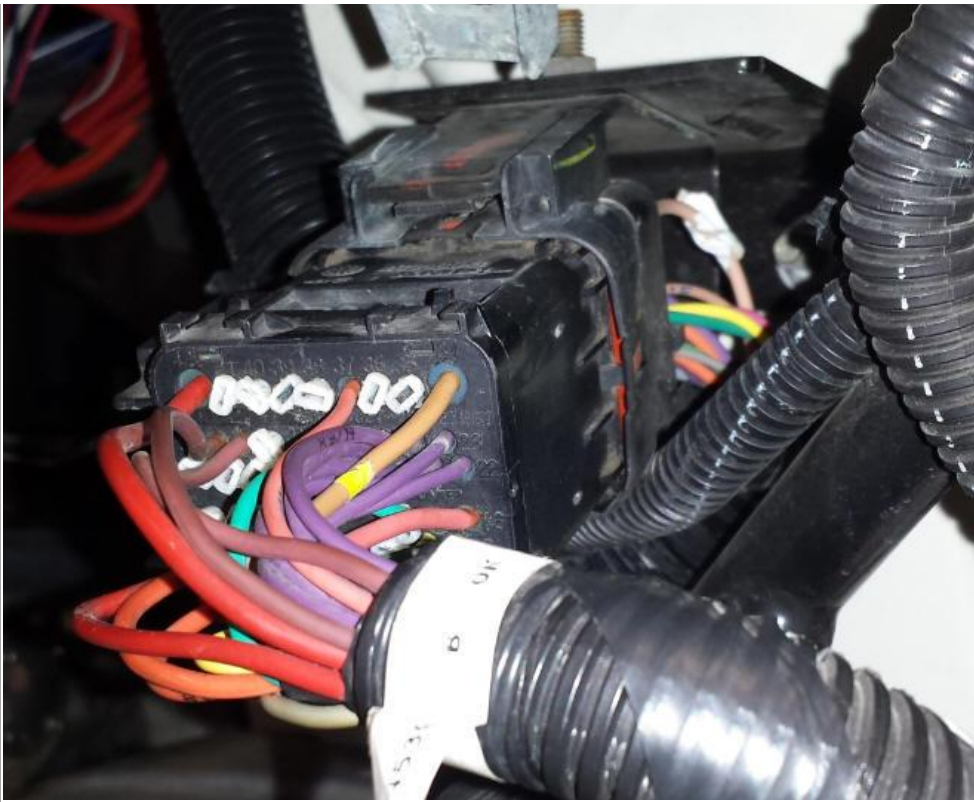
**Figure #3- Engine IP 1702 Connector**

**Use Tool #TXT126870272**

| Circuit/Wire # | Connector | Pin # |

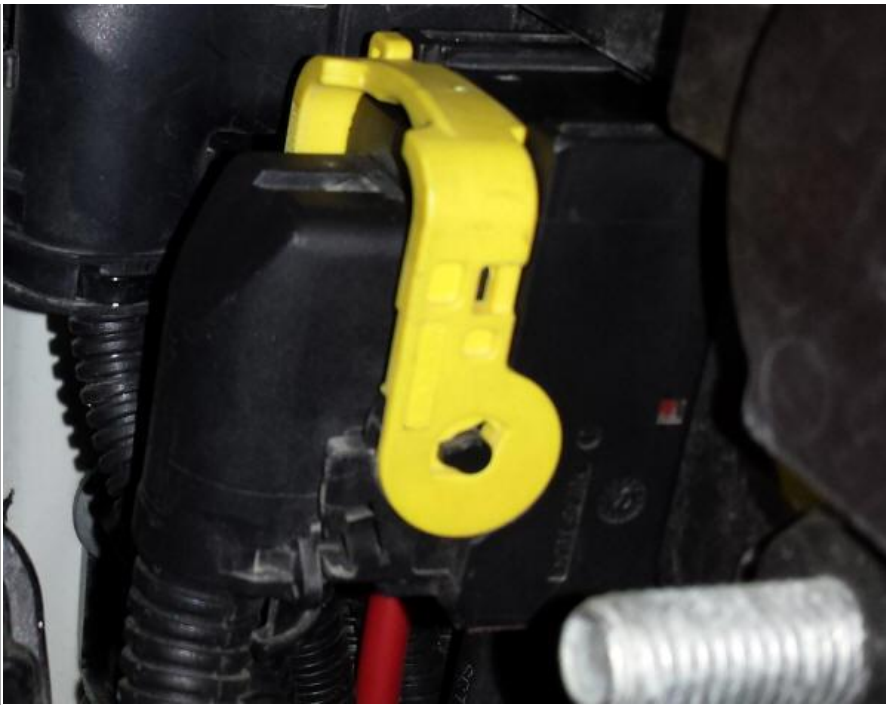
**Figure #4- Under Hood PDM**

**PDM Under Hood- Located Behind The Air Cleaner**

**PDM Under Hood Connector- Red wire gets removed from the old connector and installed into cavity 10 on the new connector**

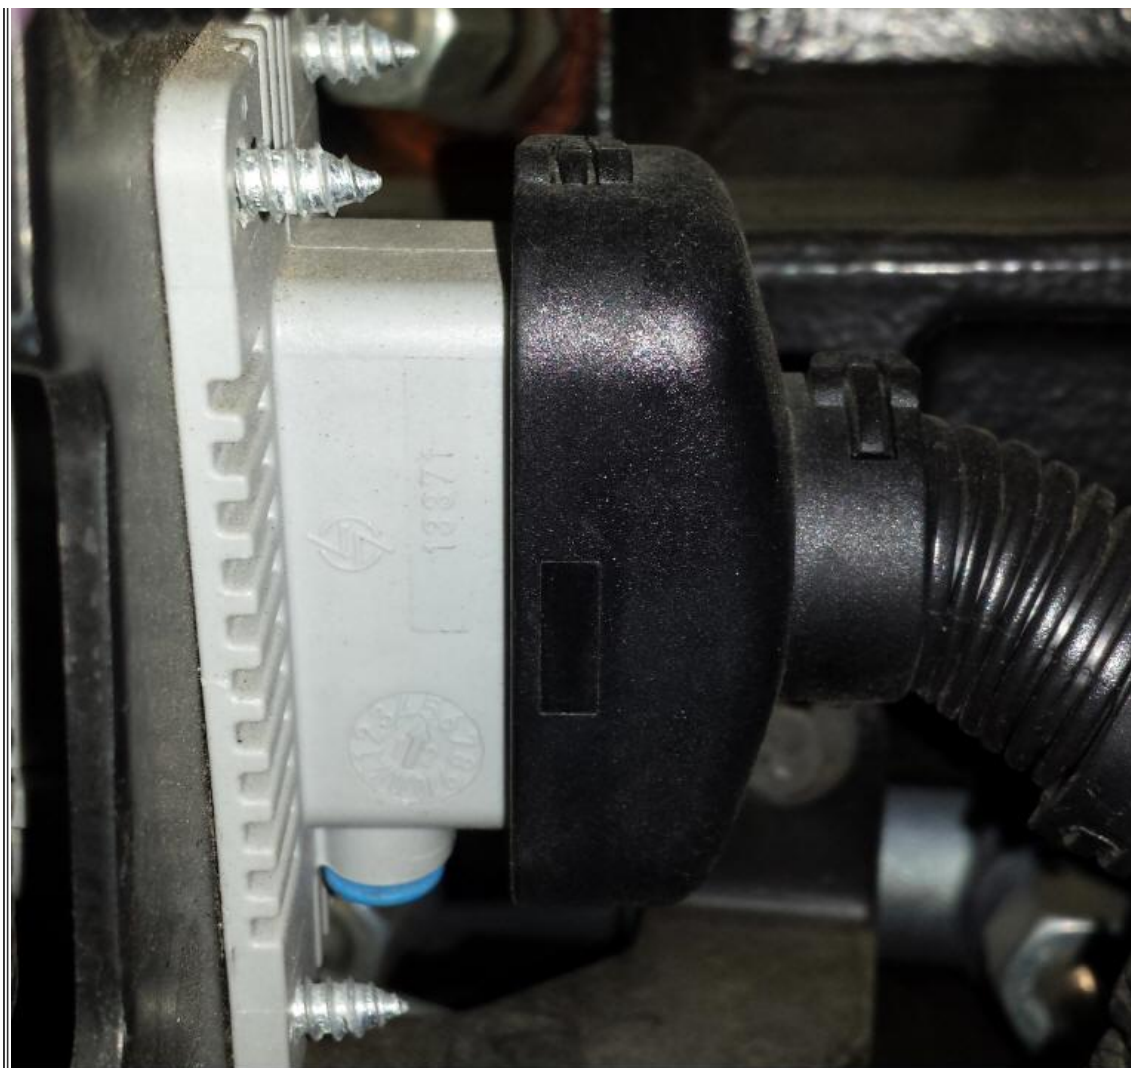
**Figure #5- 21 Way Engine Interface Connector**

21 Way Engine Sensor Interface- Located on LHS of Engine

Tool# 49303

| Circuit/Wire # | Connector | Pin # |
