Title: Batt2 Load Shed Relay Failure

Applies To: LT's Without 16UZL

This document will guide the user through identifying a failed relay and possibly a spread terminal resulting in loss of power to the sleeper.

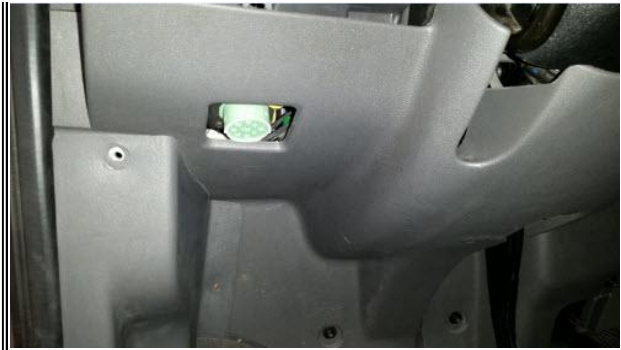
2. Remove Driver's side kickpanels for access to the bulkehead and wiring.

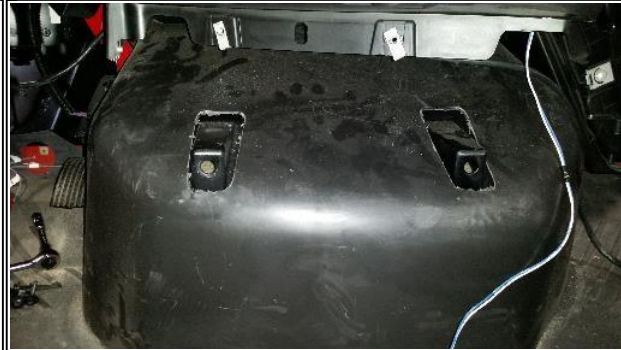
3. Remove dog house outer cover.

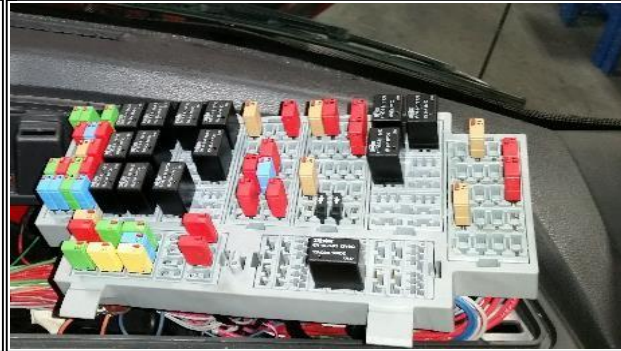
5. Loosen and set aside the PDM.

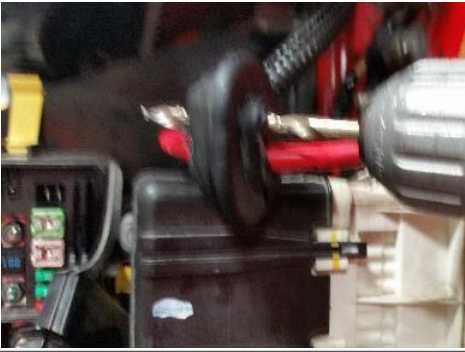
5. Drill a series of slightly increasing diameter, pilot holes into the grommet above the existing BCM power feed to carefully expand a hole thru the grommet to feed the red wire (A14A). Avoid contact between the drill bit and the BCM power feed cable. Center the drill bit so it is approximately 3/8" above the closest point of the BCM power feed cable.

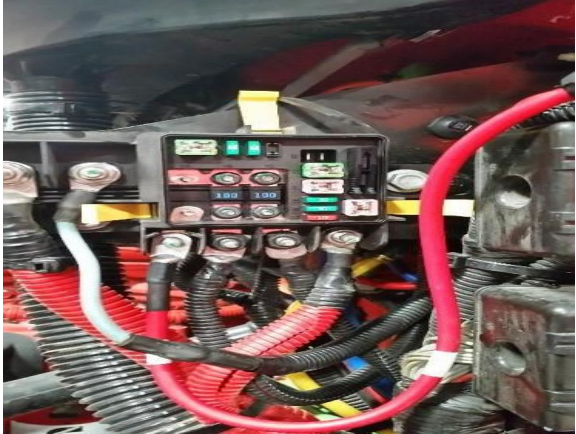
| <p>6. Feed the red wire (A14A) with ring terminal end thru the drilled hole in the grommet being careful not to tear the grommet. Pull approximately (1 to 1.5) feet of the red wire (A14A) thru the grommet.</p> <p>7. Reinsert the grommet back into the cab opening. Make sure that grommet is fully seated into the opening. It may be necessary to check the seating of the grommet from inside the cab as well.</p> <p>8. Connect the ring terminal to the same terminal that the body controller is currently receiving power from. Torque 15 +/- 1.5 N/M</p> <p>9. Install conduit and zip ties. Make sure there is a slight drip loop made with the body controller power and new harness power feed.</p> | |

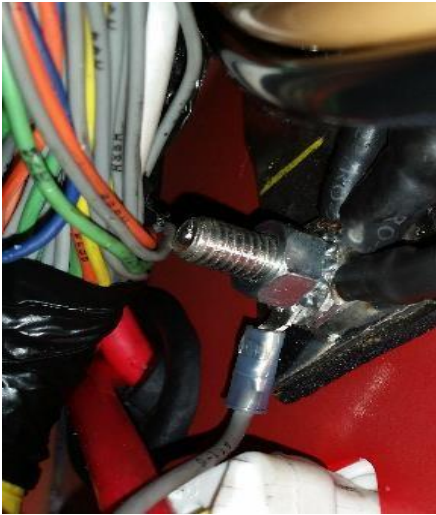
| <p>10. On the inside of the cab, connect the ground ring terminal (A111-g) to the cab ground stud.</p> <p>11. Install the plastic cap on the ground stud and ensure that the harness will not rub on the ground stud.</p> <p>12. Using the double sided adhesive and zip ties mount the fuse to the bulkhead and secure in place with the zip ties provided on any convenient location near the ground stud.</p> | |
