**Title: Catastrophic DOC and DPF Failures**

**Applies To: All Navistar Engines**

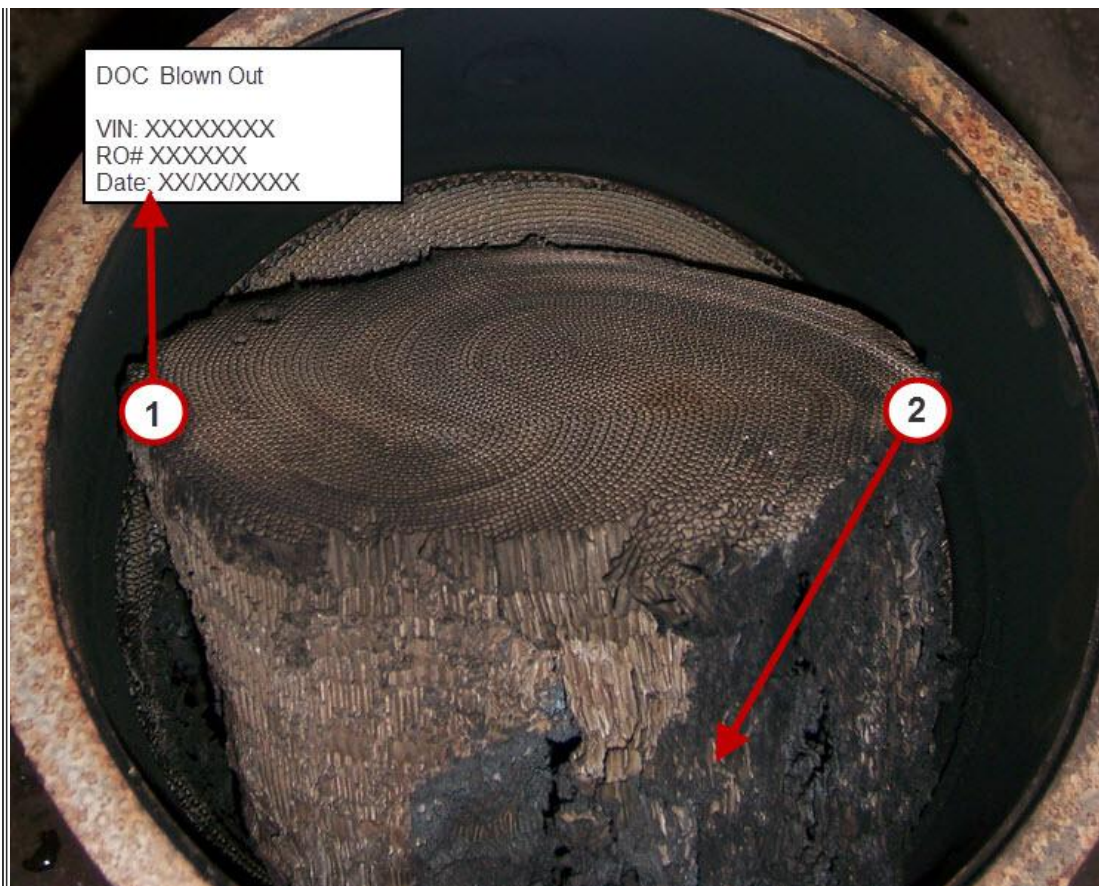
**Figure 1: DOC Substrate separation**

Item 1: Unit details (Do not block the damage with the tag).  
Item 2: Clear image of the damage.

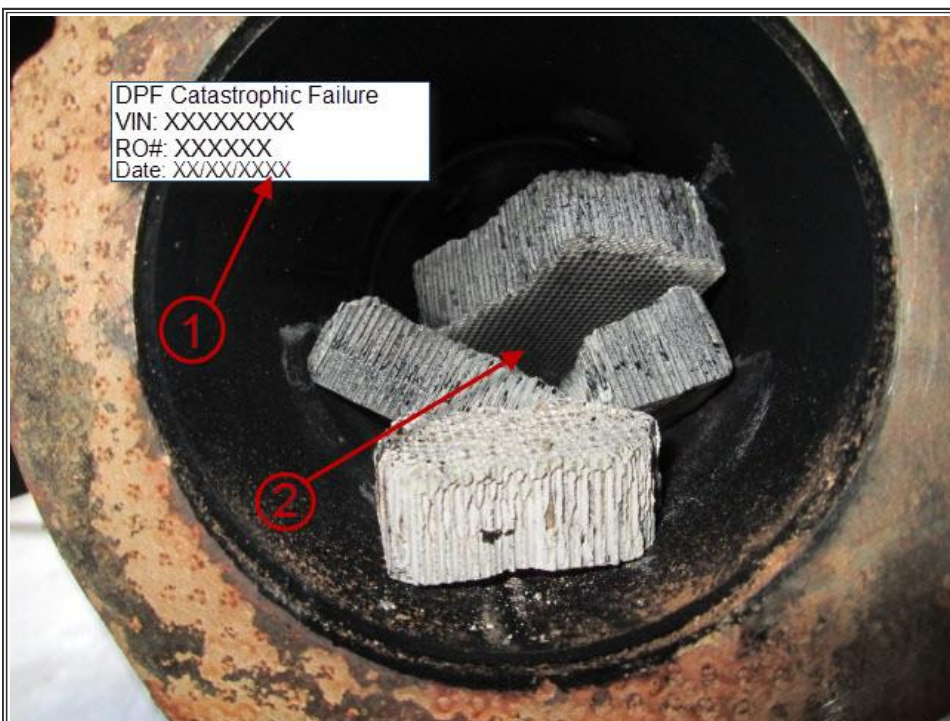
**Figure 2: DPF Substrate separation**

Item 1: Unit details (Do not block the damage with the tag).  
Item 2: Clear image of the damage.

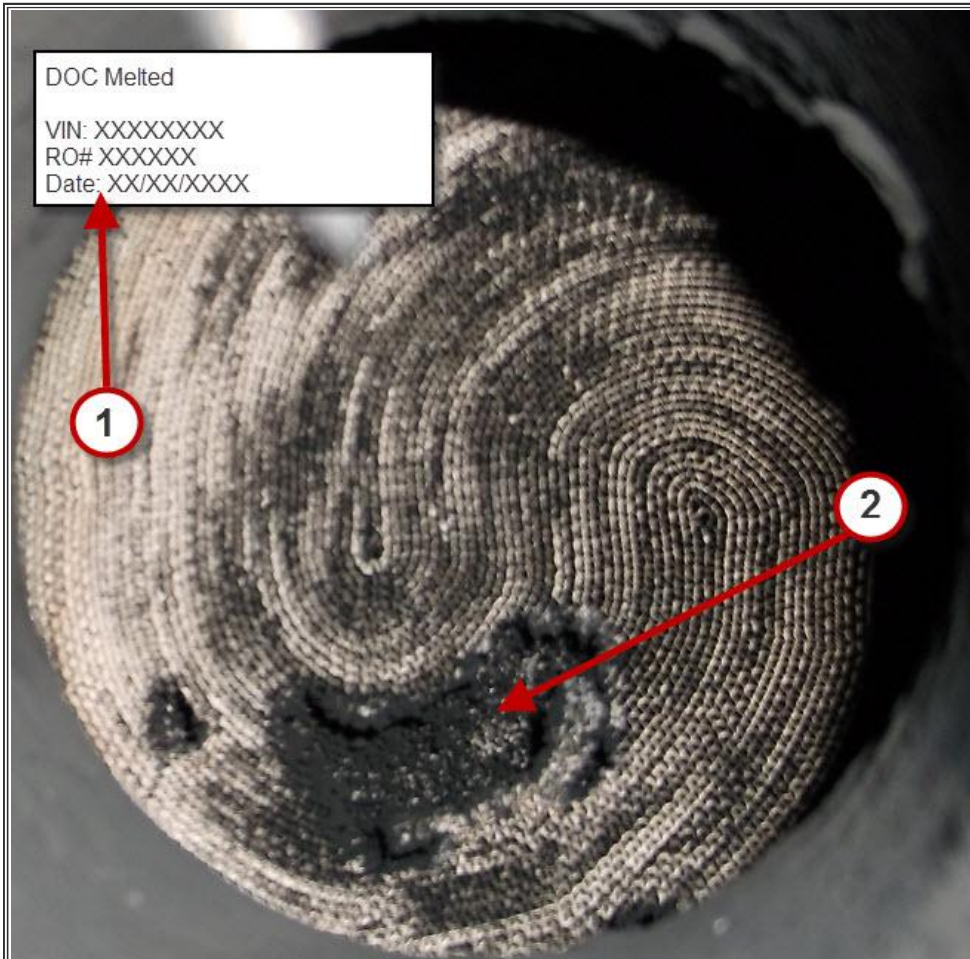
**Figure 3: Melted DOC**

Item 1: Unit details (Do not block the damage with the tag).  
Item 2: Clear image of the damage.

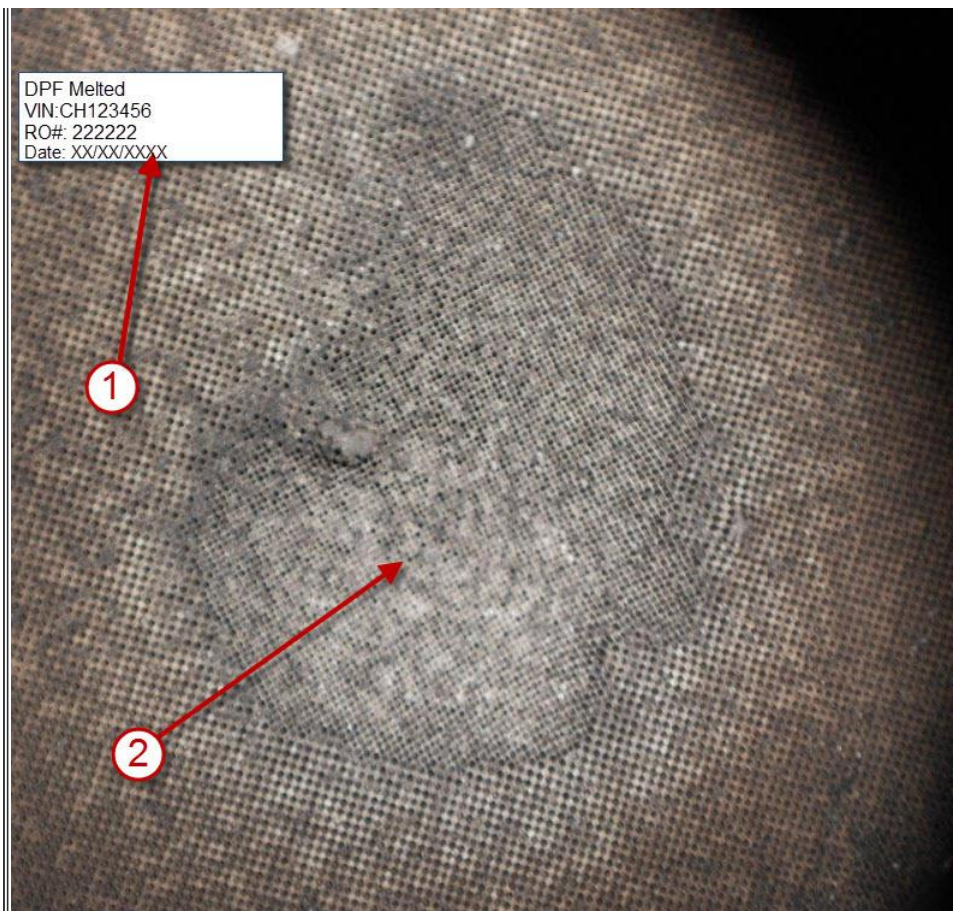
**Figure 4: Melted DPF**

Item 1: Unit details (Do not block the damage with the tag).  
Item 2: Clear image of the damage.

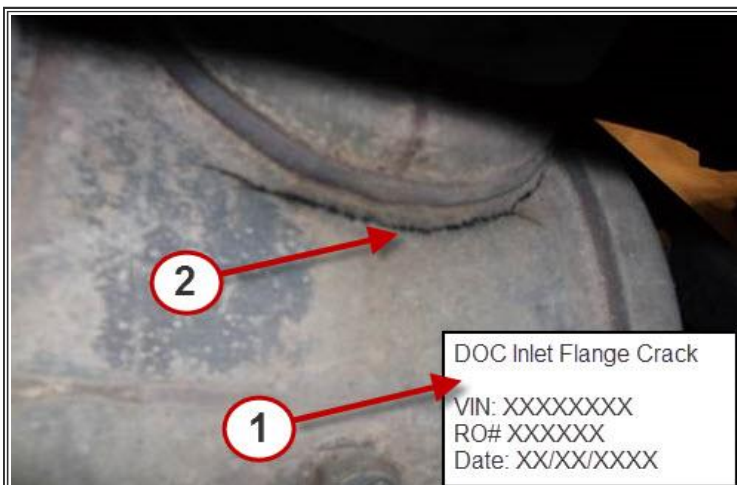
**Figure 5: DOC Cracked Inlet Flange**

Item 1: Unit details (Do not block the damage with the tag).  
Item 2: Clear image of the damage.

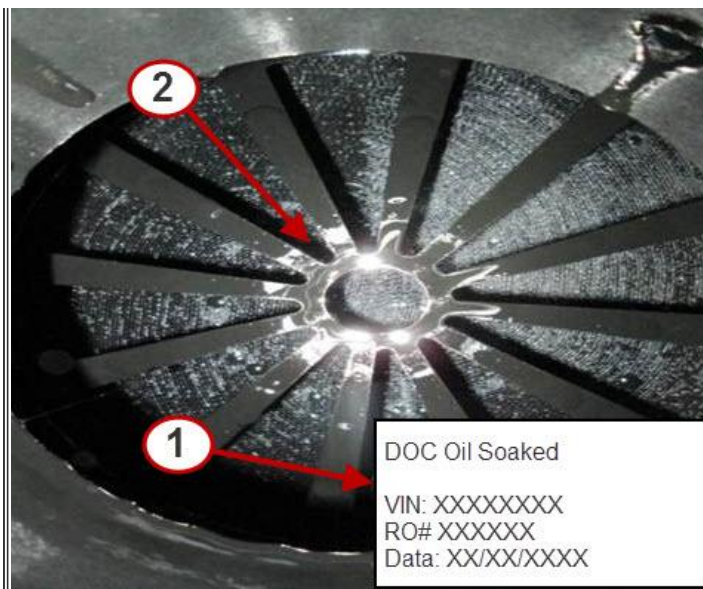
**Figure 6: Oil Soaked DOC**

Item 1: Unit details (Do not block the damage with the tag).  
Item 2: Clear image of the damage.

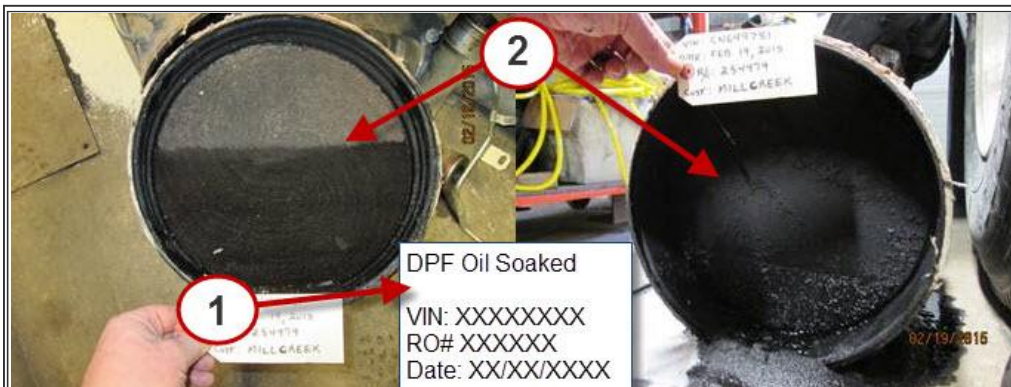
**Figure 7: Oil Soaked DPF**

Item 1: Unit details (Do not block the damage with the tag).  
Item 2: Clear image of the damage.

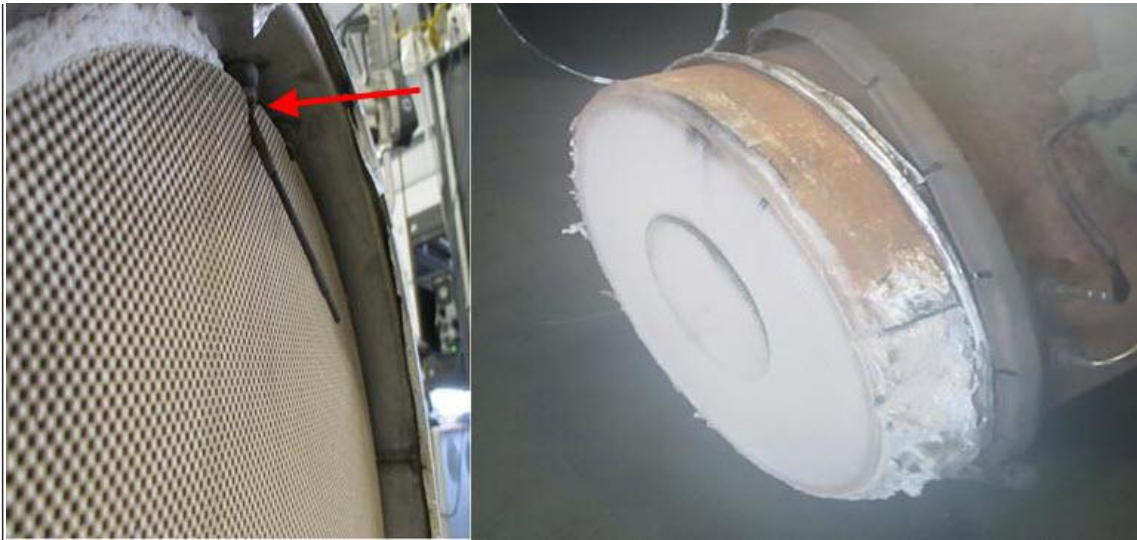
**Figure 8: Excessive substrate shifting**

**Moderate substrate shifting is not considered a catastrophic failure.** Excessive shifting is defined as enough movement to damage sensors. Please reference the aftertreatment diagnostic manual for additional information on brick shifting.

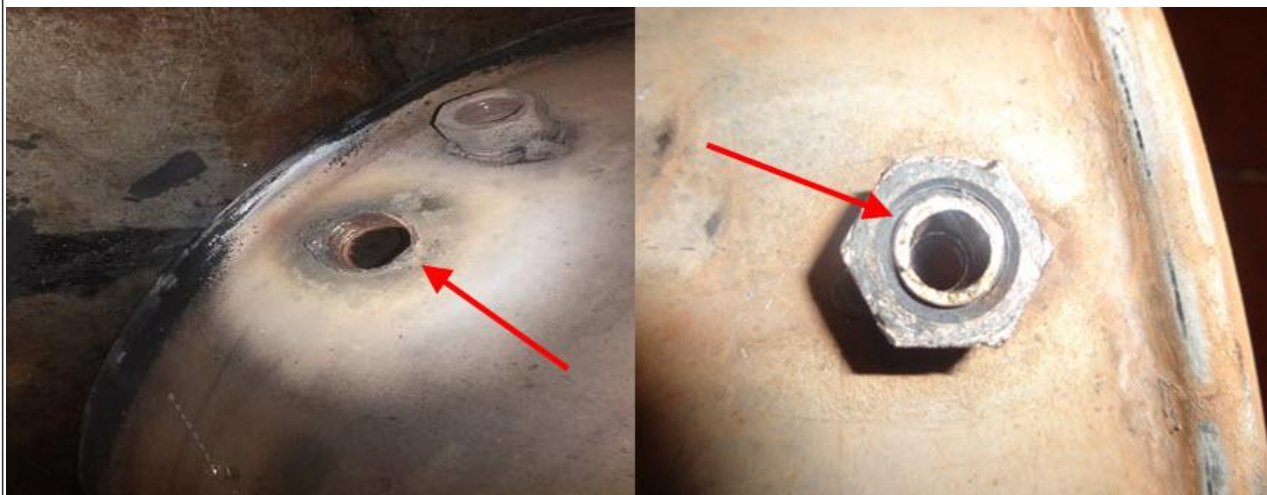
**Figure 9: Broken bung**

Pictured above are broken bungs. If broken or damaged unable to remove DPFDP tube the assembly must be replaced. **Stripped threads are not considered a catastrophic failure.** Reference the aftertreatment diagnostic manual (P.225) for repair process.

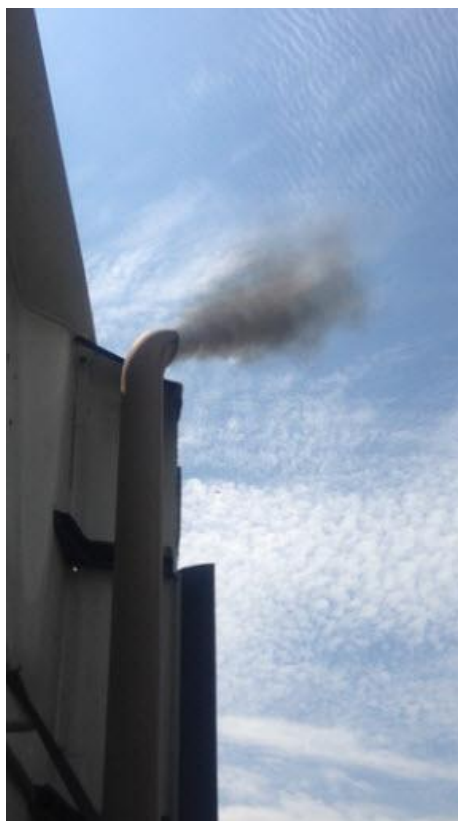
**Figure 10: Black smoke**

If continuous black smoke is seen exiting the tailpipe during **ONE** of the following tests below then the DPF has catastrophically failed.

- Snap Acceleration Test
- During zero - highway speed (100% engine load)
- Pulling a load or hill

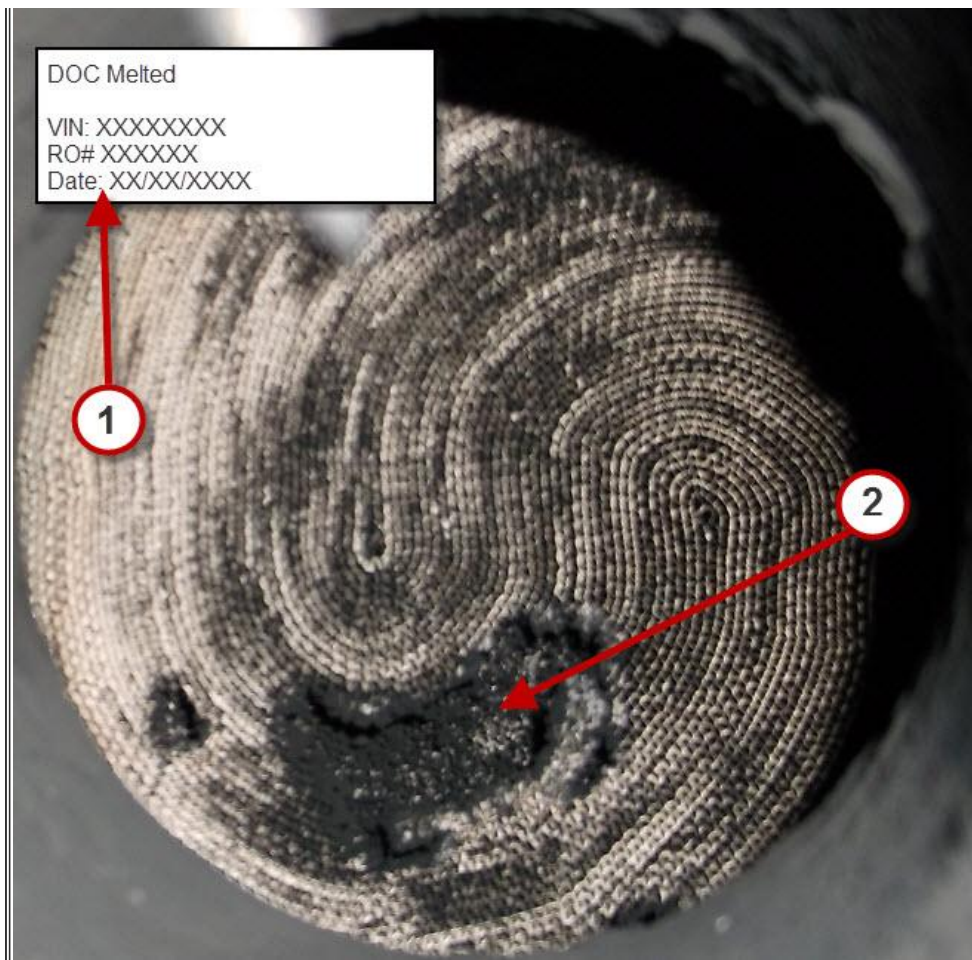
**Figure 11: Melted DOC**

Item 1: Unit details (Do not block the damage with the tag).

Item 2: Clear image of the damage.

Description: Followed Aftertreatment Diagnostic Manual 0000003081 symptom 3 to step 4, identified DOC was melted. Replaced DOC, followed to step 6 to verify system operation found unit has a cracked injector tip that is the root cause of the DOC melting. Completed all repairs and verified unit meets all operating specifications listed in the engine diagnostic manual.

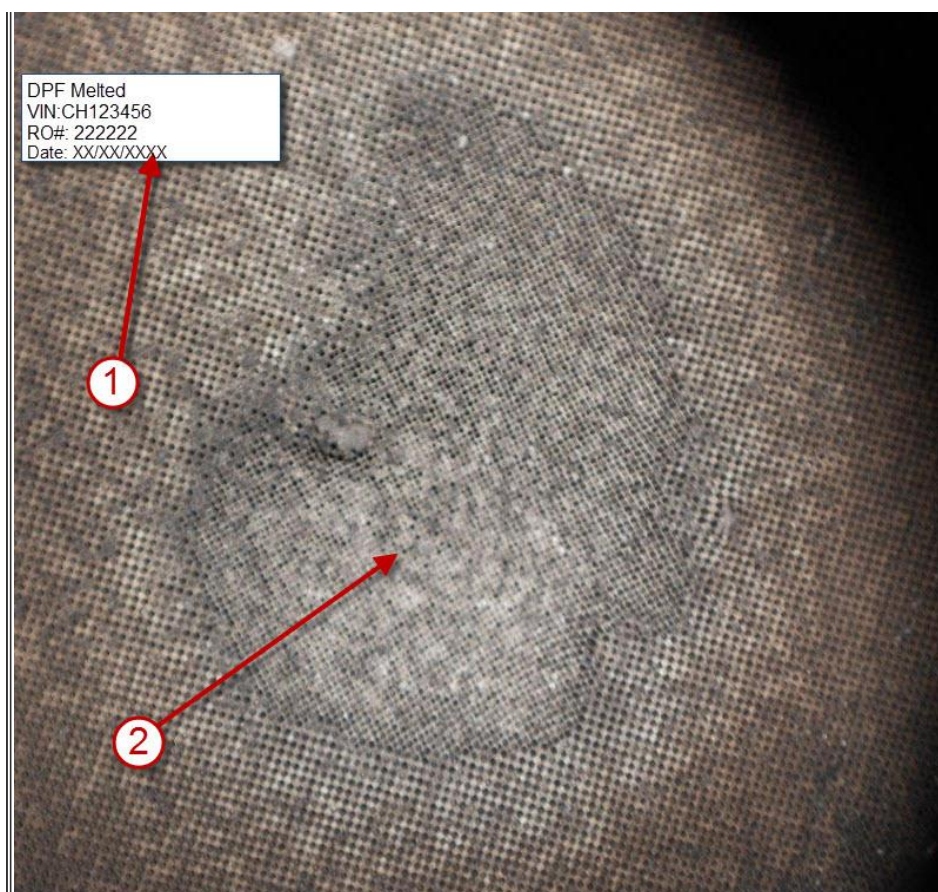
**Figure 12: Melted DPF**

Item 1: Unit details (Do not block the damage with the tag).  
 Item 2: Clear image of the damage.

*Description:* Followed Aftertreatment Diagnostic Manual 0000003081 symptom 5 to step 2, identified DPF was melted. Replaced DPF, followed to step 4 to verify system operation found unit has a cracked injector tip that is the root cause of the DPF melting. Completed all repairs and verified unit meets all operating specifications listed in the engine diagnostic manual.
