# ***SERVICE PROCEDURE***

17505  
October 2017

**SUBJECT:**    **SAFETY RECALL**  
**Hydraulic Brake Drop Hose Routing on certain CE**  
**school bus models built 07 July 2017 thru 02**  
**August 2017 with hydraulic brakes**

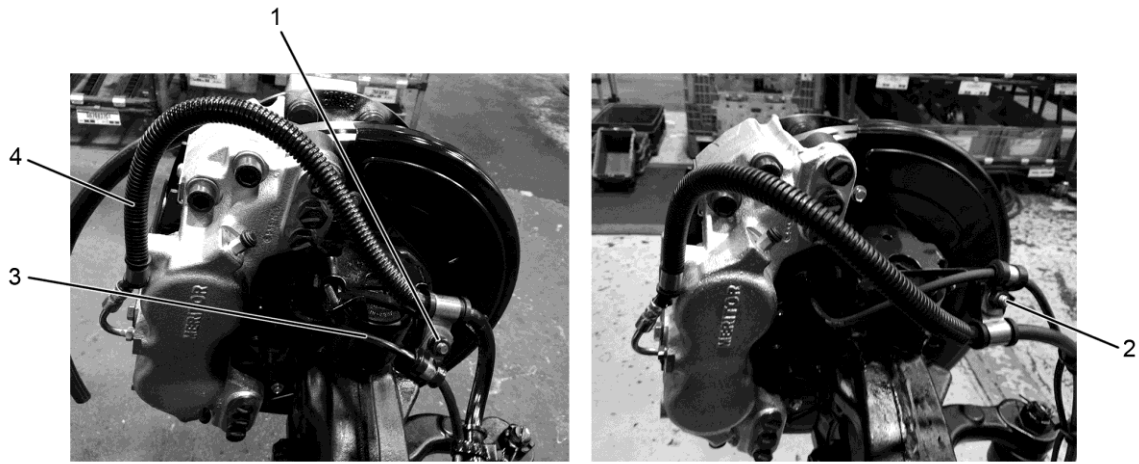
### Figure 3. Hydraulic Brake Hose Routing

1. Incorrect hose routing for 3870758C3
2. Correct hose routing for 3870758C3
3. ABS harness
4. Brake line

**NOTE: When mounted correctly, the ABS harness (Figure 3, Item 3) will be in the top position and the brake line (Figure 3, Item 4) will be in the lower position.**

9. Inspect the hose 3870758C3 for proper routing and clipping of the hose.
  - a. If the hose is routed correctly (Figure 3, Item 2), there are no additional actions required. Proceed to step 17.
  - b. If the hose is routed incorrectly (Figure 3, Item 1), proceed to Step 10.
