## ENTRANCE DOOR LIGHT

Prevost vehicles

On the vehicles affected by this bulletin, install a light at the entrance door. This bulletin describes how to install the new entrance door upper molding and the light with its wiring.

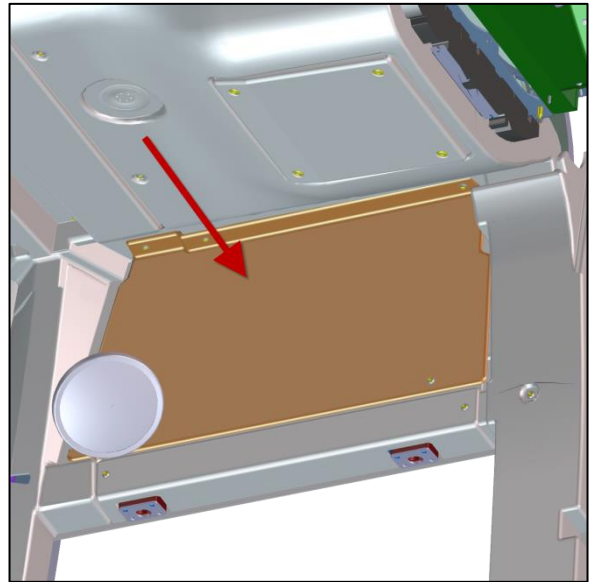
Figure 1

1. Remove closing cap (Figure 1).
2. Use a bit driving ratchet to remove the screw behind the mirror (Figure 2).

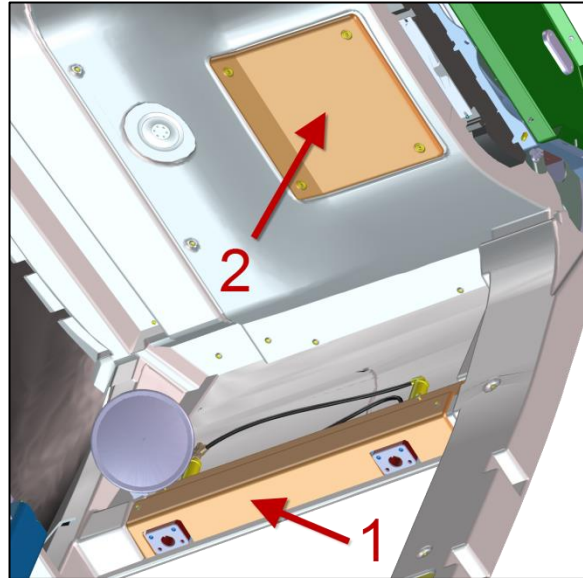
Figure 3

3. Remove entrance door upper moulding (item 1, Figure 3). This part will be replaced by the new moulding #3210118. Keep screws for the installation of the new moulding.
4. Remove front RH roof access panel (item 2, Figure 3).

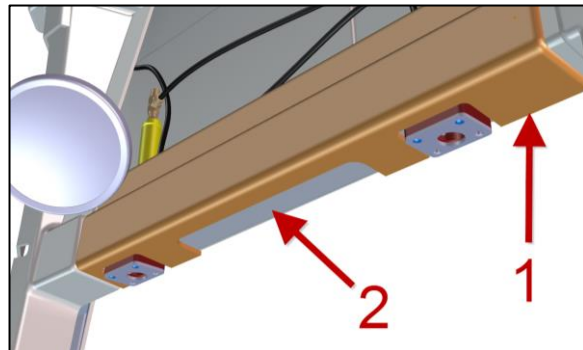
Figure 4

5. Install the new entrance door upper moulding #3210118 (item 1, Figure 7). Do not install screws yet.
6. Use a non-permanent marker to project the shape of the light opening of the moulding on the vehicle metal structure (item 2, Figure 4).

7. Remove the new entrance door upper moulding (item 1, Figure 4). The arrow in Figure 5 shows the projection of the moulding opening.

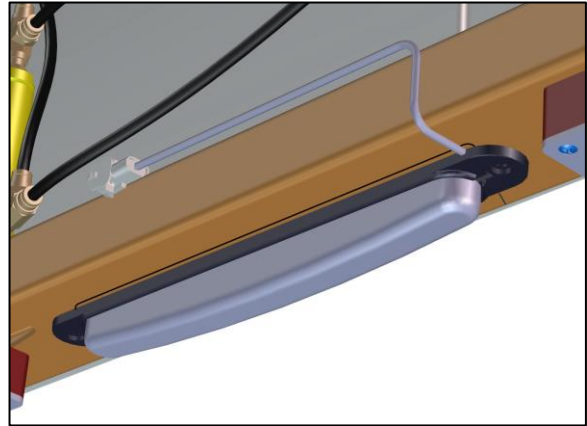
**Figure 6**

8. Center the entrance door light (Figure 6) with the marks made in step 6.
9. Mark the position of the holes to be drill through the metal structure (Figure 6). These holes will be used to support the light with screws.
10. Drill two holes  $\varnothing 1/8'' \pm 1/64''$  through the vehicle metal structure.

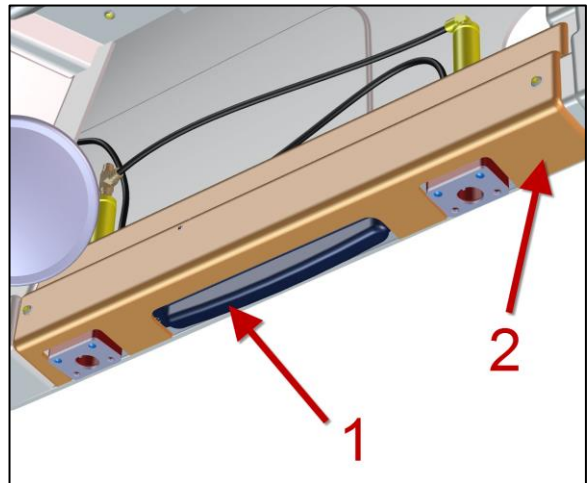
**Figure 7**

11. Install light #830008 with two screws #500854 (item 1, Figure 7).
12. Install new entrance door upper moulding #3210118 (item 2, Figure 7).

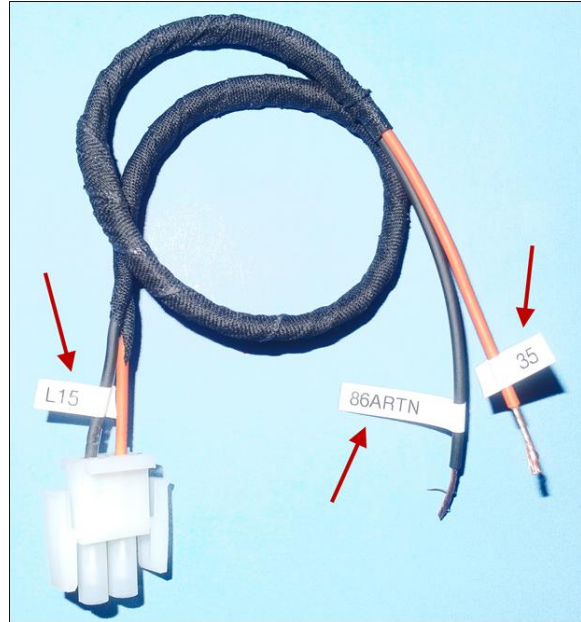
Figure 8

13. Plug new connector L15 (Figure 8) to the new light connector (Figure 9).
14. Run the other end of the wires to the top of the ceiling. The wires can be pushed up with very little effort and no fish tape is required.

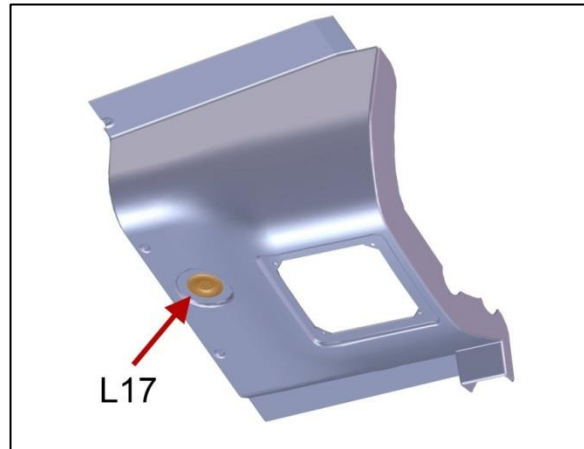
Figure 10

15. Locate the existing L17 light on the front RH roof (Figure 10).

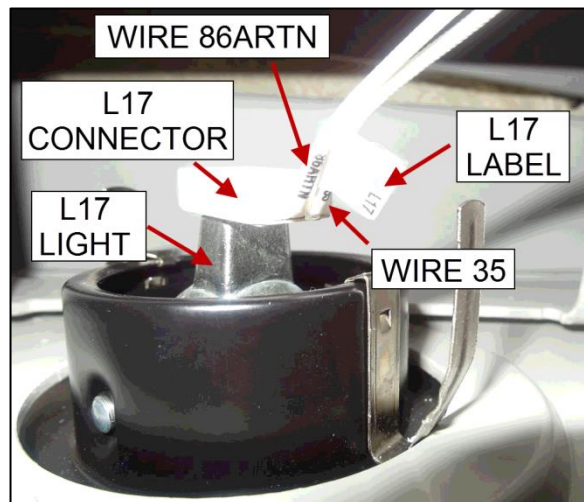
Figure 11

16. Locate wires 35 and 86ARTN of the existing L17 light inside the front RH roof (Figure 11).

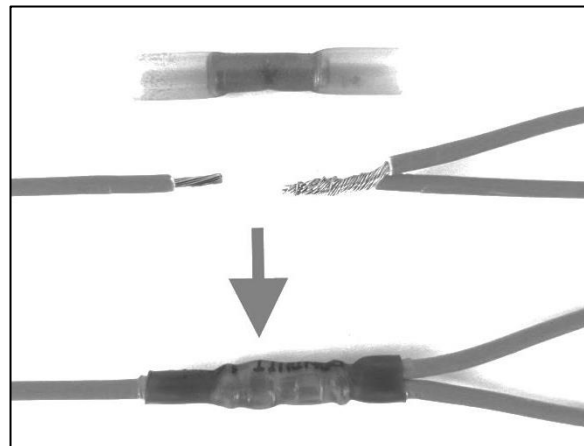
Figure 12

17. Connect wire 35 of the existing L17 light with the wire 35 of the new L15 light. Splice the wires as shown in the Figure 12.
18. Connect wire 86ARtn of the existing L17 light with the wire 86ARtn of the new L15 light. Splice the wires as shown in the Figure 12.
19. Using the heat gun, fully heat shrink the tube until no more shrinkage is apparent.
20. Check if the new light is working.
21. Tape the wires to the insulation on the side and to the upper side of the ceiling trim to prevent noise. Use hockey tape.

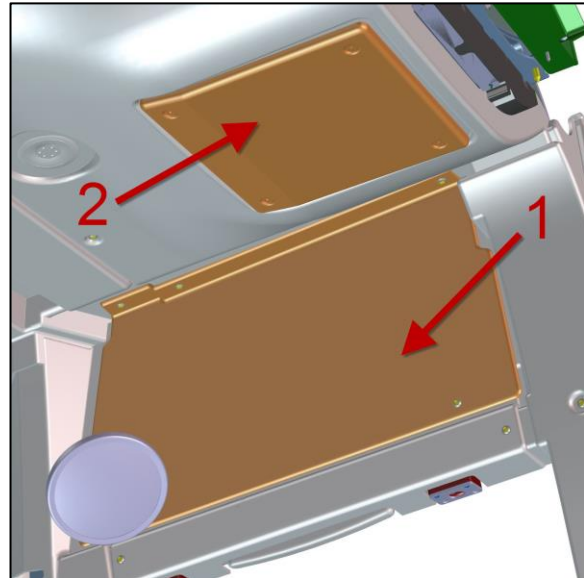
**Figure 13**

22. Install closing cap (item 1, Figure 13)
23. Install front RH roof access panel (item 2, Figure 13).
24. Bulletin is complete.
