SERVICE INFORMATION BULLETIN

APPLICABILITY: 2015-2018MY Legacy Models NUMBER: 12-230-17

SUBJECT: Trunk Garnish Installation Precautions DATE: 9/15/17

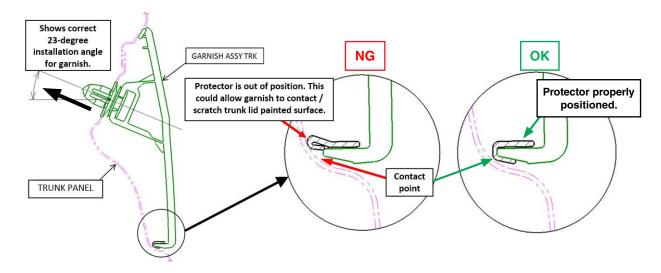
• Install the garnish by aligning the retaining clips then pushing forward and at a slightly upward angle at the same time. Pushing the garnish straight ahead may dislodge the protectors and allow the panel to contact the trunk lid. Undamaged retaining clips are reusable.

• The small rubber protectors on each lower end of the garnish must be in their proper positions. If not, CAREFULLY peel (they are self-adhesive) and reapply as necessary for proper positioning.
