Navigation Head Unit Precautions

Toyota Navigation Head Units

This bulletin is regarding best practices when handling navigation systems that use Hard Disc Drive or Micro SD Card memory.

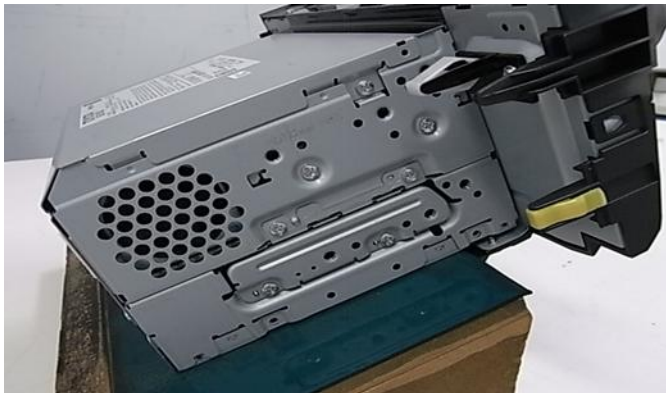
1. First type is generation 6 or 7 which utilizes HDD (Hard Disc Drive). Pioneer models that begin with **NXH**, have Map Data, Operating System and other Information in the Hard Disc Drive. With this system if a radio is being sent back for an exchange. The original Hard Disc Drive needs to be removed and installed into the newly serviced radio.

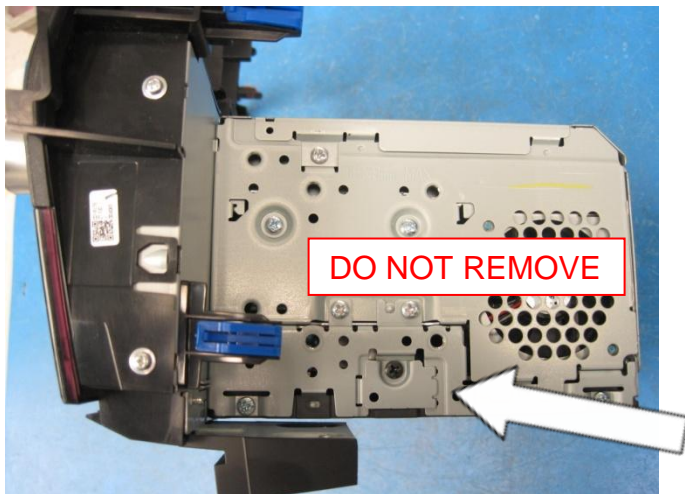
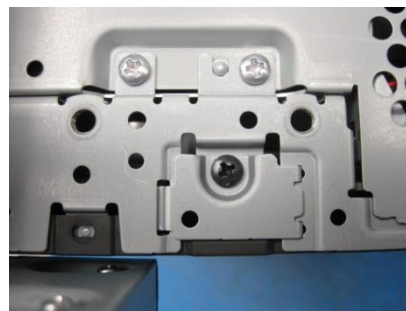
There is another Micro SD card (*Operating System*) inside the Navigation Module. (Similar location to the Hard Disc Drive in the Generation 7 system). This micro SD Card **Should Not** be removed for any reason. Micro SD cards located in this internal slot need to be returned with the original radio.

This Micro SD card MUST NOT be removed.
This will void the Warranty status from Pioneer if removed and dealer will be debited the core credit.
