# Abnormal Screen Appearance

YEAR(S)	MODEL(S)	ADDITIONAL INFORMATION
2017	Corolla

Some 2017 model year Corolla vehicles may exhibit a condition where the radio will display vertical lines on half of the screen after starting the vehicle. This condition is intermittent and may not be easily duplicated. An updated radio has been made available to address this condition.

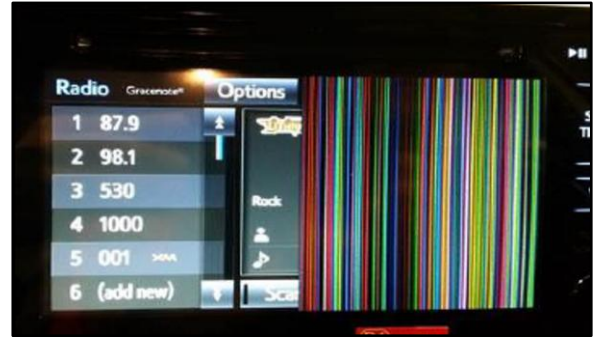
Figure 1.

- 2017 Corolla:  
*Audio/Visual/Telematics – Audio/Video*  
– “*Audio/Video: Radio Receiver:*  
[Removal / Installation](#)”
  - 2017 Corolla:  
*Audio/Visual/Telematics – Navigation/Multi Info Display* – “*Navigation/Multi Info Display: Navigation Receiver:* [Removal / Installation](#)”
2. On navigation equipped vehicles, be sure to move the navigation map micro SD card to the remanufactured radio.
  3. Confirm normal operation after the repair has been completed.
