Outside Door Handle Sticking

Service Category Vehicle Exterior

Section Door/Hatch

Some 2007 – 2015 Tundra and 2008 – 2015 model year Sequoia vehicles may exhibit an abnormal feeling, dragging or sticking when using the outside door handle. Use the following procedure to address this condition.

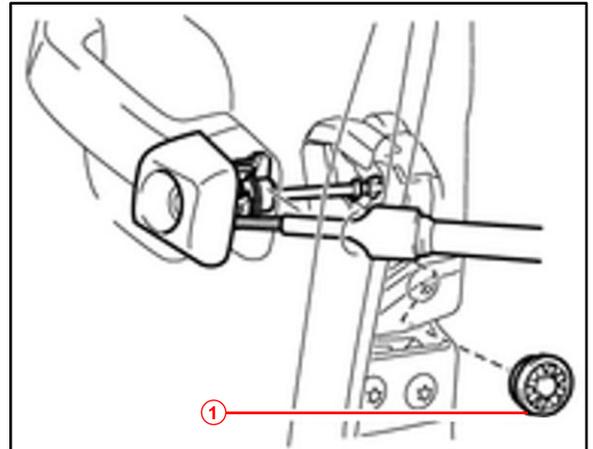
Figure 1. WITH Lock Cylinder

1. Remove the outside door handle cover.
 - A. Remove the hole plug.
 - B. Using a T30 torx wrench, loosen the screw and remove the front door outside handle cover and the door lock key cylinder (if equipped) as a unit.

1	Hole Plug
----------	------------------

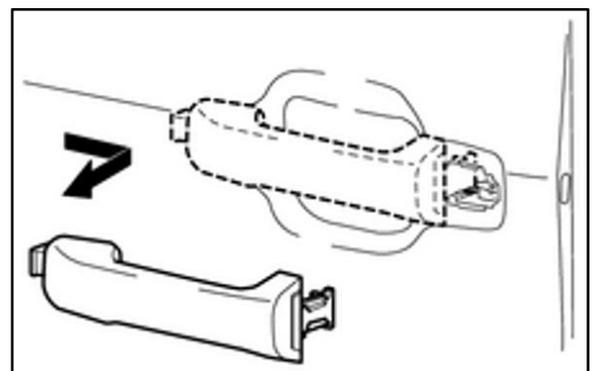
Figure 3

2. Remove the Outside Door Handle Assembly by sliding and pulling it in the direction indicated by the arrow as shown.

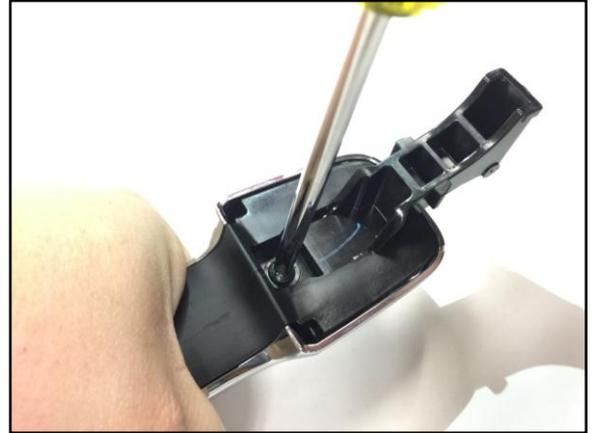
Figure 4.

3. Disassemble the outside door handle.
 - A. Remove the screw from the Outside Door Handle Assembly previously removed from the vehicle.

- The screw is secured using thread locking compound. When attempting to remove the screw, use a high quality, #2 Philips screwdriver, with an undamaged tip.
- To minimize slipping and to reduce the risk of stripping the screw head, apply firm inward pressure while turning the screw.

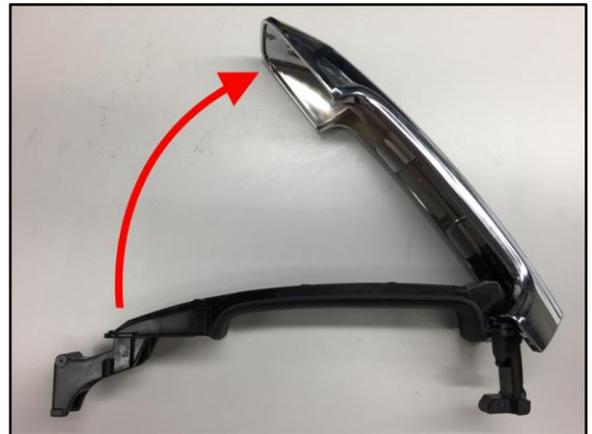
Figure 5.

- B. Remove the door handle inner from the outside door handle outer cover by rotating it in the direction indicated by the arrow as shown and discard the outside door handle inner.

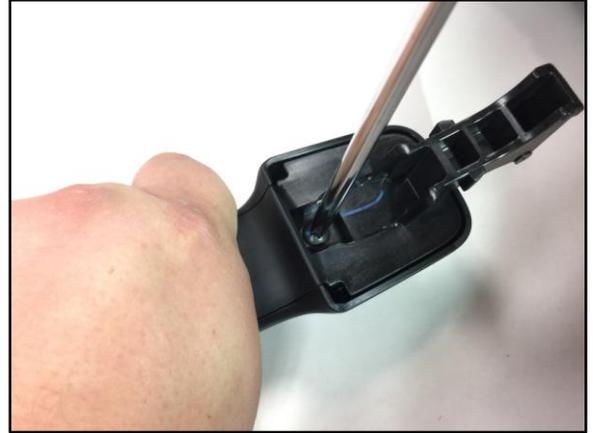
Figure 6.

4. Disassemble the NEW outside door handle.
 - A. Remove the screw from the NEW Outside Door Handle Assembly.

- The screw is secured using thread locking compound. When attempting to remove screw, use a high quality, #2 Philips screwdriver, with an undamaged tip.
- To minimize slipping and to reduce the risk of stripping the screw head, apply firm inward pressure while turning the screw.

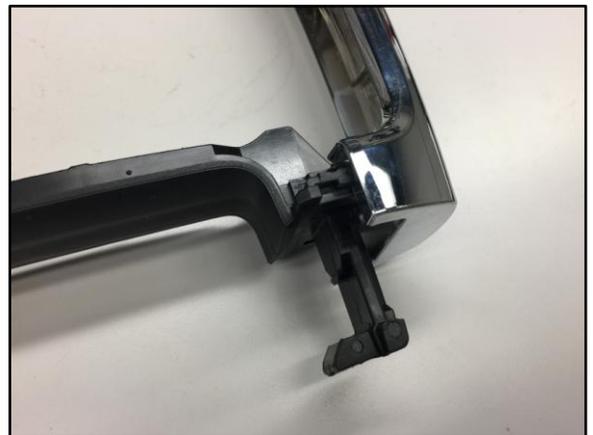
Figure 8.

5. Reassemble the outside door handle.
 - A. Install the NEW door handle inner to the OLD outside door handle cover by engaging the 2 tabs.

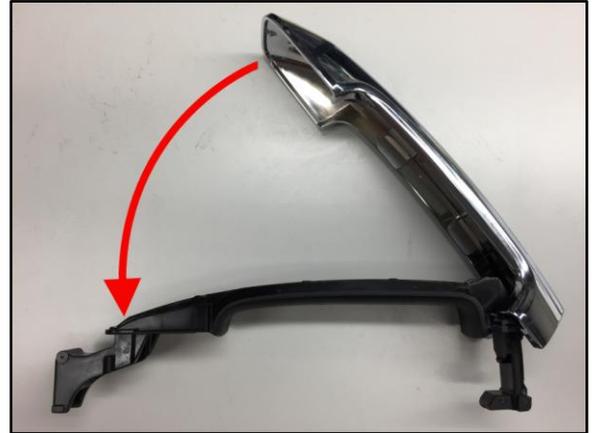
Figure 9.

- B. Seat the cover by rotating in the direction indicated by the arrow as shown.

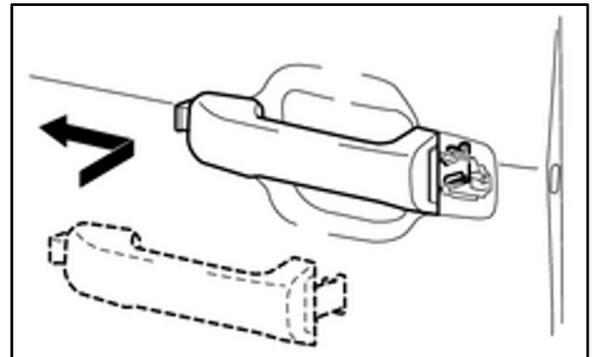
Figure 10.

- 6. Install the Outside Door Handle Assembly by pushing it in the direction of the arrow as shown.

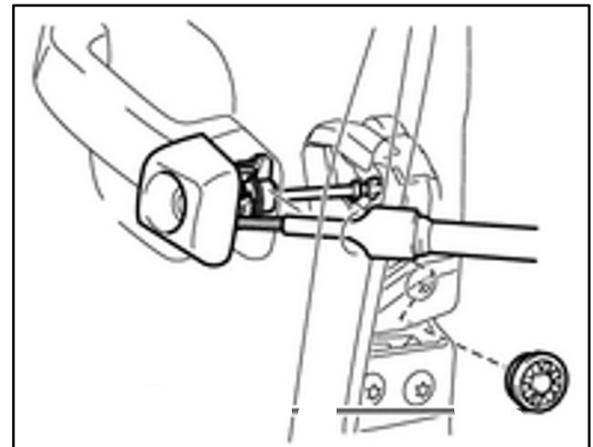
Figure 11.

- A. Using a T30 torx socket, install the outside handle cover and the door lock key cylinder (if equipped) as a unit.

Torque: 4.0 N*m (41 kgf*cm, 35 in*lbf)

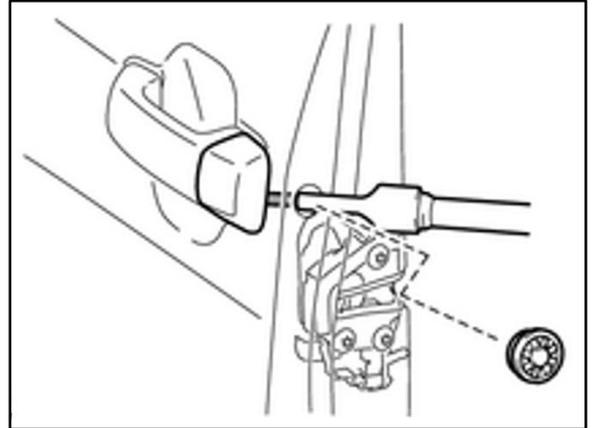
Figure 12.

- B. Install the hole plug.
